# 2

## Cases of Machinery Failure

### 2.1 The Cases

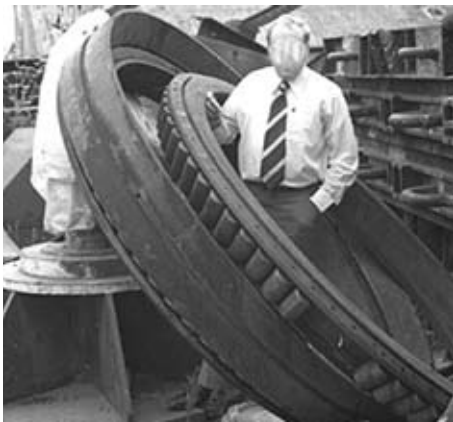
Figure 2.10 Broken main bearing of the MRTA tunnelling machine

ward on its hydraulic supports. In this condition the main hydraulic rams of the machine are fully contracted. The hydraulic supports of the machine are then extended to grip the walls of the tunnel. Following this step, the cutter head is rotated at approximately 5 r.p.m. while the main hydraulic rams push the head forward into the rock face. Figure 2.9 is schematic view of the head of the tunnelling machine, indicating the nature of loads imposed on the head by the rock face. These loads are a combination of a thrust force,  $F$ , and a moment,  $M$ , the former varying in magnitude and the latter varying in both magnitude and direction as a result of variations of rock strength in the tunnel. Figure 2.10 is a photograph of the failed bearing with a 1.7 m tall person to provide an idea of the scale of the failed component.

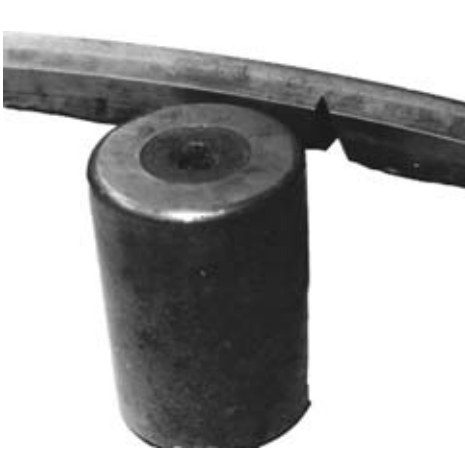
Figure 2.12 Bearing roller and part of the failed bearing cup. The notch was used for establishing material properties

Figure 2.12 is a close-up of a bearing roller, together with part of the bearing cup that broke away during the failure of the bearing. Figure 2.13 shows the complete broken part of the bearing cup representing approximately 120° of arc or about the arc length corresponding to 1/3rd (16) of the total number of bearing rollers (this bearing had 48 rollers in each row).

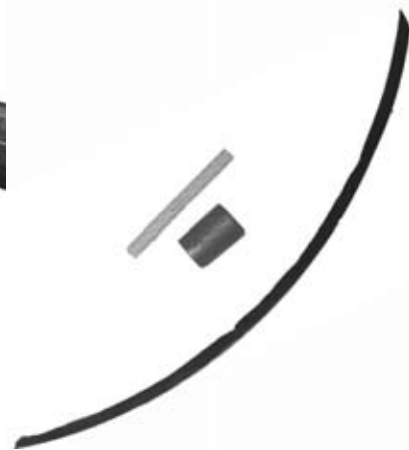
Figure 2.13 Part of the bearing broken away during the accident, with a roller and a 300 mm ruler to indicate scale

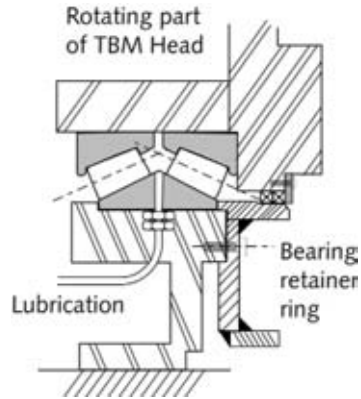
Figure 2.15 Original design of bearing mounting. This partial view shows the relatively flexible retainer ring

Using even the smallest estimated moment ( $3 \times 10^6 \text{ Nm}$ ) acting on the bearing, the flexure of the retainer ring permitted the bearing to deflect by approximately 2 minutes of arc. This value exceeded the manufacturer's safe recommendation of 0.5 minutes of arc by a factor of four for about 65% of the operating time. The rest of the time the flexure was greater than this conservative value. It was estimated that the outside edges of rollers in the front row of the bearing "rode" on the front lower part of the cup that eventually broke away, permitting the head to fall off.

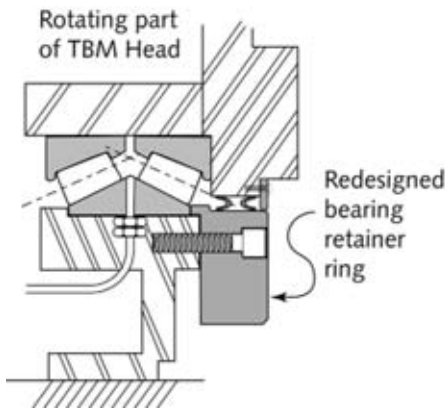
Figure 2.18 Bearing mounting with redesigned retainer ring

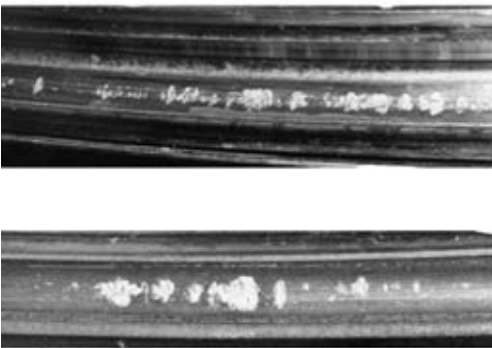
Figure 2.22 Bearing damage. The upper photo shows the damage to the inner (fixed) race. The lower photo is that of the damage to the moving (outer) race

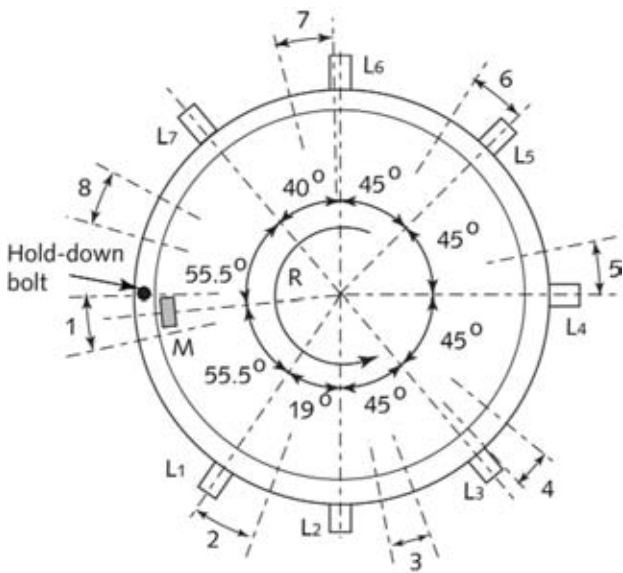
Figure 2.29 Layout of machine showing leg and bearing damage locations on the inner (fixed) bearing surface. The L numbers represent support leg locations, M is the motor drive location, R is the machine rotation direction and the damage locations numbered 1 to 8 were measured arbitrarily from the first hold-down bolt near the location of the motor drive

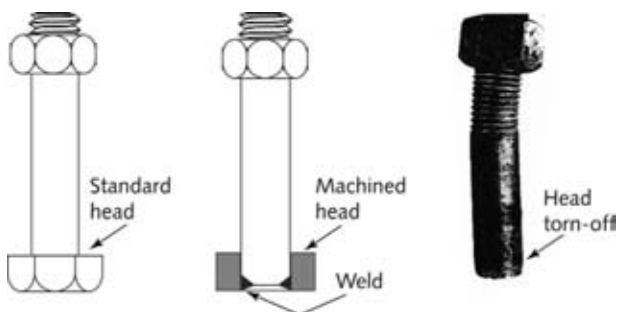
Figure 2.34 The damaged king-pin bolt and schematic sketches of a standard bolt and one similar to that manufactured by Blunt

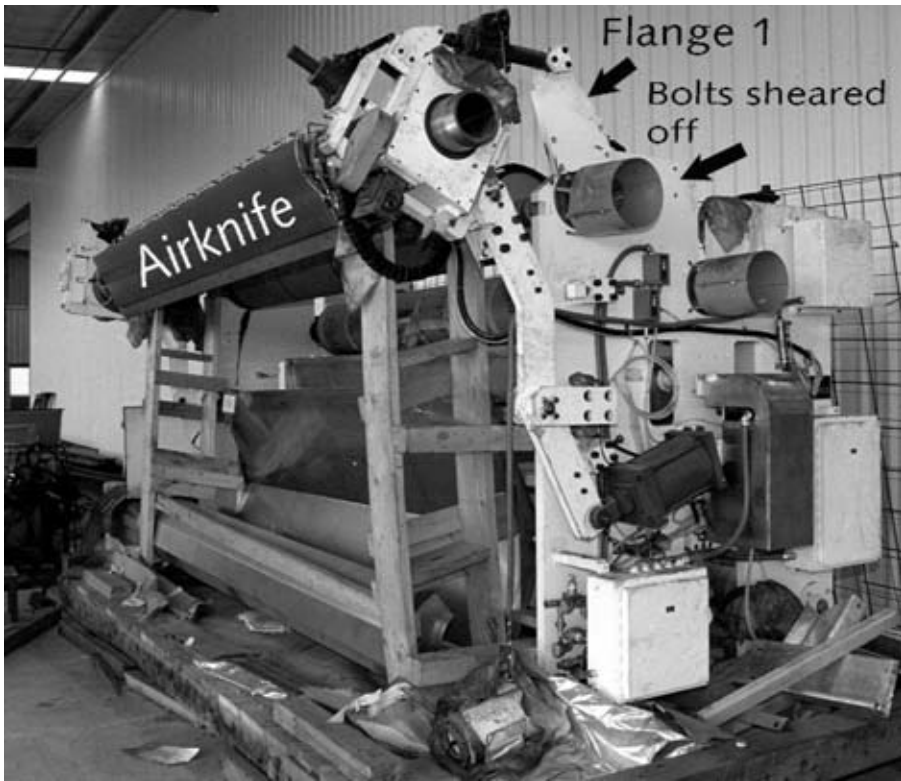
The machinery for the coating line was packaged and delivered as marine cargo to the port of Melbourne in late 1994. One package, that containing the airknife machine, was found to be seriously damaged on delivery to

Figure 2.41 General view of the partially unpacked airknife machine in its damaged packaging

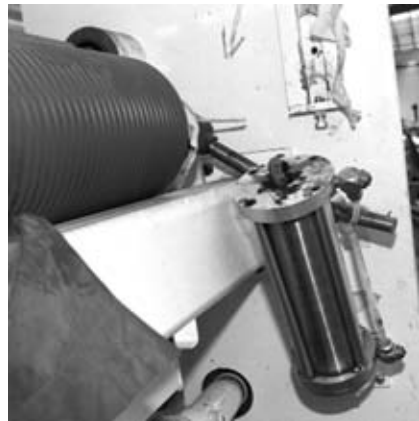
Figure 2.43 View showing roller dislodged from its bearing and damaged air cylinder

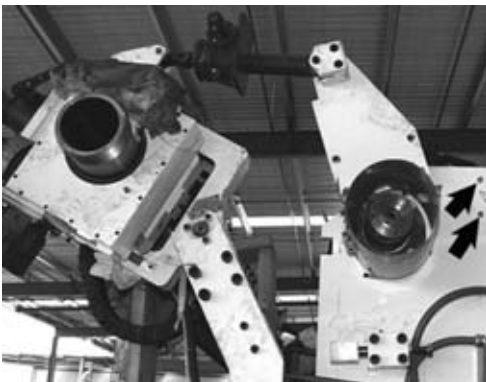
Figure 2.44 Airknife support head and its various adjustments. The arrows show where the flange bolts sheared off

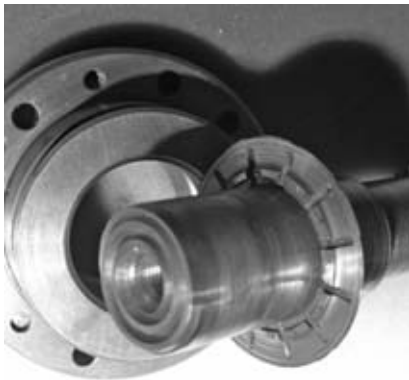
Figure 2.51 Heavily worn thrust face on high-speed journal

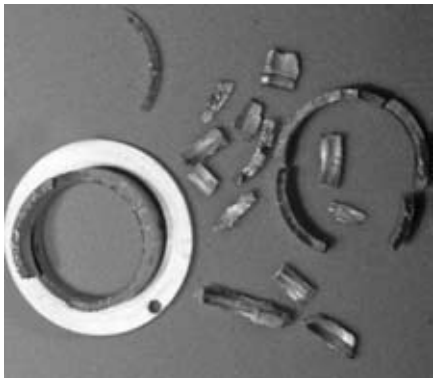
Figure 2.52 Components of bearing shell recovered from seized compressor

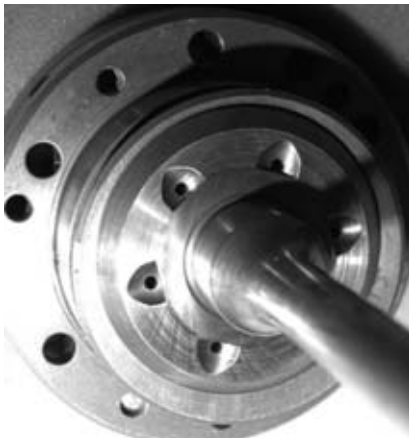
Figure 2.53 Nominally worn thrust face of high-speed shaft replaced in overhaul

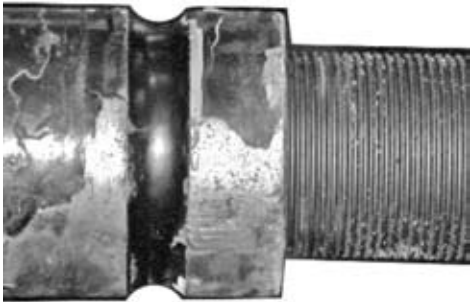
When the steering linkages of the flipped tractor were examined, it was found that the steering knuckle had been pulled out of the main steering track rod. This track rod is a heavy tubular component that connects the steering arms of the two front wheels on the tractor (see the item marked Z in diagram (b) of Figure 2.57). Three-degree-of-freedom ball joints on the steering knuckle (item marked E in diagram (a) of Figure 2.57) allow for the necessary motion freedoms required for steering the front wheels. The screw adjustment of the steering knuckle permits the camber of the front wheels to be adjusted. Camber is the angle the plane of the wheel relative to the vertical plane and is used to control steering forces.

Figure 2.59 Redesigned track rod end as found on flipped tractor

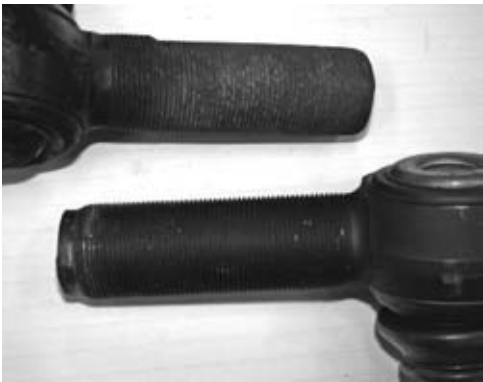
Figure 2.61 Worn knuckle (top) and new knuckle (bottom)

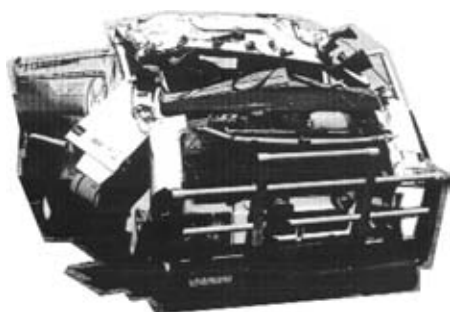
Figure 2.67 The damaged tipper owned and driven by Baritone

Figure 2.66 shows a typical tipper and Figure 2.67 is a photo of the damaged Safedrive tipper. Figures 2.68 and 2.69 show the steering linkage used on the tipper. Standard steering mechanisms use a simple Ackerman-type steering linkage based on the kinematics of the four-bar chain.<sup>2.24</sup> This linkage is designed to permit the outer steered wheel in the steering circle to roll further than the inner steered wheel, thereby eliminating tyre slip and wear. Figure 2. 70 shows a schematic sketch of the Ackerman linkage. On right-hand-drive vehicles the input to the steering linkage is provided by the steering link, normally a short link with two ball joint ends (see the link marked A in Figure 2.68). It is this link that failed on the Safedrive tipper, causing the whole steering linkage to become free to move under the steering forces generated by the ground reaction on the tyres. Once the vehicle left the sealed road and moved onto the soft shoulder of the road, the front wheels would dig into the soft soil and turn at some steep angle to the direction of motion. The wheel dug into the dirt and became a pivot about which the vehicle rolled over. Police photographs at the scene showed the

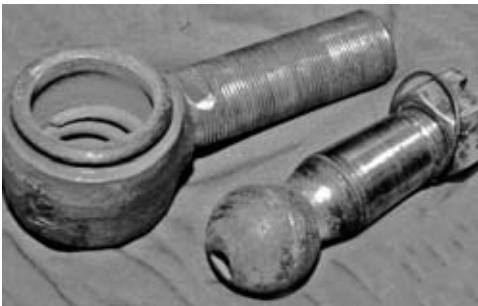
Figure 2.71 shows the two major parts of the failed ball joint. The socket was found to be completely filled with local clay and had to be cleaned out for full metallurgical examination. Figure 2.72 shows the ball joint at the other end of the failed steering link. Figure 2.73 shows a schematic sketch through a typical ball joint used on Safedrive vehicles. In the investigation of the accident the nylon bushes were not recovered. Figure 2.74 shows some parts of the sealing boot recovered from the failed joint. Sealed ball joints are generally expected to last for many years. If the sealing boot remained intact then it would be reasonable to expect such joints to last the full lifetime of the vehicle. The dispute in this case resolved into the following two issues:

Figure 2.71 The failed ball joint on the steering link. The socket had been cleaned out for this photo

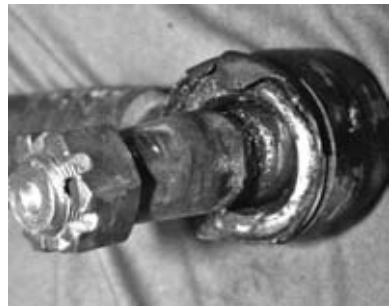
Figure 2.72 The ball joint at the other end of the steering link. Note the damaged grease boot

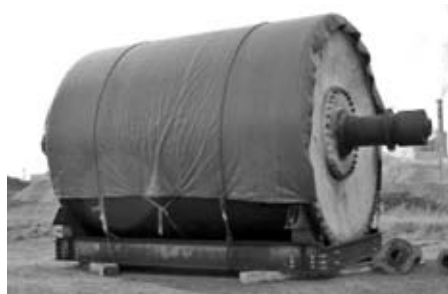
Figure 2.76 The discarded Yankee dryer stored on a field float at Marigold
