# Chapter 2

## Tsunami Damage: What Is Unexpected?

Koji Ichii

Geotechnical Predictions and Practice in Dealing with  
Geohazards

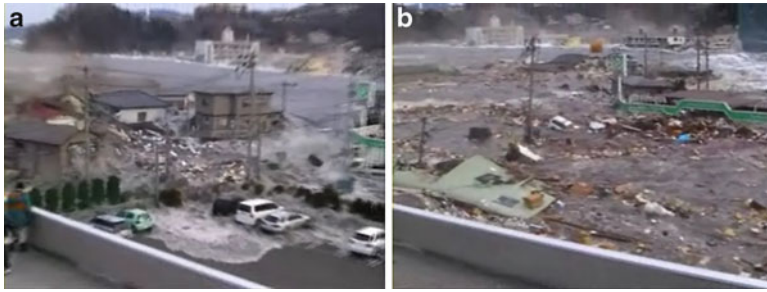
**Fig. 2.7** Snapshots of the moment of tsunami (anonymous official). (a) The moment of tsunami. (b) Tsunami covered everything

Figure 2.7 shows snapshots from the video recorded by a government official. He evacuated to the roof terrace of a building and recorded the entire event from the terrace. The tsunami height shown on the left side of Fig. 2.7a was almost as high as a two-story house, and the houses shown in the figure were swept away. The entire city was covered by the tsunami, as shown in the right side of Fig. 2.7b. These scenes were recorded at the Kamaishi Port, where breakwaters were installed as shown in Fig. 2.5.

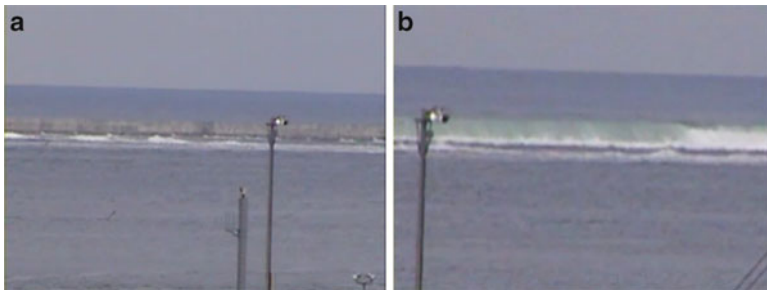
**Fig. 2.8** Snapshots of the Kamaishi Port Gate Breakwater (anonymous official). (a) Bubbles behind the caisson walls. (b) Overflowed tsunami

The observed tsunami height was larger than expected in the design of breakwaters. The real performance and effect of breakwaters for the mitigation of tsunami impact were still under investigation and discussion. The situation at the first tsunami wave at the breakwater site was recorded by the official mentioned in the preceding. Figure 2.8 shows the tsunami at the breakwaters. In the beginning, white bubbles were observed behind the caissons of breakwaters (Fig. 2.8a). The reason of this phenomenon might be the difference of the water level between the front (tsunami) and back (port) sides. But there is a discussion that this was caused by the water flow between caissons or upward flow from rubble foundations owing to the high permeability in the foundations. Nevertheless, a few moments later, the tsunami overflowed as shown in the right side of Fig. 2.8b.

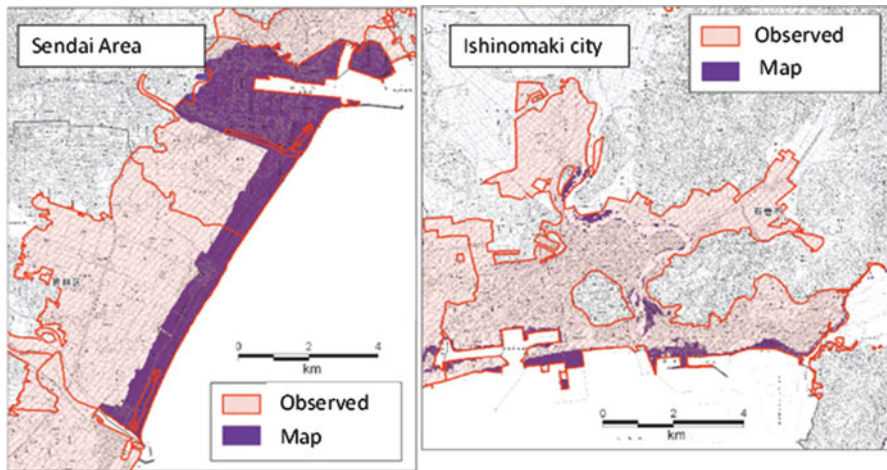
**Fig. 2.9** Tsunami inundation areas observed in reality and shown in the hazard maps (Cabinet Office, Government of Japan)

As a result of the unexpected height of the tsunami, the observed inundation was far beyond the area earlier imagined. Figure 2.9 shows the comparison between the tsunami inundation areas shown in the hazard maps and those observed in reality. The reality was much more severe than imagined.

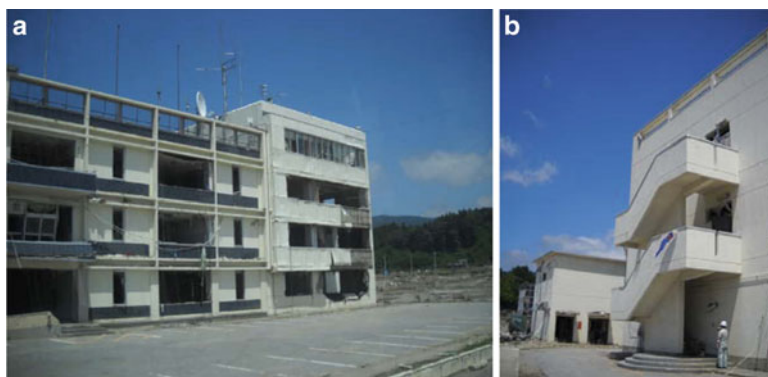
**Fig. 2.10** Photos of Rikuzentakata City Office. (a) The damaged Rikuzentakata city office. (b) Emergency stairs of the office

300 people). The height of the tsunami was unbelievable, reaching the third floor, as shown in Fig. 2.10a. A tsunami of such a height was a completely unexpected event.

What was disappointing was the fact that the emergency stairs did not reach to the roof terrace, as shown in Fig. 2.10b. Actually, some people on the roof terrace survived. (The video of evacuated people on the terrace was recorded and broadcast throughout the Internet.) Therefore, there may have been another way to evacuate to the roof terrace, which was effective. But if the emergency stairs had reached the roof, more people could have been evacuated.

It might be impossible for us to imagine that such a high tsunami would attack the office. Otherwise, more efforts would have been made. Obviously, even for such a high tsunami, more effort could have been expended to mitigate the disaster, such as extension of the stairs to the roof, preparation of a rubber boat on the roof, and so on. The point is that it is unlikely to imagine such an unbelievably high tsunami in advance, and accept the budget required for evacuation efforts that would usually be needless.

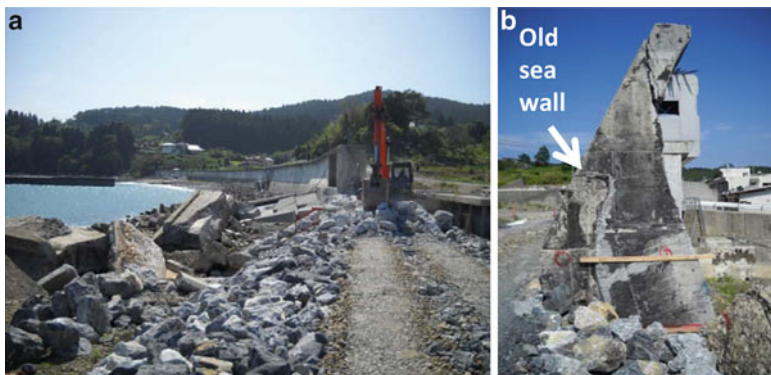
Figure 2.11 shows damaged sea walls at Ofunato city. Emergency repairs were ongoing at the time of the survey, as shown in Fig. 2.11a. The side part of the seawall survived, and the cross-section of the wall can be observed as shown in Fig. 2.11b. An old small sea wall was recognized at the cross-section, and it was obvious that the seawalls were improved before the tsunami.

Here, the improvement of sea walls means the increase of the wall height and width. Although the details (e.g., the time of improvement) are unknown, efforts were made to ensure stronger coastal protection. Unfortunately, the tsunami height was greater than expected, and the disaster could not be prevented. The problem is that how high seawalls need to be is not known.

**Fig. 2.11** Photos of seawalls with improvements prior to the tsunami. (a) Damaged sea walls in Ofunato City. (b) Evidence of improvements
