PROJECT #1: FLEMING CREEK

PROJECT TYPE: Stream bank repair and protection

Sustainable Stream Bank and Slope Stabilization

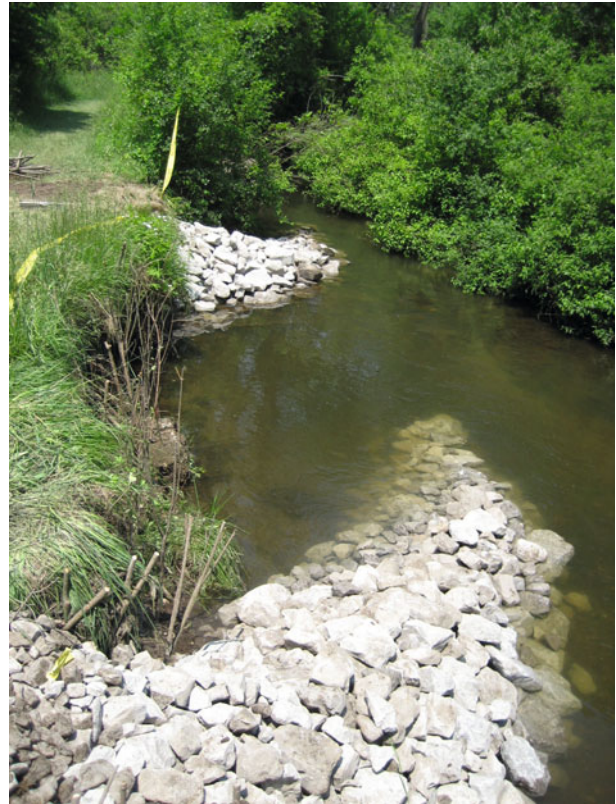
Fig. 1 Fleming Creek rock vanes

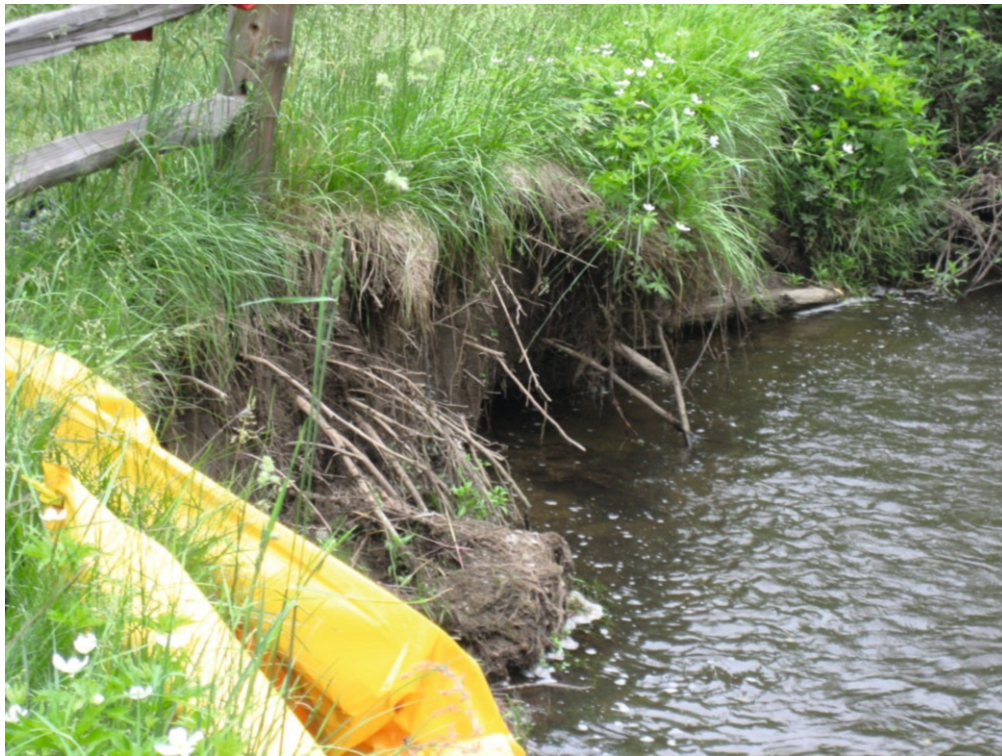
SITE CONDITIONS AND PROBLEMS: Scour erosion at the outside bend of the stream had removed up to 10 ft of the bank and produced a near vertical, unstable slope. The stream channel was also beginning to encroach into the walking path (see [Fig. 2](#)). Erosion and bank scour were caused by high velocity, impinging flows that occurred during storm events.

Fig. 2 Stream bank before treatment

Rock vanes. Elongated, rock prisms with a triangular cross section were placed at strategic locations to deflect or redirect impinging flow away from the eroding bank. The vanes were oriented in an upstream direction at a 30° angle with the bank. The vanes sloped down from the bank to a point at their upstream end. The vanes were submerged along most of their length (except at very low water) and only encroached into the stream channel about one-fourth of the channel width. The vanes were keyed into the bank (by placing rock in a trench oriented perpendicularly to the bank) to prevent flow from cutting around the vanes during high water (see [Fig. 3](#)).

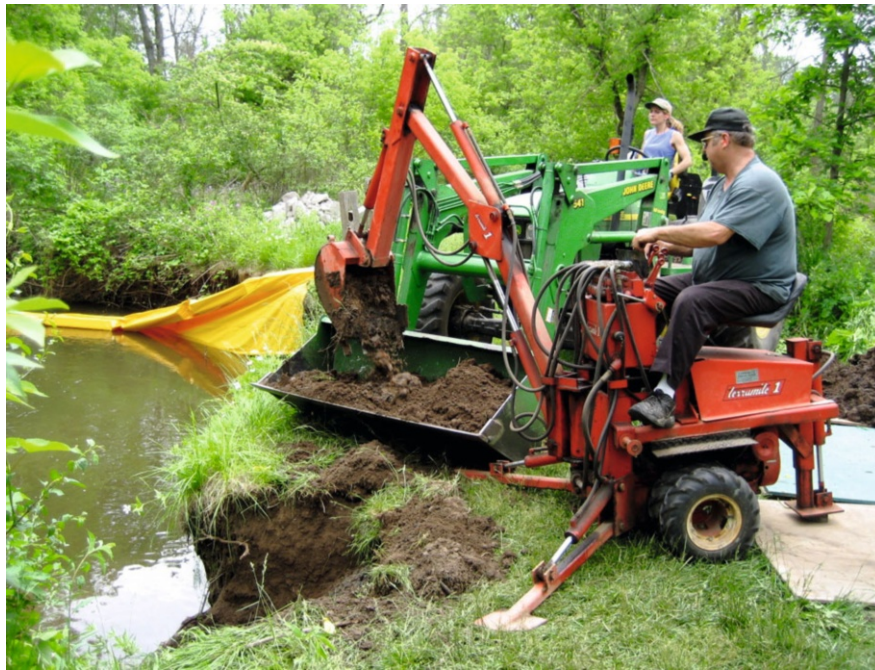
Fig. 3 Construction of keyway for a rock vane

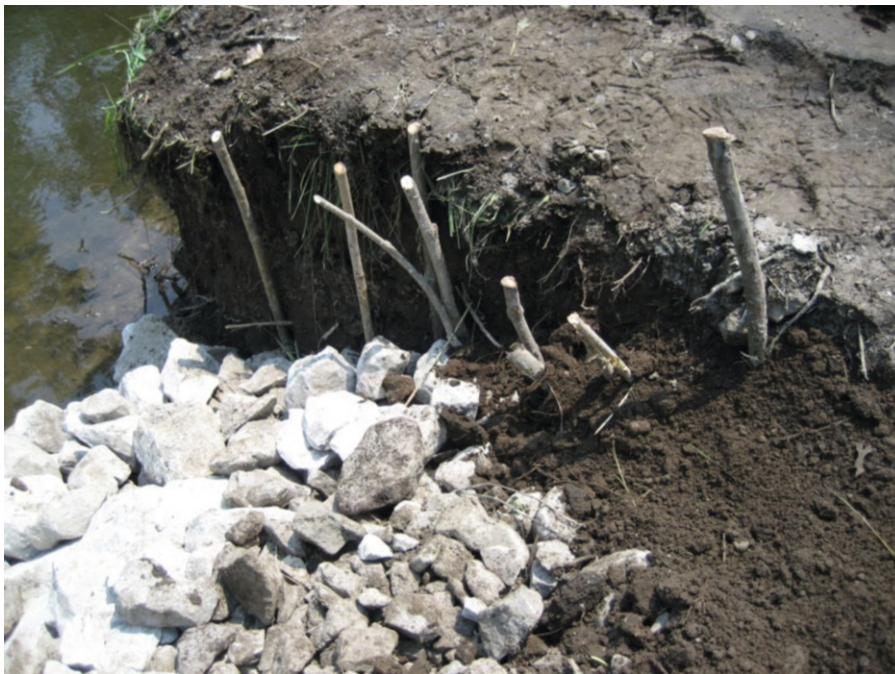
Fig. 4 Placement of willow poles in keyway

Live willow pole planting. Live willow poles or cuttings were inserted into the sides of the key way trenches and also along the toe of the bank (see [Fig. 4](#)). The cuttings eventually rooted and leafed out. This vegetation provided additional protection against erosion and bank scour.

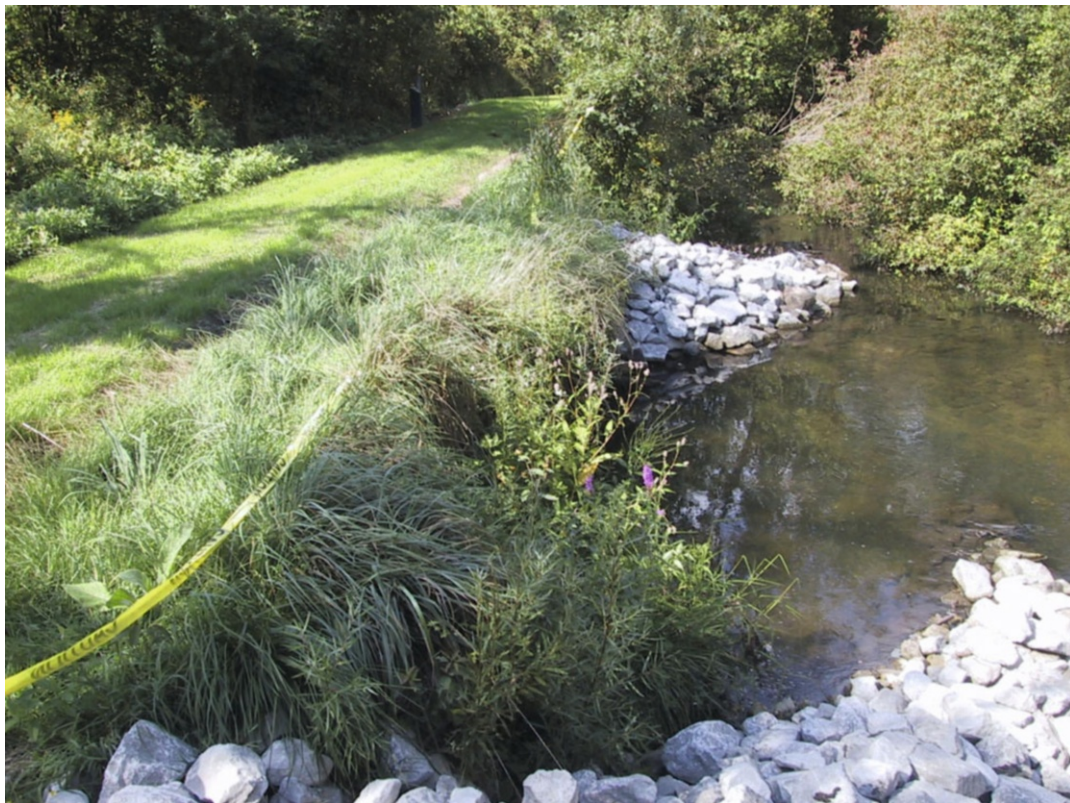
PERFORMANCE EVALUATION: The rock vanes have successfully “bumped” the flow away from the bank towards the center of the channel. This change can be observed by noting the stream flow patterns in the vicinity of the vanes. Scouring and erosion downstream of the vanes have ceased; instead water velocity in these areas is now minimal, and sedimentation has been enhanced. This change has improved bank stability. The vanes have also enhanced aquatic habitat by creating more hydrologic diversity with the formation of scour pools (at the vane tips) and zones of slow and fast water. The willow poles successfully leafed out and rooted thus providing additional bank protection and visual benefits (see [Fig. 5](#)).

Fig. 5 Stream bank after treatment
