## Chapter 2

# Tools for Preliminary Analysis of a Mechanical Failure

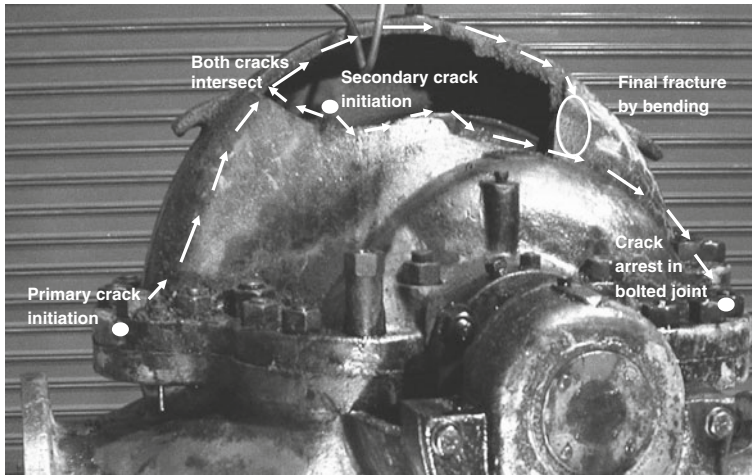
**Fig. 2.A1** Cracked casing of a centrifugal pump

Figure 2.A1 shows the casing of a centrifugal pump from a liquid hydrocarbon (oil) pumping station. Circumferential fracture was propagated by the stresses due to internal pressure. The arrows indicate how the crack propagated, as defined by the fractographic analysis. In this case, there has been an unusual situation: the

propagation of the fracture was such that a window opened. The right (final) part of the window broke due to bending; the area that became a “hinge” is highlighted by an ellipse in the figure.

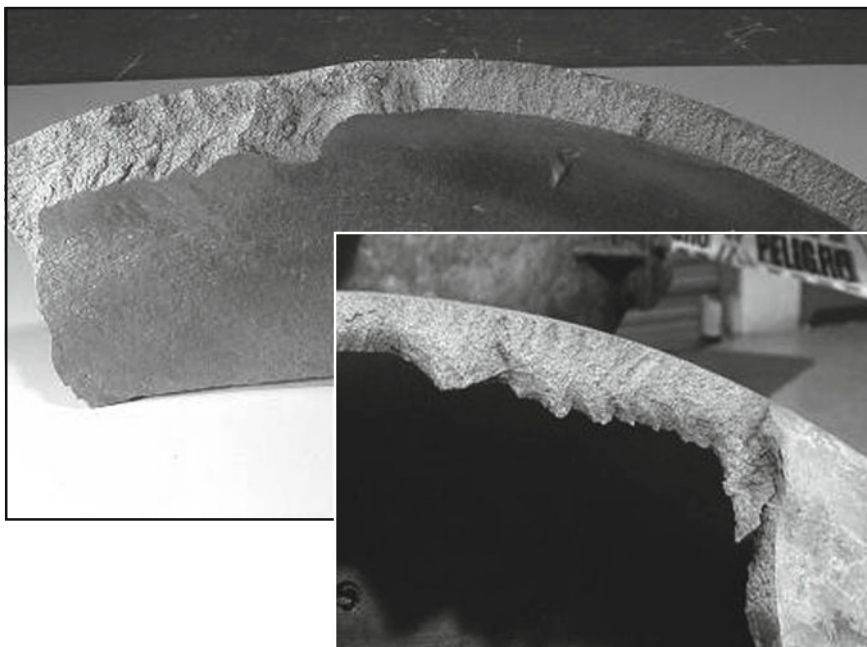
**Fig. 2.A2** Chevrons in different parts of the fracture surface

Figure 2.A2 shows the chevron marks in the fracture zone shown at the top of Fig. 2.A1. From the analysis of the chevrons in Fig. 2.A1, it was possible to reconstruct the failure occurred in the pump casing, and the definition of its origin (central circle in the Figure). Note that the tips of the chevrons are not located in the middle of the thickness, but in the third closest to the inner surface. This asymmetry is associated with the bending stress field generated by the outward force produced by fluid pressure acting against the inner surface of the “window.”

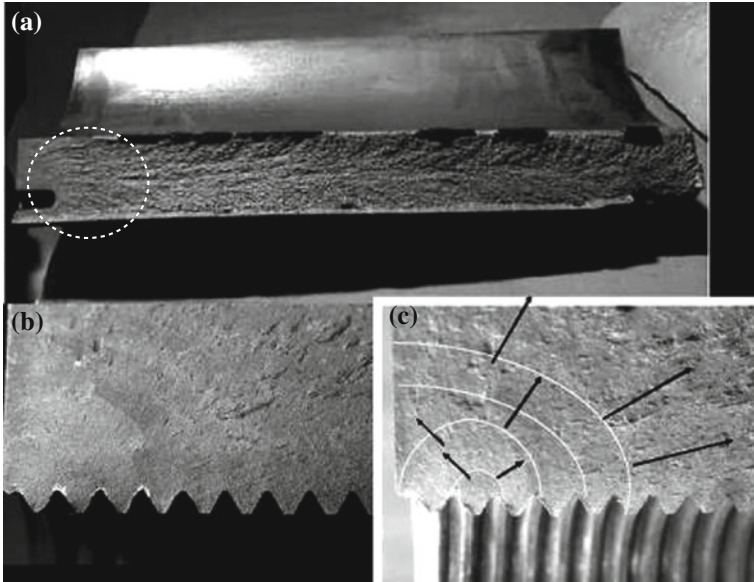
**Fig. 2.B1** a Brittle propagation with chevron marks and shear lips b Smooth crack surface c Crack initiation site

An instant fracture of a cylinder liner of a piston compressor at a petrochemical plant is depicted in Fig. 2.B1. Figure 2.B1a shows the characteristic chevron marks and shear lips of a brittle fast fracture. Chevron marks indicate initiation at the left of the Figure, and point to the location of a threaded hole. This hole hosts one of the bolts used in positioning of the cylinder during maintenance. Figure 2.B1b shows the smooth crack surface, typical of subcritical propagation, that is to say, it occurred during a service period. The analysis of beach marks and ratchet marks allow identifying the site of crack initiation at the bottom of the second thread in the hole, Fig. 2.B1c.

Higher magnification allowed observing signs of plastic deformation within the thread. Apparently, during maintenance activities at the last plant stop, a bolt was used that did not correspond exactly with the geometry of the thread. As a result, interference generated between the threads damaged the threaded hole. Many months later, the cyclic stresses from the compressor ended up propagating a fatigue crack, which grew as a quarter circle. When the size of this crack was of the order of the hole depth, a critical condition was reached: the crack became unstable and propagated instantaneously, causing the catastrophic failure of the component.

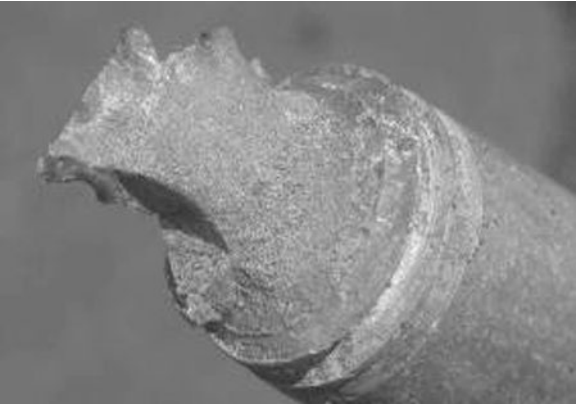
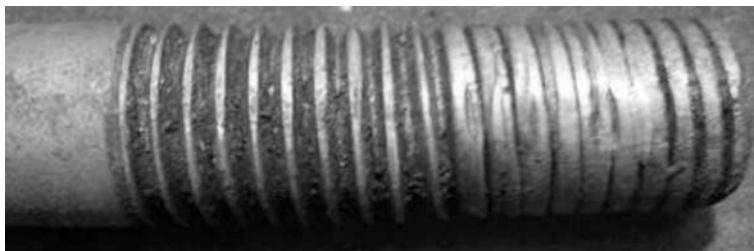
**Fig. 2.C4** Worn out threads

Other bolts presented worn out threads, both in rod and nuts, Fig. 2.C4. This failure can be progressive in nature and no obvious cumulative damage be detected until final failure. Nut threads were sliced at their roots, as the bolt material is stronger than the nut. This is normal, intended to redistribute the stresses in the fillets.

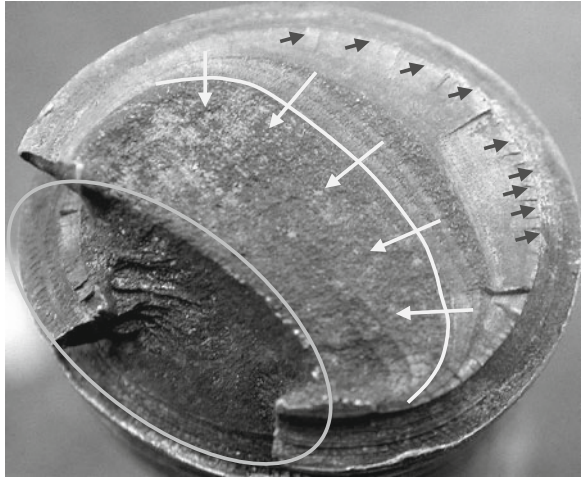
**Fig. 2.C5** Bolts with clear evidence of fatigue

Some bolts were also found with obvious signs of fatigue; this is normally associated with a deficiency in preloading (Fig. 2.C5). Black arrows indicate microcracks at initiation sites at the bottom of the thread, white arrows indicate fatigue propagation until final failure.

These bolts were located in the crown area diametrically opposite to the direction of the loading arm and were the first to fail, thus increasing the load on the rest of the fastening system. Due to lack of proper tool access, verification of torque applied to the bolts of the inner row was performed using an impact wrench, making it impossible to apply the torque accurately (Fig. 2.C6).

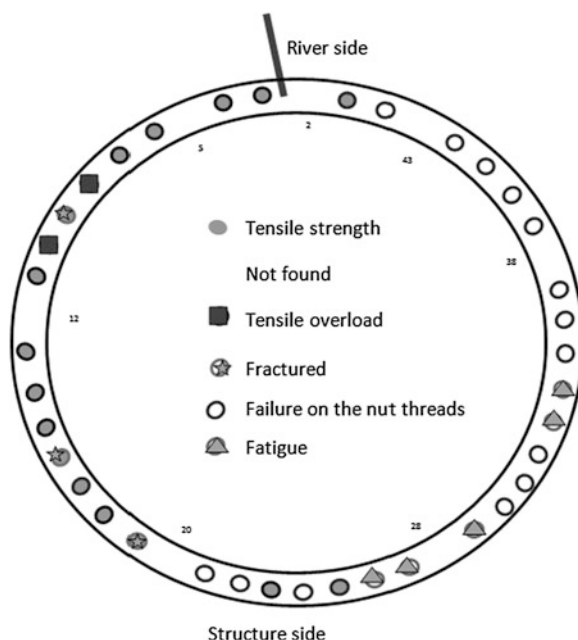
**Fig. 2.C7** Scheme of damage in the bolted ring

Figure 2.C7 shows an outline of the damage to the bolts around the crown, viewed from below. The distribution of damage clearly identifies what were the bolts whose rupture was the cause of the failure, and what were broken during the collapse of the structure.
