DEFORMATION OF A RIVER DIKE DUE TO THE MIYAGI-KEN HOKUBU EARTHQUAKE

Osamu NAKAYAMA¹, Yasushi SASAKI², Motoharu SEKIZAWA³, Tomoyuki HIRATSUKA⁴,
and Yoshitomo SUZUKI⁵

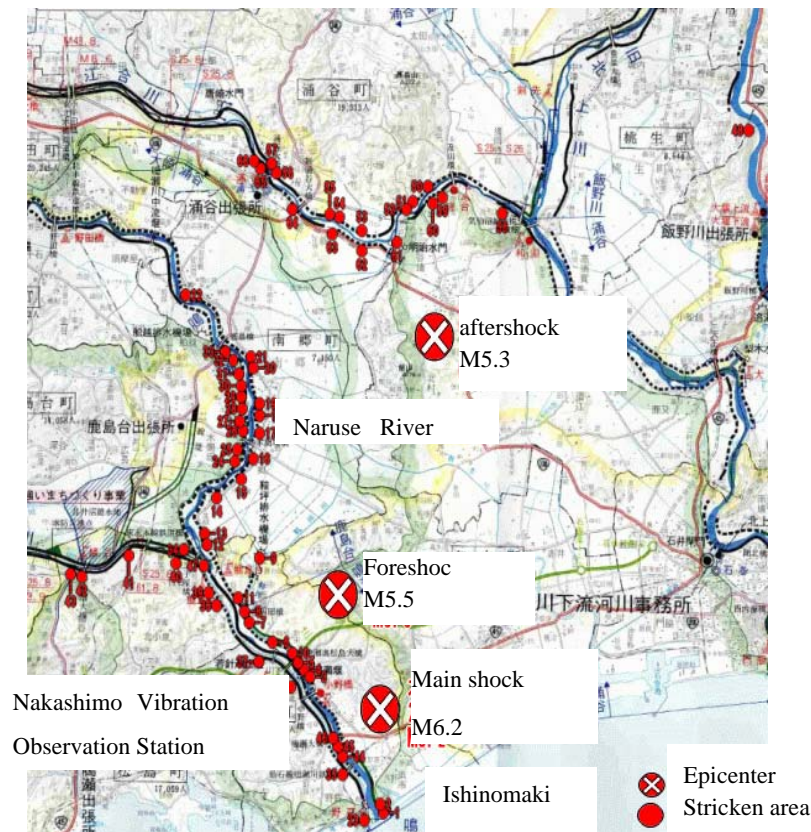
There are 66 places in the Kitakami River and Naruse River where the dikes were damaged, many of which are concentrated at the Naruse River near the epicenter. Severely damaged sections (indicated by the arrow in Fig. 2) are concentrated at the dike 8 to 17 km from the mouth of the river.

Figure 2. Damaged spots of dike

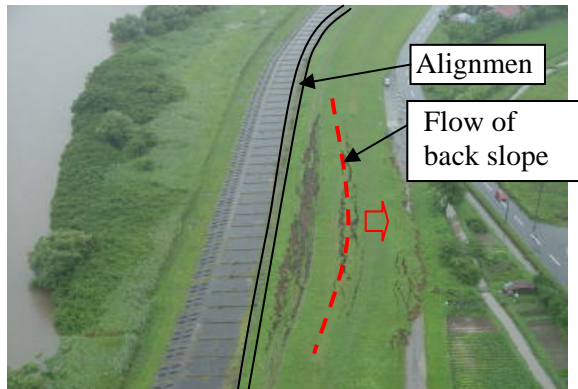
Figure 3 shows the state of damage to the right bank of the middle reaches of the Naruse River in the Kimazuka District. A large difference in level occurred at the dike crest, and deformation whereby mass of soil was pushed out toward the land side can be confirmed.

Figure 3. State of damage to dike (Naruse River right bank 13.0 k, Kimazuka)

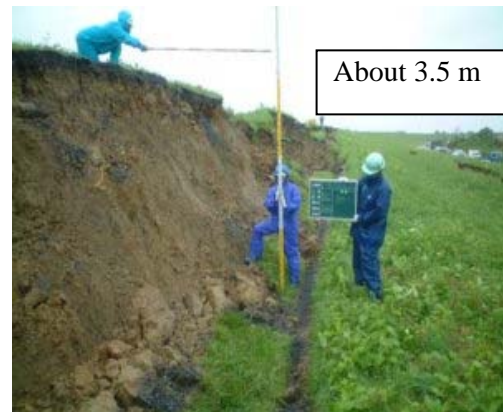
The difference in level at the dike crown is about 3.5 m in height (Figure 4.), and a crack about 100 m long runs in a longitudinal direction. The depth of the crack is about 2 m (Figure 5.), and it was confirmed that water, presumably from underground, is present in the crack.

Figure 4. Difference in level at Kimazuka

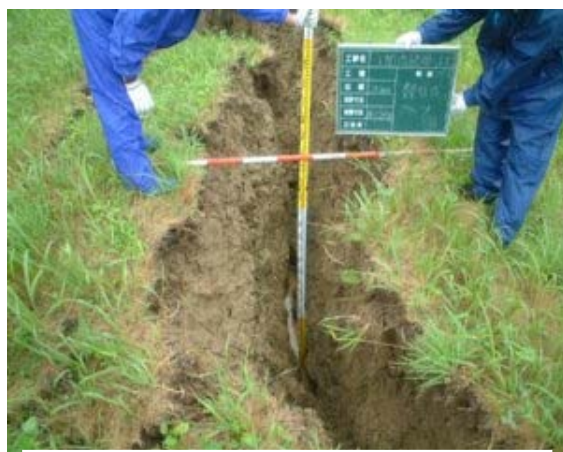
Figure 5. Crack on land side at Kimazuka

This height almost matches the water level observed through the boring implemented immediately after the earthquake and the level of the water surface found in Figure 5. Presumably, the water level in the dike rose when the earthquake occurred, and the degree of saturation in the dike also increased.

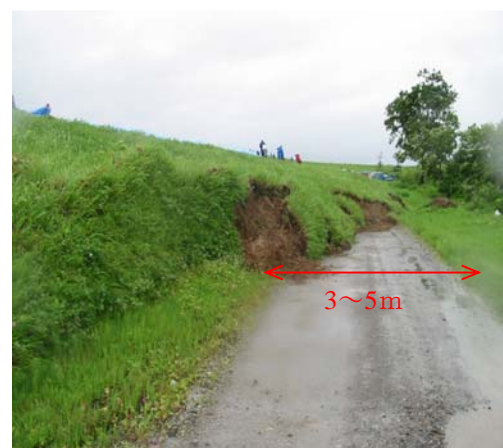
The back slope pushed-out flow was about 5 m wide (Figure 6.), and it buried a road running parallel to the dike. The moisture content was so high that the soil was muddy. Water had oozed from the edge of sediments immediately after the earthquake occurred.

Figure 6. Flow of sediment on land side at Kimazuka

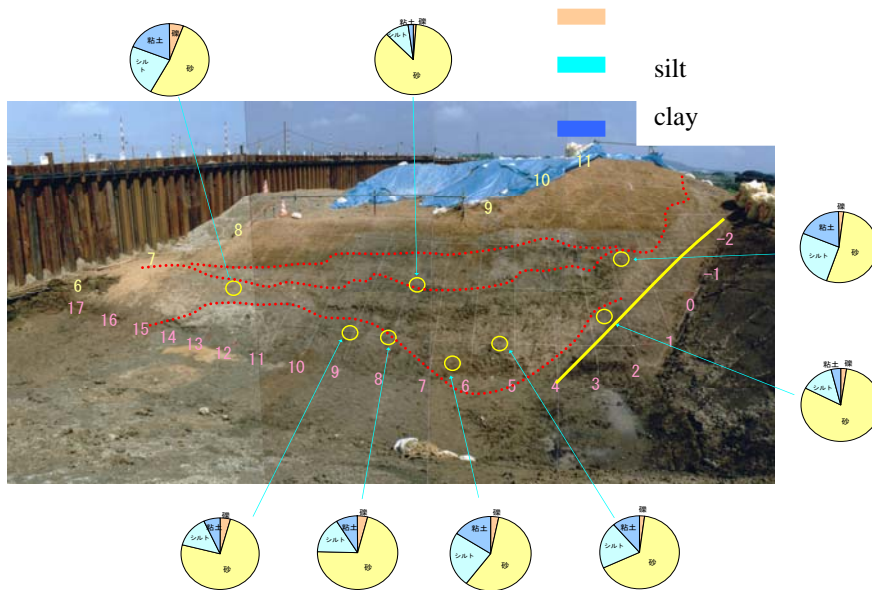
A dike excavation examination was carried out at severely damaged sections. The results confirmed that the slip plane of the dike failure caused by the earthquake exists near the outside boundary of the original dike. A sand chain considered to be derived from the foundation ground beneath the dike was also confirmed.

Figure 11. Excavation examination (Kimaguka Section)

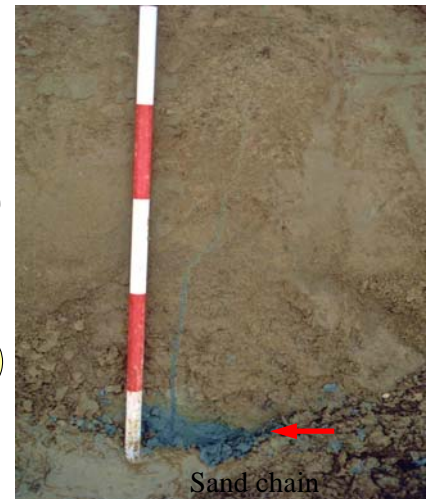
Figure 12. Sand chain (Nigo Section)

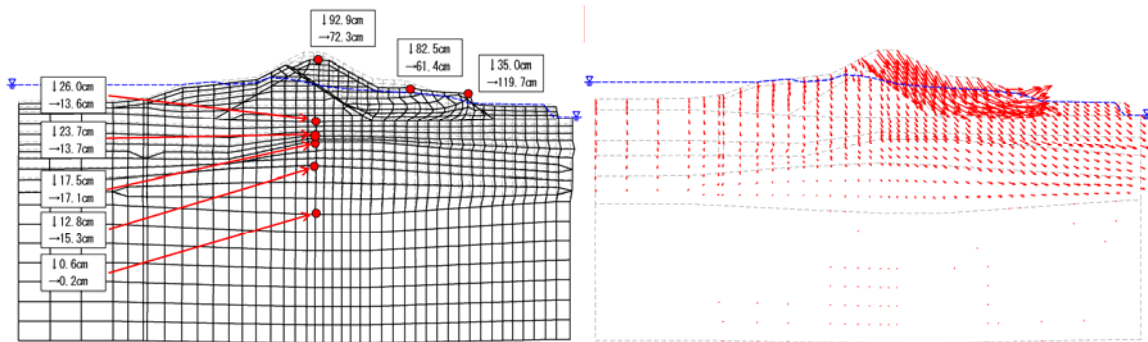
Furthermore, the amount of deformation and deformation mode of the dike at the Kimazuka section when the main shock occurred were analyzed using a static deformation analysis technique (ALID) (Yasuda et al., 1999). Figure 17 shows a deformation of the dike obtained from ALID analysis, and Fig. 18 shows displacement vectors. The amount of horizontal displacement on the land side is about 1.2 m, smaller than the actual phenomenon, and the deformation pattern, whereby the dike is pushed out toward the land side, was reproduced.

Figure 17. Deformation of the dike at Kimazuka section Figure 18. Displacement vector map

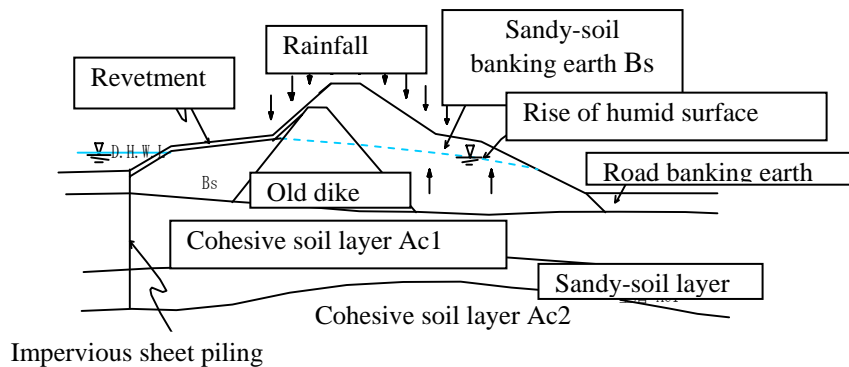
The water level in the river channel rose due to prolonged rainfall, but its permeation into the dike was presumably suppressed by the sheet piling and revetment. However, the saturation degree and saturation line in the dike is considered to have risen due to rainwater infiltration and the integrity of the dike was reduced accordingly.

Figure 19. State of dike prior to earthquake

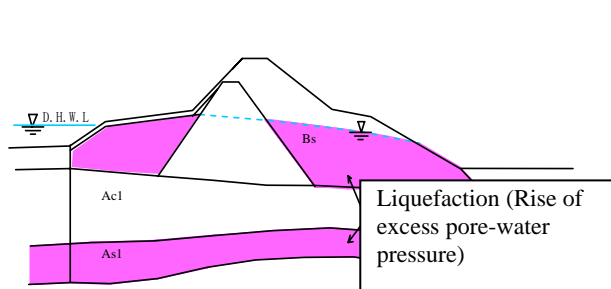
- a) Liquefaction presumably occurred in part of the A_{s1} layer and below the saturation line of the sandy soil in the dike (groundwater level) due to the foreshock of the earthquake, causing the pore-water pressure to rise and the integrity of the dike to lower. However, at that point, no significant deformation or crack was found in emergency checkups carried out immediately after the foreshock, indicating that deformation of the dike was nil or small.
- b) Liquefaction of the lower part of the dike and the A_{s1} layer presumably expanded due to the main shock that occurred seven hours after the foreshock, causing further reduction in the rigidity and integrity of these layers.

- a) As a result, the stability of the dike was lost, and sliding failure, which pushed out the failed mass of soil to the land side along the border of the original dike (cohesive soil), presumably occurred.
- b) On the other hand, no deformation was found on the water side. Since impervious sheet piling and revetment had been provided on the water side, they are considered to have effectively suppressed deformation.
- c) Settlement presumably occurred as well in accordance with the liquefaction of the A_{s1} layer. However, since traces of sand boiling could not be found in or around the dike, it is considered that the A_{c1} layer above the A_{s1} layer was not destroyed.

Figure 20. State of dike during earthquake occurred
