## LIQUEFACTION MITIGATION USING JET-GROUT COLUMNS – 1999 KOCAELI EARTHQUAKE CASE HISTORY AND NUMERICAL MODELING

James R. MARTIN<sup>1</sup>, and C. Guney OLGUN<sup>2</sup>

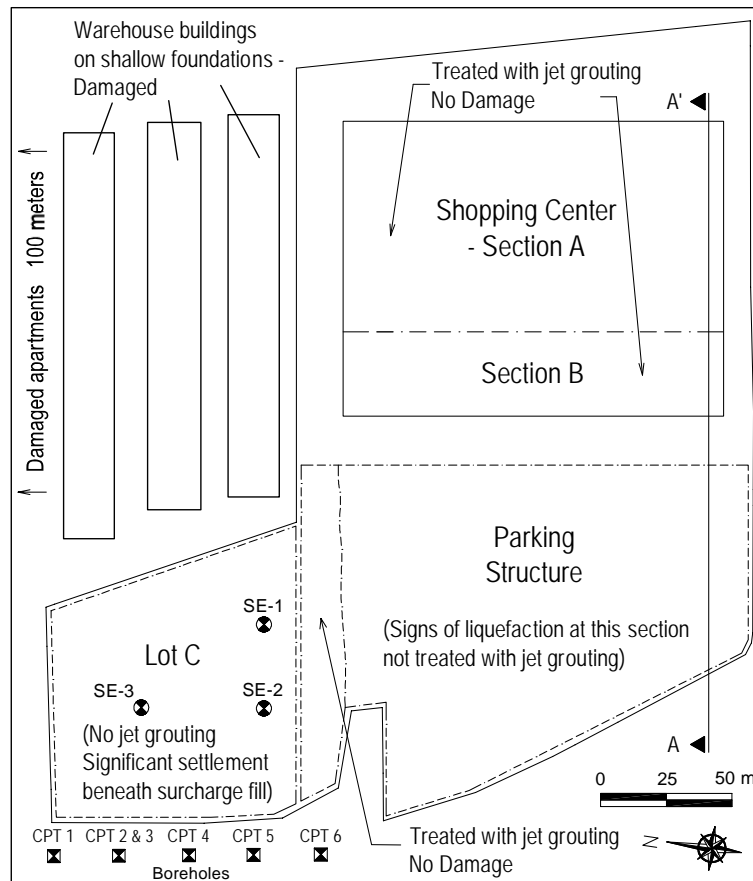
**Figure 2. Site plan of Carrefour Shopping Center showing improved area and unimproved areas along with observed earthquake damages.**

A post-earthquake field inspection showed dramatic differences in the performance of the improved section relative to the untreated areas. No settlements or signs of ground damage were found beneath the supermarket building, and construction resumed following the event. In stark contrast, significant settlements occurred in unimproved sections at the site and neighboring properties, including some level-ground areas as well as most areas that were loaded with fills or buildings, including relatively light structures.

The 3.3-m surcharge fill constituted a relatively heavy load, as did the neighboring 5- and 6-story apartment buildings; see Figure 2. The extensometers indicated 10-12 cm of earthquake-induced settlement beneath the fill, and surprisingly, much of the settlement was associated with the ML/CL and CH strata. The neighboring apartment buildings suffered settlements of similar magnitudes based on visual inspections. The level-ground parking garage section suffered estimated settlements of 8-10 cm, and water was ponded on the surface, presumably due to post-earthquake reconsolidation of the SP/SM stratum that was 4 m thick in this area. Finally, a row of three warehouses located on mat foundations about 25 m from the supermarket suffered about 5 cm of settlement. These light structures are probably similar in foundation bearing pressure to that of the partially-built supermarket.

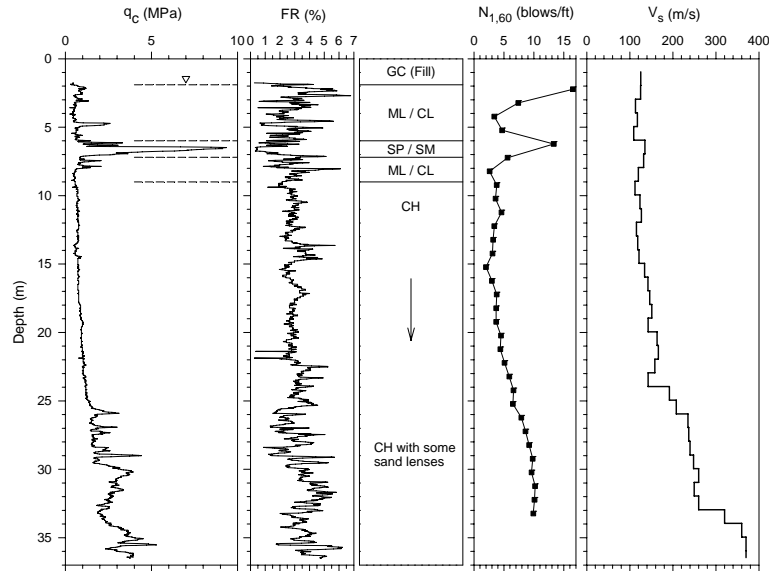
Representative geotechnical data (before ground improvement) are presented in Figure 3. As shown, the stratigraphy is variable, consisting of alternating strata of silt-clay mixtures, silty sands, and soft-to-medium clays. The Cone Penetration Test (CPT) tip resistances are low, and with the exception of the silty sand stratum (SP/SM), the values average about 1 MPa throughout the upper 25 m of the profile. Standard Penetration Test (SPT)  $N_{1,60}$  blowcounts average 5 blows/ft. in most strata. Shear wave velocities measured by seismic CPTs are 110-140 m/sec throughout the upper 25 m.

Of concern to the designers was the potential liquefaction of the loose-to-medium SP/SM stratum found at an average depth of 6 m. This stratum varies from 2 to 4 m in thickness across the site and contains an average of 30% non-plastic fines. And although not understood at the time, the ML/CL and CH strata were also vulnerable to significant earthquake-induced deformations beneath loaded areas, as measured by site engineers; see Martin et al. (2004). The ML/CL has a PI = 10 and LL = 34, whereas the CH has a PI = 37 and LL = 66.

**Figure 3. Typical pre-improvement geotechnical parameters from Carrefour site.**

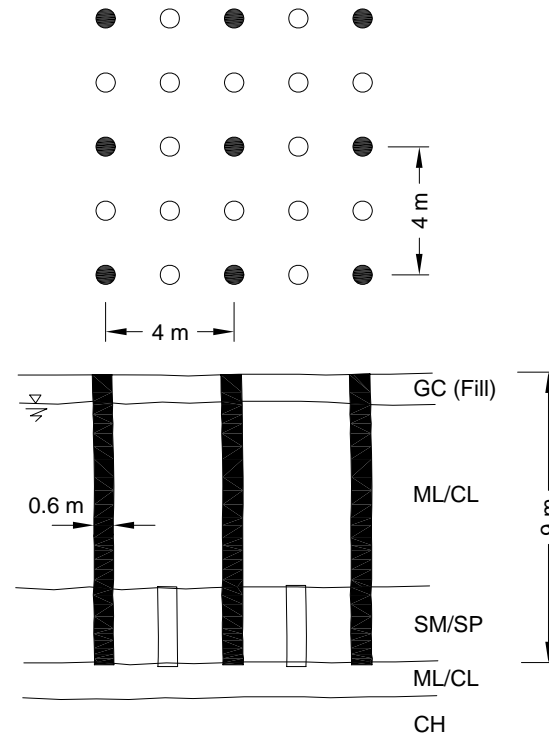
**Figure 4. Typical blanket treatment used under shopping center. Area replacement in ML/CL was about 2% and 7% in the SP/SM stratum.**

Section A is founded on spread footings, while Section B is supported on a mat foundation. As depicted in Figure 4, primary and secondary grids of jet-grout columns were installed to provide blanket treatment. The primary columns were 0.6 m in diameter with a center-to-center spacing of 4

m, and extended from the ground surface to a depth of 9.0 m. A secondary grid of 2.5 m-long columns was installed between the primary columns. These truncated columns, which penetrated only the SP/SM stratum, were installed with the tacit assumption that the higher jet-grout replacement in this layer would reduce liquefaction potential. In addition to the blanket treatment, groups of two and four primary columns were installed beneath the exterior and interior footings, respectively.

Section B, which rests on a mat foundation, was blanket-treated with primary columns installed at a 1.5 m center-to-center spacing. No treatment was performed outside the footprint of the building. The average area replacement ratio beneath the building was about 2% for the ML/CL stratum, and 7% for the SP/SM stratum.

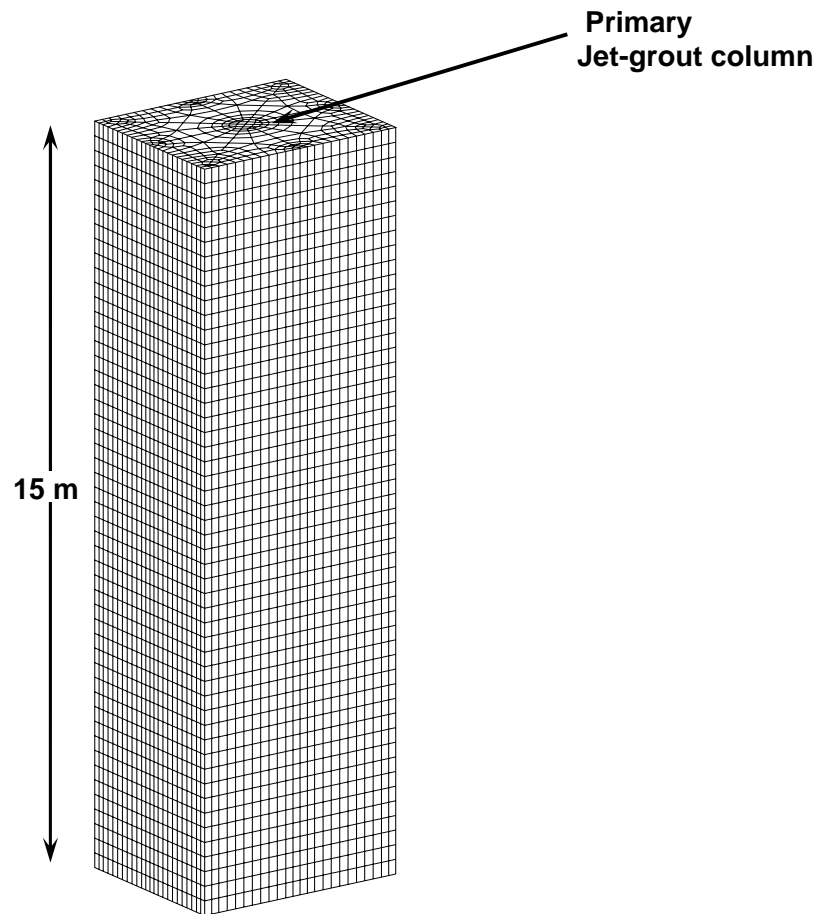
The reinforced ground, treated with 4 m x 4 m grids of primary (9 m-long) and secondary (2.5 m-long) 60 cm-diameter columns, as shown in Figure 4, was modeled in three dimensions. The finite element mesh contained approximately 22,000 elements and is shown in Figure 5. As shown, the model of the soil profile extended to a depth of 15 m. The analyses were performed with total stress analyses where pore pressure generation was not considered. Detailed soil testing data were not available at the time to calibrate the constitutive models for fully-coupled pore pressure generation behavior. Constitutive soil parameters were based on laboratory and field tests performed by the authors (Olgun 2003), and the soils were modeled to be fully non-linear during shaking using the elasto-plastic soil model developed by Prevost (1981). The jet-grout columns were modeled as structural elements with strengths and stiffnesses consistent with those measured during post-treatment field quality control tests (Emrem, 2000). To provide a benchmark for comparison, a series of runs was also performed for the case where the jet-grout columns were removed from the model such that the soil was unimproved. In terms of boundary conditions along the sides, the three-dimensional model was assumed to be surrounded by an infinitely repeating sequence of identical 4 m x 4 m reinforced soil sections. This was achieved by assigning the opposite nodes on each face of the model to be equivalent. By assigning nodal equivalency to node couples at the same elevation they share the same set of equations of motion, and therefore undergo the same motion in each direction. This equivalency imposes symmetry along each vertical face of the model. The models were shaken in two horizontal directions simultaneously using the horizontal components of the ground motions recorded in Izmit (IZT recording) during the 1999 Kocaeli Earthquake at approximately 2 km from the site. Of primary interest in the analyses was evaluating the effectiveness of the columns in reducing shear stresses and strains in the reinforced soil mass.

**Figure 5. 3-D finite element mesh of the 4 m x 4 m jet-grout improved soil section.**

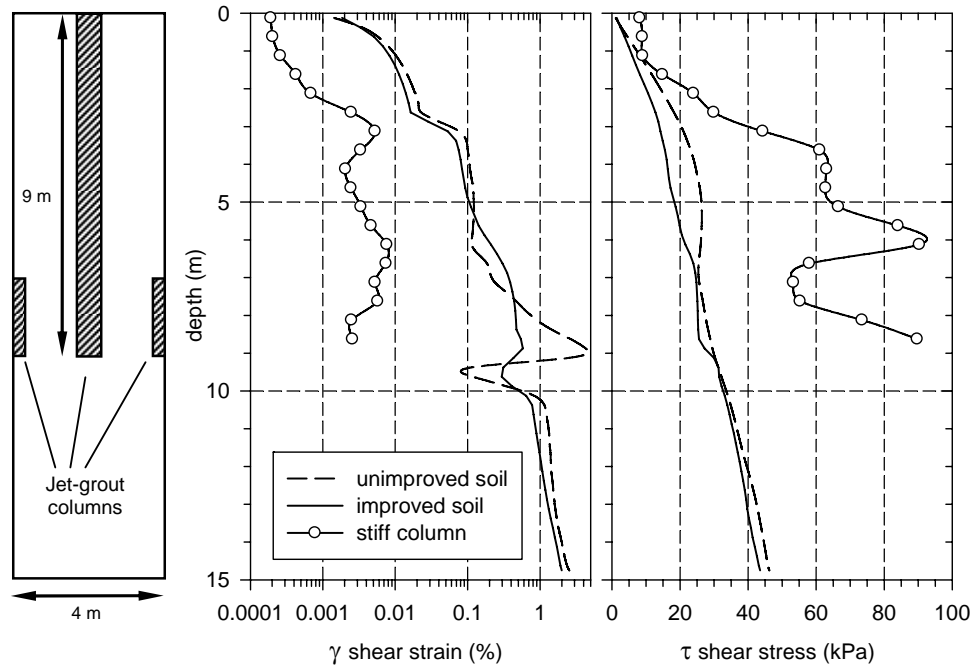
The analyses results are summarized in Figure 6. The figure shows the predicted peak seismic shear strains and stresses developed in the jet-grout columns and improved soil mass. For comparison, results are also shown for the unimproved soil mass. Although the stresses and strains were computed for two horizontal directions (x and y), as per the three-dimensional analyses, the results shown in the figure are the average values for both directions (average of  $\gamma_{zx}$  &  $\gamma_{zy}$ , and  $\tau_{zx}$  &  $\tau_{zy}$ ). Also, it should be noted that the values shown for the improved and unimproved soil are representative of the average stresses and strains in the soil mass between the columns.

As can be seen on the left plot in the figure, the stiff columns were not strained as hard as the soil around them—they experienced negligible shear strains, while peak strains in the reinforced soil mass approached 1%. The analyses suggest significant strain incompatibility between the soil and columns which were about 50-100 times stiffer in shear relative to the soil. Such incompatibility was also evident in the deformed mesh shapes, which showed that the columns tended to flex back and forth within the soil profile and rotate at the ends during shaking rather than shearing along with the surrounding soil. Instead, the columns underwent mainly flexural deformations as opposed to shearing deformations. As such, they clearly did not behave as shear beams to any significant degree during shaking, as tacitly assumed. Therefore, even though the columns were much stiffer, they did not strain sufficiently in shear to attract a significant portion of the shear loading. This means the columns should not have significantly reduced shear strains, and thus excess pore pressures, in the soil mass as

initially thought. As such, it can be seen in the figure that the predicted strains in the jet-grout improved soil mass were essentially equal to those in the unimproved soil.

Similarly, the predicted peak seismic shear stresses are shown on the right-most plot in Figure 6. The peak stresses in the jet-grout columns (~60 - 80 kPa) were consistently higher than those in the soil mass (~20 kPa), as would be expected because the columns are stiffer and attracted more load; however, they did not attract nearly enough shear stress to significantly reduce the shear stresses in the reinforced soil mass which were only slightly lower than those in the unimproved soil. Of particular significance, the stiff columns picked up only a small percentage of the shear stresses implied by area-replacement ratio methods such as Baez and Martin (1994) that assume composite shear behavior. The average shear stress reduction (shear stresses in improved soil relative to unimproved soil) that would have been expected for composite behavior at Carrefour is on the order of 80%, but as shown, the actual stress reduction was nowhere near this amount. This finding is consistent with results reported by Goughnour and Pestana (1998) based on their analysis of ground reinforced with stone columns. They found that the columns should provide little, if any, shear stress reduction in most cases. The main implication is that commonly-used design approaches based on assumptions of composite behavior for ground reinforced with discrete elements may greatly over-estimate seismic improvement (in terms of shear behavior). At the time of this writing, detailed parametric studies are being performed to better understand the effects of reinforcement stiffness, geometry and layout, end-restraint conditions, etc.

**Figure 6 - Summarized results of dynamic finite element analyses of unimproved and jet-grout reinforced ground at Carrefour. Figure shows average seismic stresses and strains computed in two horizontal directions in the 3-D analyses (average of  $\gamma_{zx}$  &  $\gamma_{zy}$ , and  $\tau_{zx}$  &  $\tau_{zy}$ ).**
