EARTHQUAKE DAMAGES TO EMBANKMENTS IN ANDAMAN ISLANDS IN INDIA

Prasad, S. K.¹ and Chandradhara, G. P.²

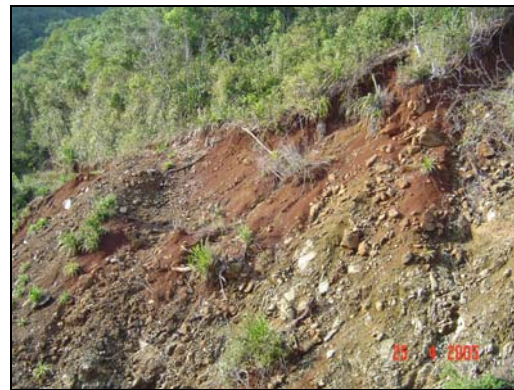
Figure 4 : Picturesque hill side slopes experienced slope failure

The project is recently completed and the Sumatra earthquake was the first major earthquake experienced by the structures after completion. The site is located at over 750 km from the epicenter of the earthquake. Further, considerable shaking was experienced by the people in the region. The concrete dam did not suffer any damage. However, the rockfill dams including saddle dykes suffered longitudinal cracks all along their length after the shaking. The reservoir was not full during the earthquake. Cracks were visible on the upstream slopes of the dam. Some of the natural slopes had experienced land slides and slope failure. It was difficult to establish whether the slope failures were the effect of earthquake. Figure 4 shows some of the slopes that experienced landslide and failure. It should be noted that most of these are not natural, but recently formed after the construction of the project.

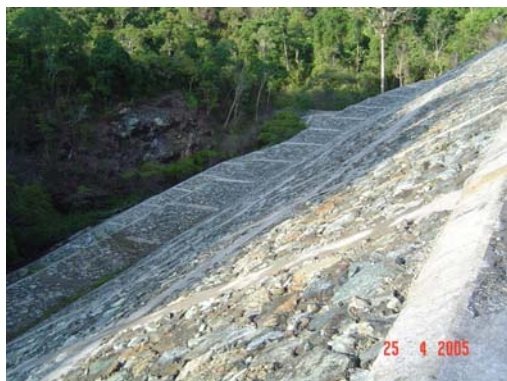
Figure 5 presents the upstream slope that had a few of the revetments disturbed. Both upstream and downstream surfaces of the dam were supported by Reinforced Cement Concrete ribs around 0.6 m wide. The ribs extended in both the directions. These ribs did not suffer any damage during the earthquake. If the ribs were closely spaced and properly tied the pitching failure would have been prevented. Figure 6 shows the top view of the dam with cracks on the crest of the dam. It can be observed that the cracks continue all along the length of the dam. The power house building on the

Figure 5 : Side slope of rockfill dam that experienced some disturbance

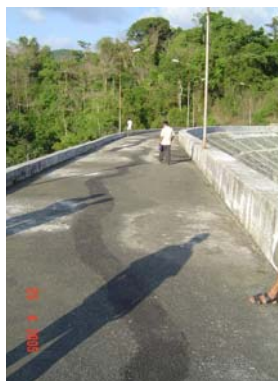
Figure 6: Longitudinal crack developed all along the length of rockfill dam

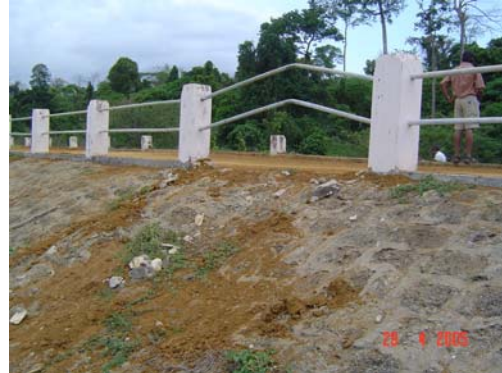
Figure 8 : Side rails and side slope of embankment dam still in distress

Figure 8 shows some of the failures on the slope of the earthen embankment portion. The alignment and the longitudinal cracks had already been repaired by the time the authors visited the spot. It is interesting that the concrete portion of the dam consisting of the spill way was intact during the earthquake. Hence strong and stable constructions withstood the earthquake.

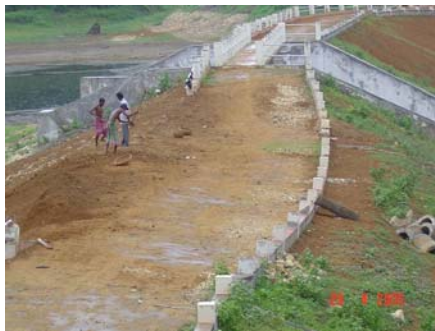
It is another small irrigation dam in the neighborhood of Hutbay. Similar to R. K. Pura dam, this dam is made of long earthen embankment and a small concrete spill way portion. It is interesting that the dam experienced similar failures as in R. K. Pura dam. Figure 9 and Figure 10 show the common distresses observed in this case. The distorted alignment of the dam, longitudinal crack at the crest of dam, settlement and uneven movement of the embankment crest, failures of side slope and horizontal cracks were the common failures observed.

Figure 9: Loss of alignment of Vishnu Nalla Dam

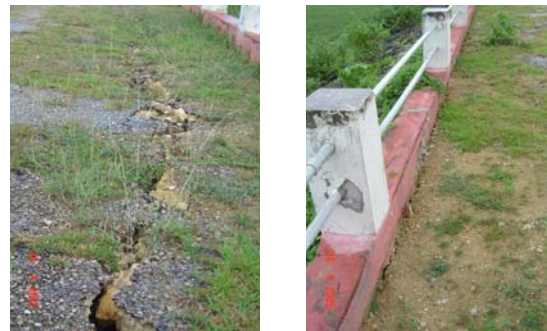
Figure 10: Longitudinal crack on the Vishnu Nalla earthen dam

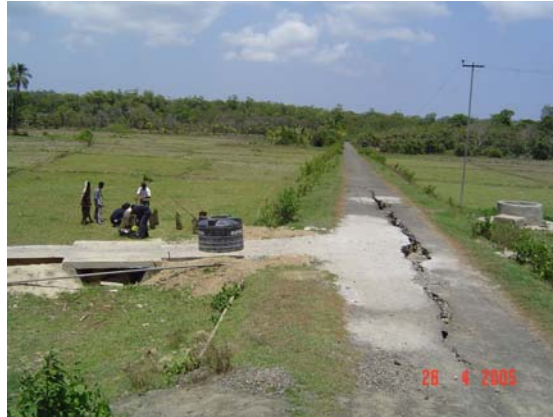
Figure 11 : Complete and close up View of Longitudinal crack along the rural embankment

Figure 11 shows the stretch of the road, which is about 3.5 m wide on an embankment that experienced a distress. The height of embankment varies from 1 to 3 m. The longitudinal crack at the middle of the road was as wide as 300 mm and extending to over 1 m depth. On either side of the embankment road, cultivable land is observed. There were horizontal cracks that developed across the road (Figure 12). The embankment was about 7 m wide and 2 m deep with a side slope of 1.5 horizontal to 1 vertical. Figure 13 provides the location and schematic view of the rural embankment. It can be seen that the rural road for a length of about 900 m has suffered severe damage. The damaged location is 150 m beyond the intersection point with the main road. The road leading to a local jetty has agricultural field on either side of the embankment. The approximate water table in the region at the time of testing was assessed to be 2.5 m below natural ground level from the observation open well available in the region. The longitudinal crack on the surface of embankment was sufficiently wide and extended to great depth.

The test clearly revealed that the subsoil below the embankment was very soft and weak. It could not withstand the shaking and perhaps the ground motion was amplified causing a distress in the embankment.

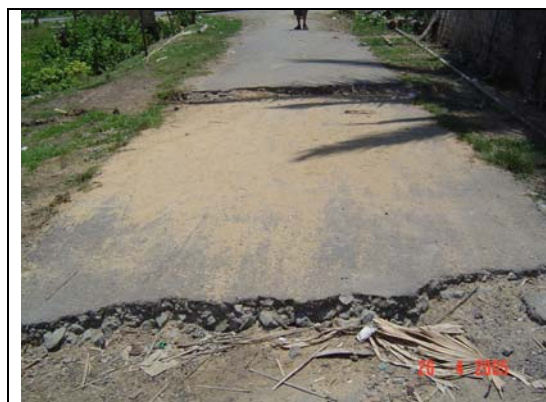
Figure 12: Horizontal cracks along the rural embankment and the Cross Section of the Embankment near Testing Site

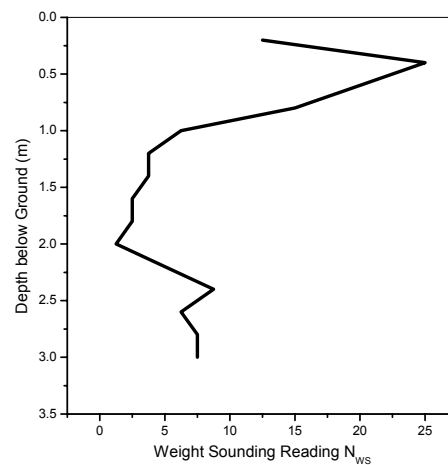
The weight sounding was carried out for a depth of 3 m in to the subsoil. As the ground was inferred to be fairly soft, the total weight placed was half of the standard weight (500 N). Figure 14 shows variation of N_{ws} (along horizontal axis) with depth below ground level (along vertical axis). N_{ws} refers to number of rotations required for 1 m penetration of the sounding rod. It can be seen that N_{ws} is sufficiently large at around 0.4 m below ground level. There after it decreases to a very low value. Even at a depth of 3 m below ground level, the number of rotations required for 200 mm penetration was less than 3 ($N_{ws} < 15$) with a weight of 500 N. The soil consisted of fine clayey silt, dark brown in colour. The approximate correlation obtained between SPT 'N' value and N_{ws} after initial calibration was $N = N_{ws}/10$, up to $N_{ws} = 100$. It is believed that the SPT N value in the subsoil at the site was therefore much lower than 5.

Figure 14 : Variation of Weight Sounding Number with depth for Diglipur rural road embankment
