DAMAGE IN NIAS ISLAND CAUSED BY THE M8.7 OFF-SHORE SUMATRA EARTHQUAKE, MARCH 28, 2005 AND THE SUPPORT ACTIVITIES FOR THE RECOVERY AND RECONSTRUCTION

ABSTRACT

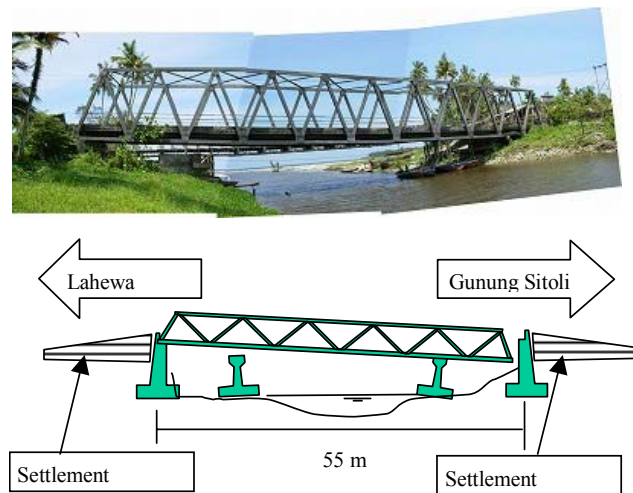
The heavily damaged non-accessible large bridges within the surveyed area are Lafau bridge and Muzoi bridge in the northern coast between Gunung Sitoli and Lahewa route and Idano Gawo bridge between Gunung Sitoli and Telukdalam nearby Tetehosi at the eastern coast. These bridges mainly consist of truss super-structures with RC foundation piers or RC box culverts. The piers of Lafau bridge and Muzoi bridge were tilted and settled due to the reduced bearing capacity and lateral spreading problems associated with liquefaction of ground. The approach embankment road was settled and laterally moved towards the river due to liquefaction. Figures 4 and 5 show the damage of these bridges respectively. A part of about 50 m to 70 m length of the approach embankment at both the sides of Muzoi bridge is settled by 4.5m at maximum and laterally moved towards the river, which can be clearly inferred from the tilted electric poles next to the bridge while the lateral movement of the ground was more than 4m on both sides. The piers were founded on piles. However, the piles were fractured at the top with exposure of the reinforcement and were not functional. The engineers of Department of Public Works pointed out that piers have piles reaching rock formation. It seems that the piles were designed against vertical loads and horizontal loads were not considered.

Figure 4. Damage of Lafau Bridge

The damaged bridges generally need to be re-constructed and It should be moved next to existing piers where geotechnical investigation of ground and its characteristics are necessary. The present truss decks can be used in the new-constructions with some replacement of damaged elements and bolts and bearings together with appropriate stopper against horizontal and vertical relative movements.

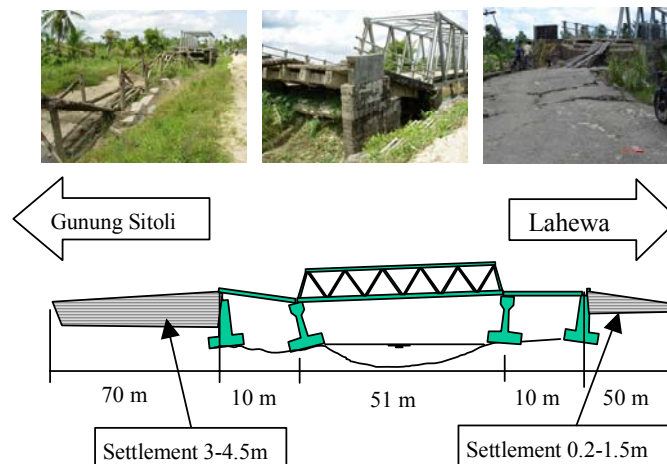
Figure 5: Damage of Muzoi Bridge

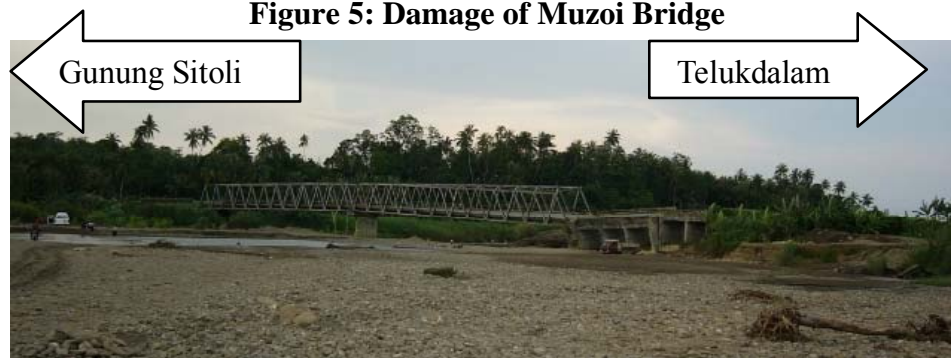
Figure 6 shows the damage of Idano Gawo bridge. The second pier of Idano Gawo bridge was tilted and slid towards the upstream side of the river and the box-culvert next to this pier was also tilted and slid together with the pier. The upper deck of the truss section of the bridge is horizontally shifted by about 1.3m. The river flow is directed towards the pier and box-culvert. It seems that the toe erosion of the pier and box culvert, bearing capacity of foundation and large horizontal shaking may be the major causes of the damage to Idano Gawo bridge.

Figure 6. Damage of Idano Gawo Bridge

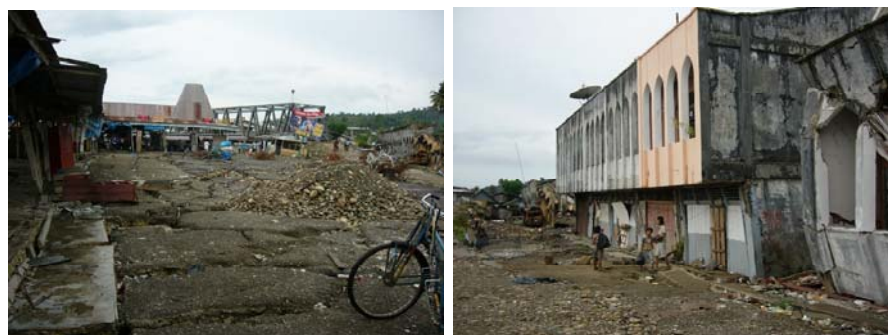
Figure 7. Effect of liquefaction and lateral spreading on RC building and truss bridge

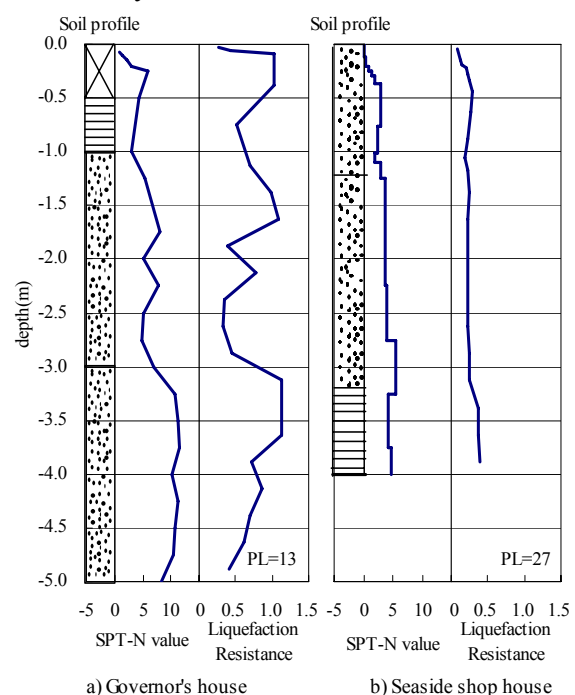
Method of liquefaction assessment is according to the Recommendation for Design of Building Foundations, Architectural Institute of Japan (Architectural Institute of Japan, 2001). In this study, maximum acceleration of strong ground motion is taken as 350cm/s^2 for ultimate limit, which is as large as observed in liquefied area during the Hyogoken-Nambu earthquake. There is a 3m thick loose sandy layer at the subsurface of reclaimed ground (see the case of shop house in Figure 9), which is inferred to be easily liquefiable from the result of Swedish weight sounding. As mentioned above, many buildings in such areas were heavily damaged with partial settlement, inclination and uplift of ground floor. As a result, almost all buildings were demolished. At the site of Governor's house, there exists a sandy layer, but having relatively large N-value and partially liquefiable during strong ground motion obtained from the assessment based on the test result. The elevation of the site is slightly higher than that of the reclaimed area and only small damages such as cracking in floor concrete were observed after the earthquake. The results obtained from geotechnical investigation are in accordance with the observed damages caused by the earthquake. However, the geotechnical investigations of ground are scarce in Nias Island and it would be desirable to carry out such investigations in areas particularly affected by ground liquefaction in relation to recovery and reconstruction of Nias Island.

Figure 9. Soil profile, Converted SPT N-value from Swedish weight sounding test and liquefaction resistance at 2 sites in Gunung Sitoli
