DUZCE (M7.2, 1999) EARTHQUAKE: DAMAGE CORRELATION WITH THE MICROZONATION STUDY AND VULNERABILITY ASSESSMENT OF THE WATER SYSTEM IN DUZCE, TURKEY

Dimitra MANOY¹, Maria ALEXOUDI², Dimitrios RAPTAKIS³, Kyriazis PITILAKIS⁴

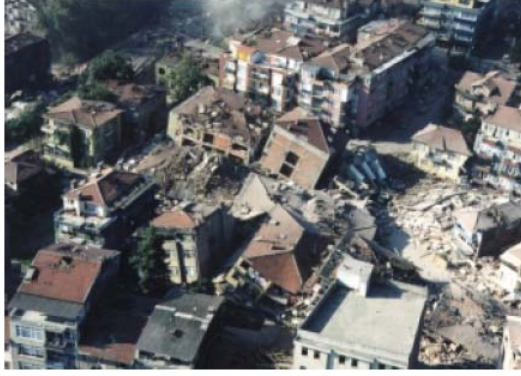
Figure 1a. A general view of building damage in Duzce (Erdik, 1999).

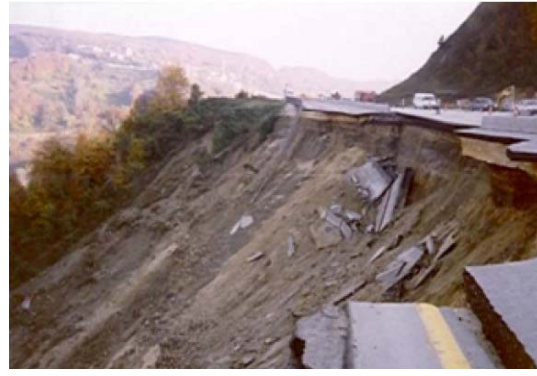
The 12 November 1999 earthquake in Turkey caused considerable damage to residential and commercial buildings, public facilities and infrastructures with substantial casualties. The epicenter of the earthquake was located about 6km south of Duzce. Buildings, already moderately and lightly damaged by 17/8/1999 Kocaeli M7.4 earthquake, have been seriously damaged and many collapsed (Figure 1a). Office buildings, utility systems accounted additional serious damages. The water and the sewage system were heavily damaged due to ground deformations and shaking. Damage to the transport infrastructure observed along the 60 km of the Ankara-Istanbul highway crossing the Duzce Fault; at Bakacak section (between Kaynasli and Bolu) two lanes of the four-lane highway collapsed due to land slide for a section of about 200m, as it is depicted in Figure 1b (Erdik, 1999).

Figure 1b. Landslide on E5 highway in Duzce earthquake (Erdik, 1999).

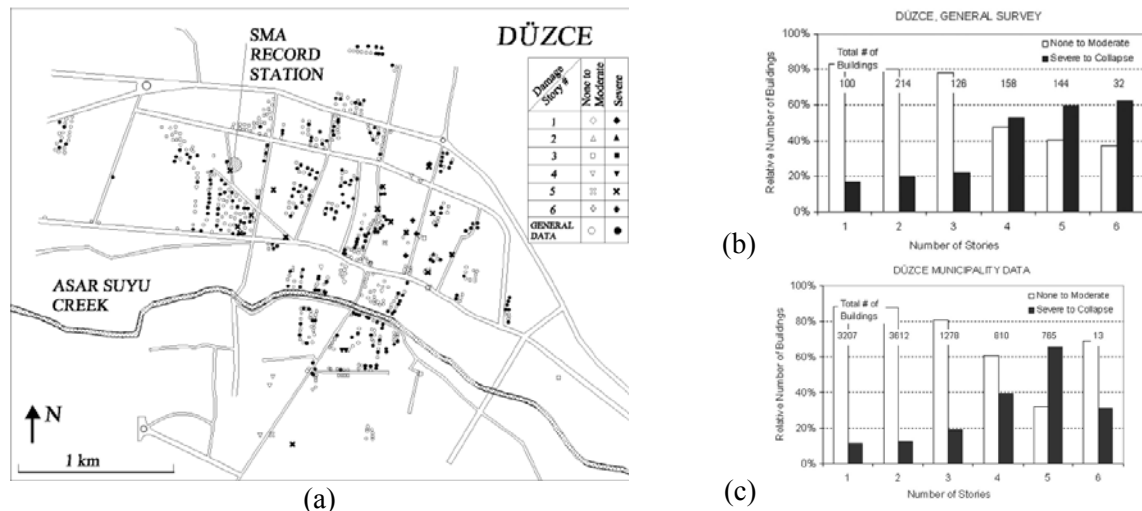
Figure 4. (a) Distribution of building damage in Duzce (b) Number of stories vs. damage (c) Number of stories vs. damage, reported by the municipality (Donmez and Pujol, 2005).

An extensive survey study was carried out in Duzce to document the sustained damages of the reinforced concrete structures (Donmez and Pujol, 2005). Based on these data, an interesting observation is the correlation between the spatial distribution of the damages observed in buildings and their location with respect to site conditions and the fault. The majority of the buildings that suffered great damage or collapsed are located at the centre of the city close to the river and closer to the fault trace. Soil formations are composed mainly of soft alluvial deposits (Figures 4a). However there is not a clear conclusion whether or not extensive damages are correlated to the soft soil conditions as we observe at least equal number of building with low to moderate damages. The quality and the performance of the building stock in Duzce has to play the critical role. Another interesting observation of the survey is the fact that taller buildings of 4-6 stories with $T_0=0.3-0.4s$ according to Aydan et al., (2000), suffered relatively more damages. The fundamental period of these type of buildings is very close to the predominant period of the record in Meteorological station (see Figure 2b). However based on the available records it is difficult to attribute the higher damages solely to a resonance effect, as actually the high spectral values are spreading in a wide range from 0.2s to 0.8s and the fundamental period of the site where the station is located is around 0.75s, as we will see later.

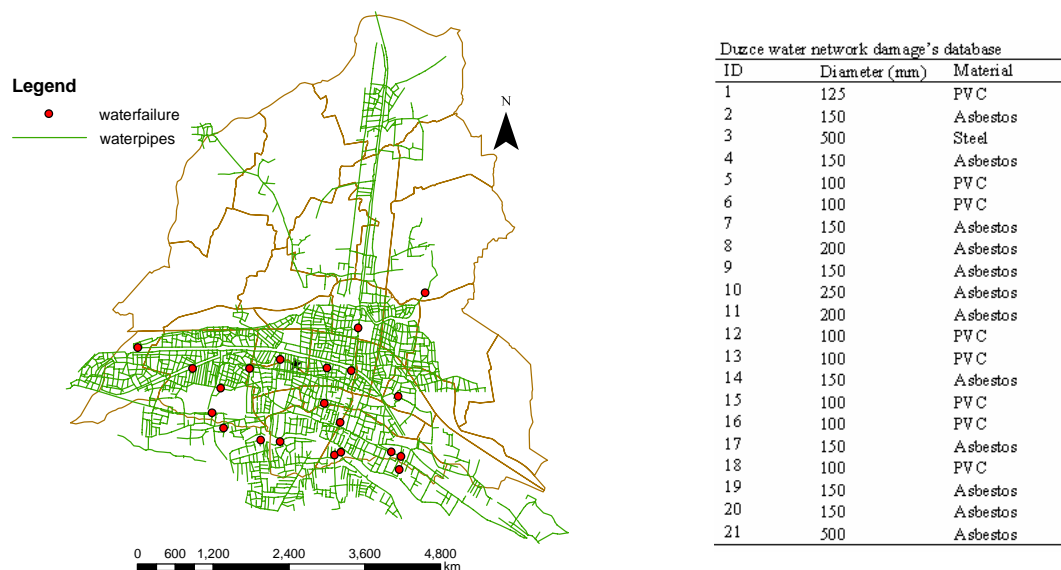
Figure 5. Water system damage in Duzce (Kocaeli & Duzce 1999 earthquakes.) (Alexoudi, 2005).

The water system in Duzce was also severely damaged due the combined effects of Kocaeli (17/8/1999) and Duzce (12/11/1999) earthquakes. Tromans, (2004) developed a general database providing water pipe failures per district for three time periods; before Kocaeli earthquake, between Kocaeli and Duzce earthquake and after Duzce earthquake. In the present study another water system damage database is used, created by Alexoudi, (2005) (Figure 5), which provides a limited number of fully documented failures. As it can be observed, most failures are concentrated at the southern part of the city, around the river area, where -as already mentioned before- the soil conditions are dominantly soft and loose.

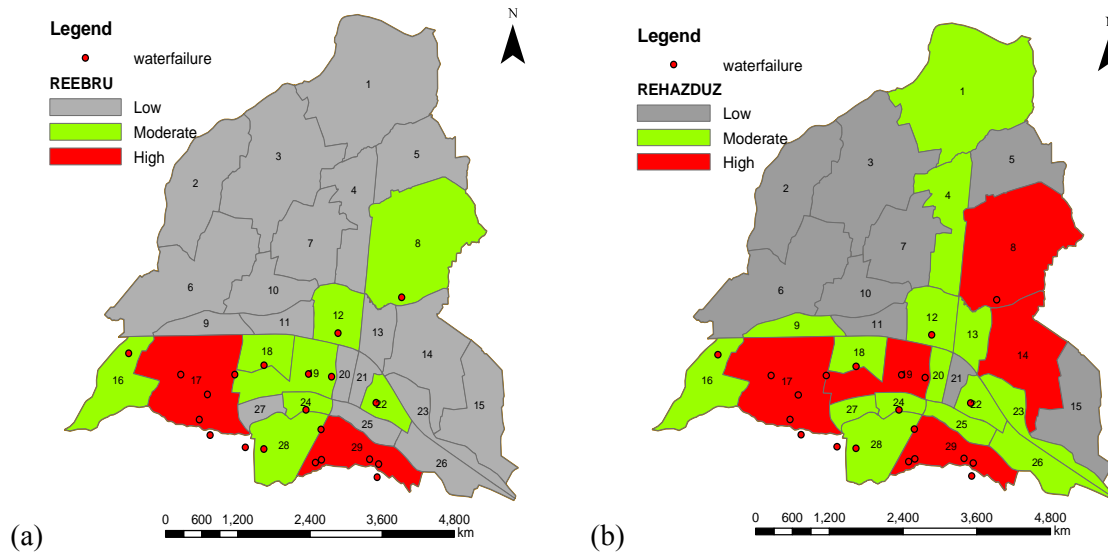
A set of well documented water system failures in Duzce caused by the 12-11-1999 M7.2 earthquake have already been presented in Figure 5 (Alexoudi, 2005). In Figure 13a, the above set of failures are plotted with the average reported damages per district (mahalle). This set of data is one of the rare cases of reported damages in water systems in Europe and Turkey. In the following paragraph we examine if the available vulnerability relationships and the associated damage states could reproduce accurately the reported damages in Duzce. The necessary spatial distribution of PGV for the M7.2 earthquake in Duzce has been estimated from the pilot microzonation study using as outcrop input motion the deconvolution of the recorded ground motion at the Metereological Station. After proper validation it was decided to apply in this study the fragility function of O'Rourke & Ayala (1993) proposed also in HAZUS 2004. This is an empirical relationship based on data collected from actual pipeline damages observed in four USA and two Mexican earthquakes. Two damage states for pipelines were considered, leaks and breaks. The Repair Rate according to O'Rourke & Ayala (1993) for wave propagation is given as follows:

Figure 13. Mahalle with low (grey), moderate (green) and high (red) damages as result of Duzce earthquake (a) Marmara damage database, (2005), (b) Fragility curve: O'Rourke & Ayala, (1993) (With red color are illustrated the documented specific failures/ mahalle).

In Figure 13b the computed damage states (low, moderate and major damages) are illustrated per district, applying as already mentioned before the O'Rourke & Ayala (1993) fragility relation for pipeline failures.

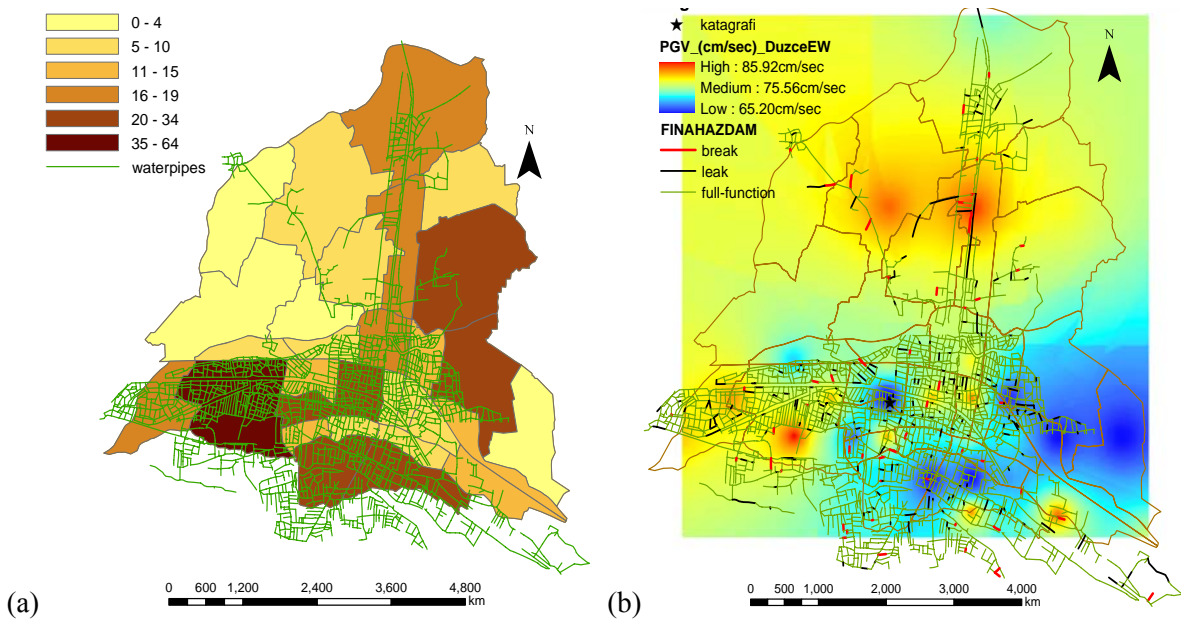
In Figure 14a the number of water pipe damages per district are presented, while in Figure 14b the computed damages in the water system of Duzce are depicted. In general, it is observed that O'Rourke & Ayala (1993) relation presents a good correlation of damages both in regards of the total number of damages and their spatial distribution, as it is illustrated in Figure 13. Most damages are observed at the southern district and the western part of Duzce which is in good agreement with the actually reported damages. Soil conditions at these area are rather soft and loose which produced higher peak ground velocities and consequently damages as well.

Figure 14 Vulnerability assessment of water system in Duzce after 12-11-1999 earthquake (a) Average number of damages per district (mahalle), O'Rourke & Ayala (1993), (b) Specific spatial distribution of damages using the O'Rourke & Ayala 1993 relation and the results of the pilot microzonation study in terms of ground velocity.
