CHARACTERISTICS OF VERY-HIGH-CYCLE FATIGUE FOR A HIGH CARBON LOW ALLOY STEEL

Youshi HONG, Cheng-en ZHOU

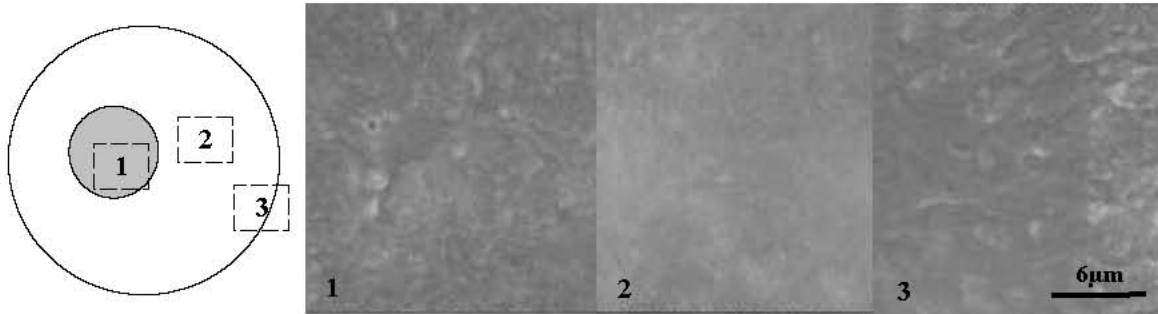
Scanning Electron Microscopy (SEM) was used to examine the fracture surface of fatigue failure specimen. The observations showed that, the inclusion near the surface is very likely the origin of fatigue crack. Figure 3 is an example of “fish-eye” pattern. We may see the morphology in different local regions labeled 1, 2 and 3. Local region 1 is the

Fig.3 SEM photographs showing morphology of different local regions of a “fish-eye”.

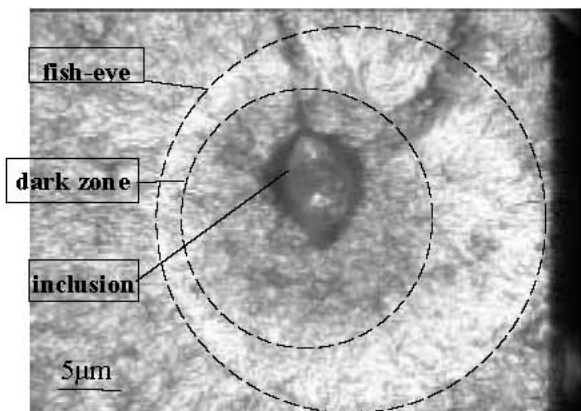
Fig.4 General view of a “fish-eye”.

origin of the “fish-eye” i.e. the source of crack initiation. Figure 4 shows the entire morphology of a “fish-eye”. The shape of the “eye” is almost circular. Therefore we measured the equivalent diameter of the “eye”. Based on this measurements we are able to estimate the stress intensity factor and the results are given in Fig.5, where A is related to the inclusion area and B is related to dark zone area. The corrected value for A zone is about $30\text{MPam}^{1/2}$, which is comparable to the fracture toughness of the test material. Further analysis obtained that the value of stress intensity factor for fatigue crack initiation is very close to the fatigue threshold of the material (about $6\text{MPam}^{1/2}$).
