Geological Prerequisites for Landslide Dams' Disaster Assessment and Mitigation in Central Asia

Alexander Strom

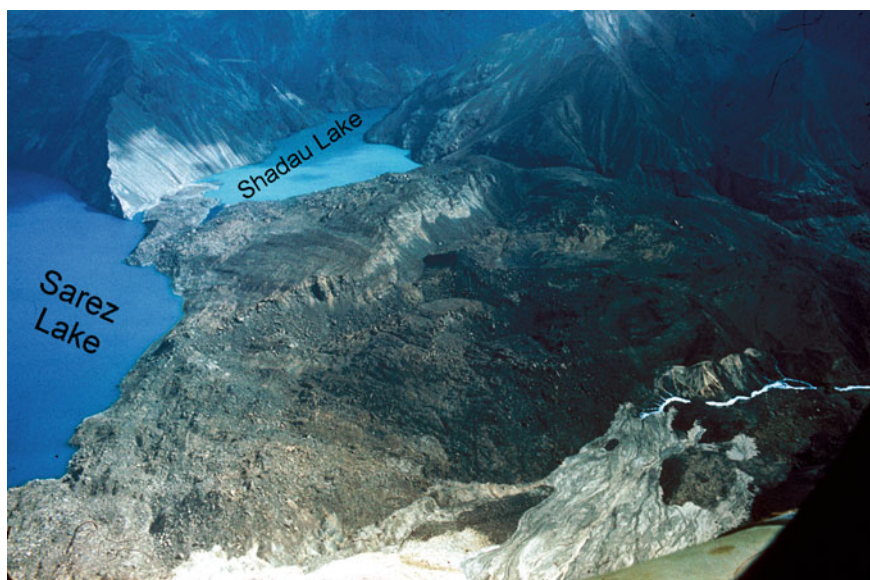
Fig. 3 The Usoi natural dam. Helicopter view from north. Giant block retaining original structure is visible on top of the dam in front of the Shadau Lake. Seeping water forms springs at the left bank of the erosion canyon. Whitish flat area above the canyon—deposits of debris flows that came in this direction before their diversion towards the Lake in 1947. Steep scarp that crosses the dam body indicate its transverse spreading likely due to impact over the steep opposite slope of the Murgab River valley

The 5-km long (across the valley) and 3.75-km wide dam (Fig. 3) have blocked the Murgab River valley at $38^\circ 16.5' \text{ N}$, $72^\circ 36' \text{ E}$ (1 on Fig. 1). Despite the remoteness and inaccessibility of the site, Russian researchers performed first studies of this unique feature soon after the event (Bukinich 1913; Shpilko 1915; Preobrajensky 1920). Its regular studies started in sixtieth of the twentieth Century (Scheko and Lekhatinov 1970; Gaziev 1984; Agakhanjanz 1989).

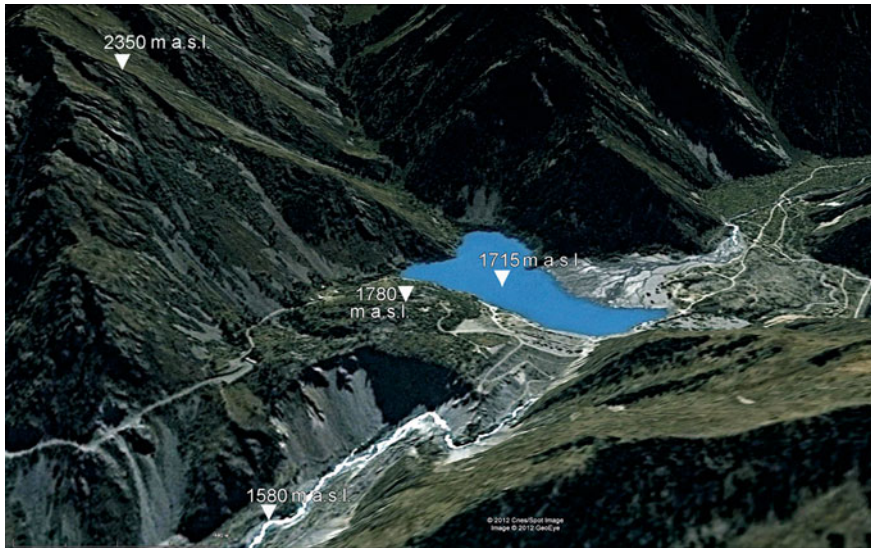
Fig. 5 The Issuk dam and Lake after restoration of the dam. The rockslide headscarp is on the left. Large alluvial fan was formed by debris flow that caused the dam's breach in 1963. 3D Google Earth view

The prehistoric landslide dam about 0.6 km^2 in size and up to 200 m high (about 50 Mm^3 in volume), composed of diorite blocks (on top) and same rock crushed at a high extent in the dams' interior (Eugen Gaspirovich, personal communication), was breached by overtopping caused by debris flow that originated in the upper reaches of the catchment due to the Jarsai glacial lake breach. Up to 6–7 million m^3 of debris was brought into the Issyk Lake within 3–4 h resulting in rapid increase of the lake level and creation of waves that destroyed the upper part of the blockage. Water stored in the lake rushed downstream eroding the dam body as well as river banks and valley bottom (Gerasimov 1965). Peak discharge recorded about 10 km downstream, close to the Issyk town, was $745 \text{ m}^3/\text{s}$, while mean discharge of the river at this site is $4,96 \text{ m}^3/\text{s}$ (from (State Water Inventory 1964–1981). Only small remnant lake has remained after the disaster. Later on an artificial dike was built in the eroded canyon to protect downstream valley and the Issyk town from new debris flows and to renew this beautiful touristic site (Fig. 5).

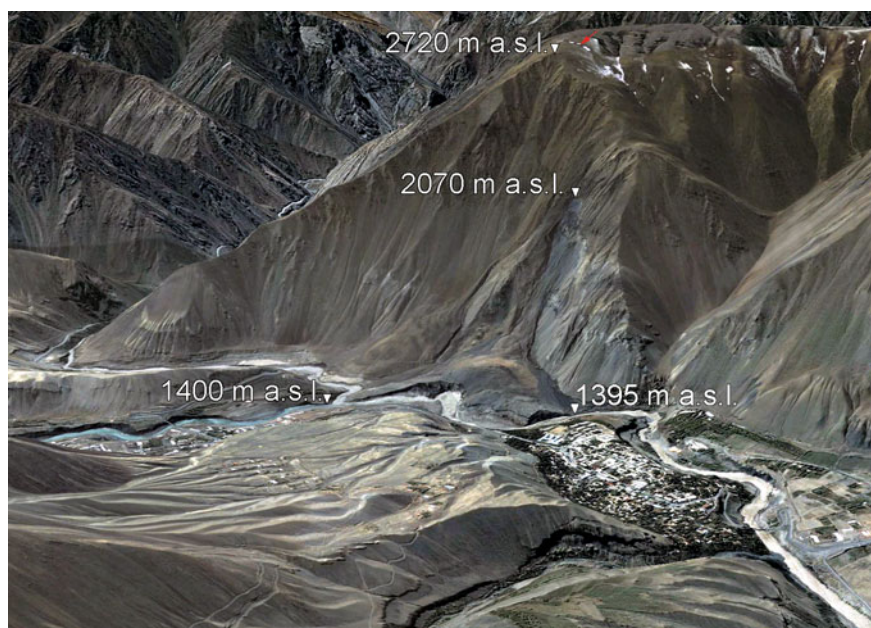
Fig. 6 Remnant of the 1964 rockslide dam at the Aini town (Tajikistan) immediately downstream from the junction of the Zeravshan river (coming from the left with clear blue water) and the Fandarya River (with muddy water, coming from the gorge at the background). *Red arrow marks an arcuate scarp indicating possibility of slope failure at this site in future. 3D Google Earth view*

town area in the Zeravshan River valley in Tajikistan, described above (see Fig. 6). The 1964 river-damming landslide was preceded by much larger prehistoric one and indications of future instabilities are evident on the left-bank watershed.

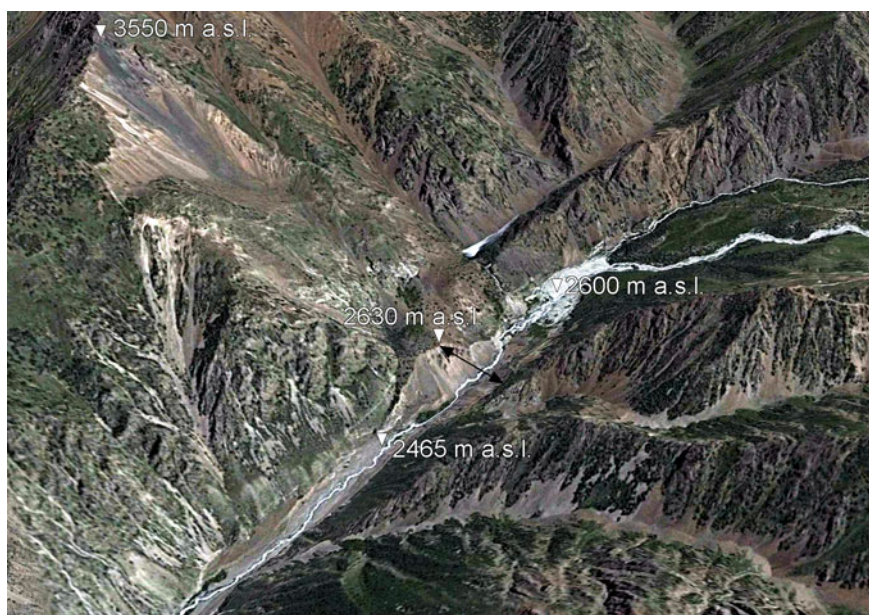
Fig. 7 The Yashinkul dam breached in 1966. Note large difference of the benchmarks elevations upstream and downstream from the dam resulting from the significant sedimentation of the 300-years old lake (compare with the Aini landslide dam on Fig. 6). Just downstream from the dam evidence of valley aggradation are still visible. 3D Google Earth view

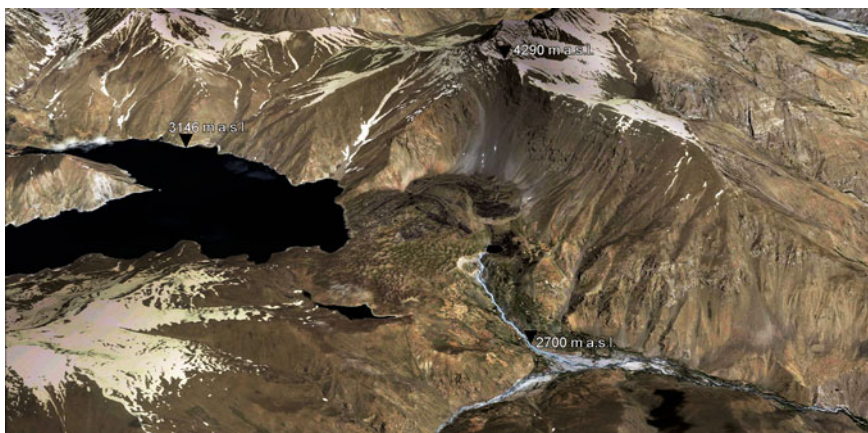
Fig. 9 Rockslide dam of the Shiva Lake in the Afghan Badakhshan at $37^{\circ}23' \text{ N}$, $71^{\circ}24' \text{ E}$ (6 on Fig. 1). It is clearly visible that the headscarp is a unique feature which relief is much younger than that of other parts of the valley slope. 3D Google Earth view

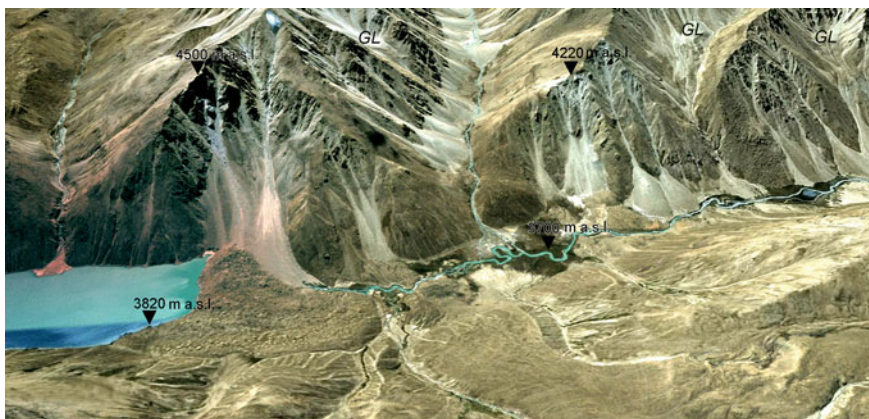
Fig. 10 The Rivakkul Lake dam in the Gunt River basin at $37^{\circ}37' \text{ N}$, $72^{\circ}03.5' \text{ E}$ (7 on Fig. 1). One more smaller blockage can be seen immediately downstream from the dam and one more—downstream from the small green plane at 3700 m a.s.l., which is the bottom of the small emptied lake. GL—modern glacier deposits contemporary with the damming features develop much higher than rockslides that blocked the valley. 3D Google Earth view

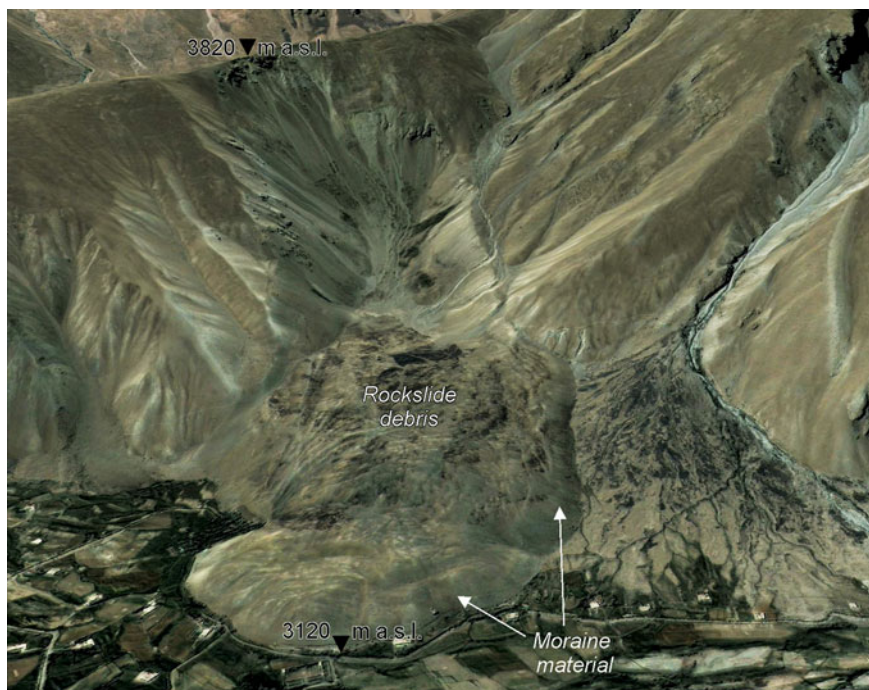
Fig. 11 The Imom rockslide at the left bank of the Gunt River valley. Frontal and flank parts of its body are composed of moraine material resting at the slope base that had been bulldozed by moving rockslide debris. 3D Google Earth view

This mechanism—pushing-out of old moraine material resting at the feet of valley slopes in front of moving rockslide debris can be seen very clearly at the Imom rock avalanche in the Gunt River valley ($31^{\circ}41.5' \text{ N}$, $72^{\circ}19.6' \text{ E}$, 8 on Fig. 1, Fig. 11). This 2.5 km long and $20\text{--}30 \text{ Mm}^3$ in volume rockslide caved from the 700 m high slope composed of Precambrian crystalline rocks. The inner part of its body is composed of angular blocks and rubble of crystalline rocks while the frontal 300 m and 50–100 m wide ‘stripes’ bounding the main body from both sides are composed of typical moraine material—rounded and semi-rounded boulders with sandy-rubbly matrix. This material originated from the remnants of lateral moraine that rest on the slope and, partially, of the alluvial fan that is now overlaid by rockslide body, but originally was formed at the slopes’ foot.

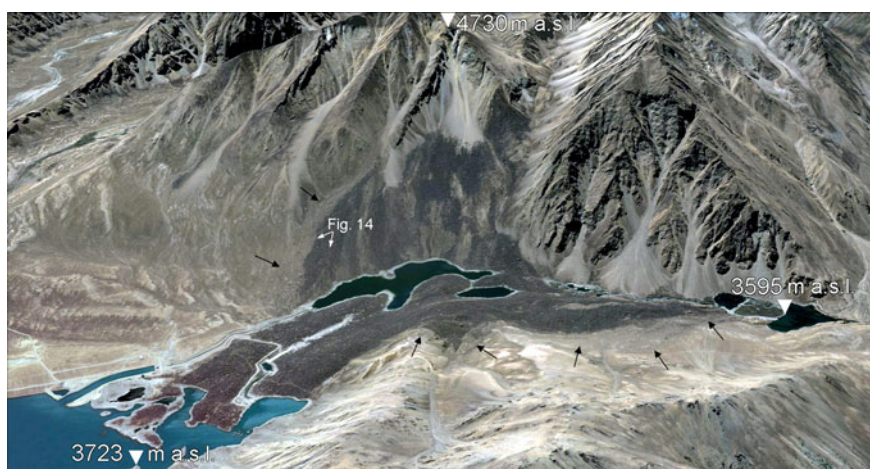
Fig. 13 Yashilkul rockslide dam. Dammed lake is the source of the Gunt River. Gneiss rock avalanche debris is dark brown; black arrows mark the outer limit of light-brown moraine material spread in front and sideways from gneiss debris and being part of rock avalanche; white arrows mark the site from where photograph shown on Fig. 14 was made. 3D Google Earth view

part of the latter spread outside the limits of the blocky gneiss zone forming microrelief that differs significantly from the intact terrain outside (Figs. 13, 14). Besides, here we can also see that the headscarp is a unique feature at this slope within its elevations range, which indicate non-climatic cause of its origin.

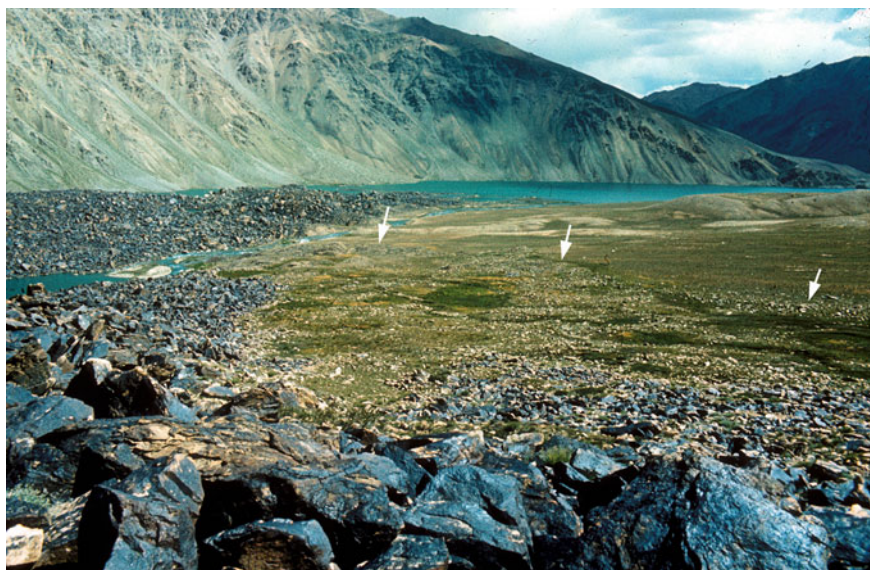
Fig. 14 Wide thin stripe of moraine material bounding central part of the Yashilkul rock avalanche debris composed of gneiss blocks. Its microrelief differs significantly from old moraine material (outer limit of rock avalanche is marked by arrows). Photograph was made in 1980s before the construction of the spillway visible on Fig. 13

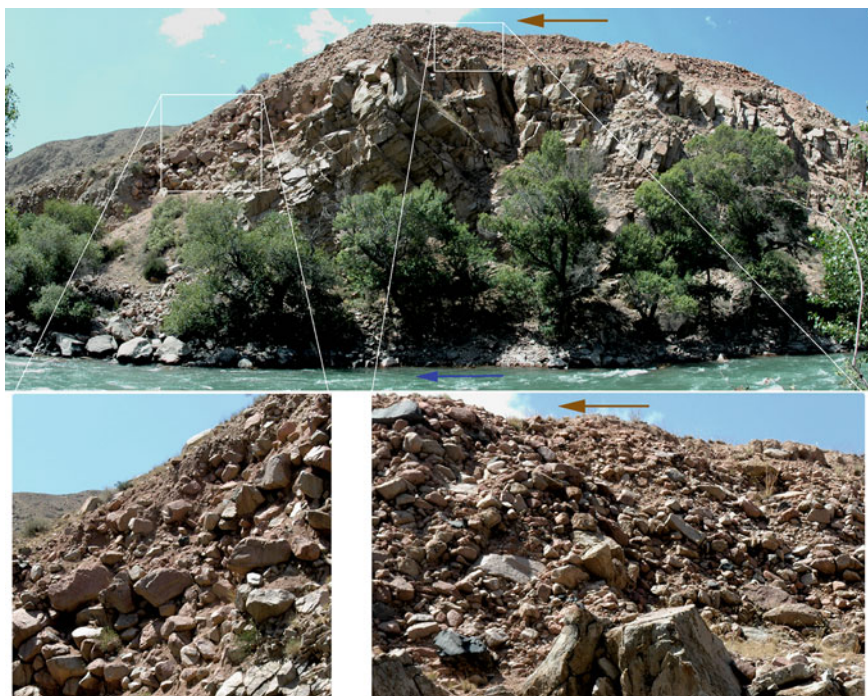
Fig. 21 Debris left by outburst flood after breach of the Lower Aral Holocene landslide dam on the isolated ~ 10 m high cliff about 2 km downstream from the breached dam. *Dark blue arrow* shows river flow direction. *Left inset*—large angular blocks of granite up to 1 m in size carried by the first, most powerful surge of the debris flow formed by outburst and deposited immediately downstream from the cliff in its ‘shadow’. This material was, likely, eroded from the dams’ outer part. *Right inset*—cliff is covered by stony angular granite debris left by the following part of the debris flow enriched by smaller fragments, likely from the internal part of the dams’ body. Orientation of flattened fragments clearly indicates direction of debris flow motion (*brown arrows*). Note that debris flow was thick enough to leave about 2-m thick debris 10 m above the river level

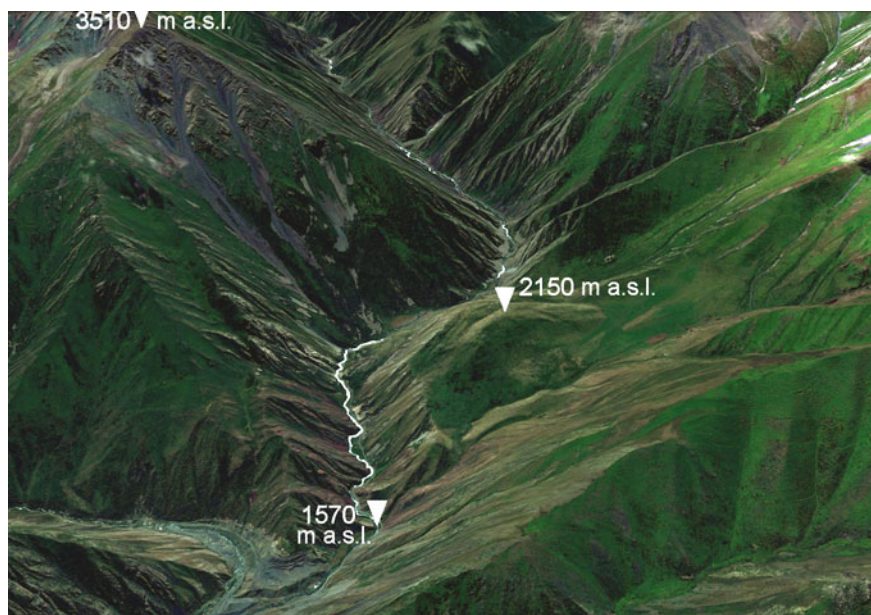
Fig. 22 Breached Aksu dam in the Aksu River valley at the northern slope of the Kyrgyz Range. Remaining part of the dam's body is the smooth hill with top mark at 2150 m a.s.l. 3D Google Earth view
