Chapter 2

Mechanical Failure of Materials

Abstract This chapter describes the major causes of mechanical failure of the engineering components or structure. Various level of materials performance is introduced. Failures due to fracture, fatigue, creep, wear and corrosion have been explained in order to understand the common mechanical failure. A case study on the failure analysis of an electrical disconnecter has been presented with the recommendation to prevent the failure.

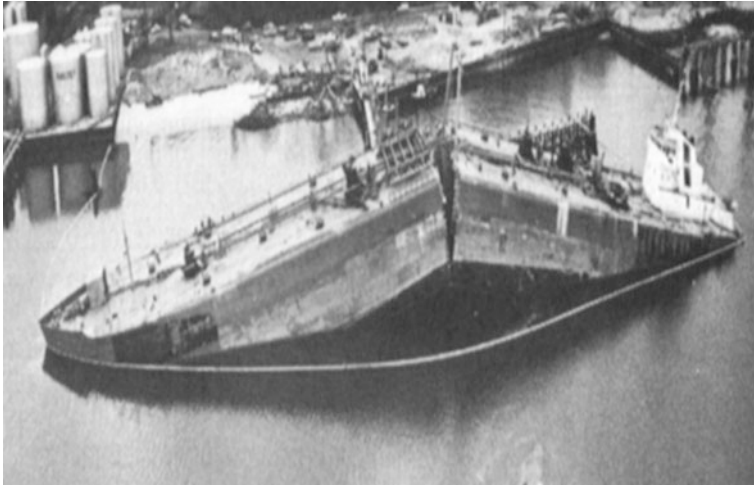
Fig. 2.1 An oil tanker that fractured in a brittle manner by crack propagation around its girth (Callister 1997, 4e) (This material is reproduced with permission of John Wiley & Sons, Inc.)

anticipate and plan for possible failure prevention in advance. Figure 2.1 shows a catastrophic failure of an oil tanker that fractured in a brittle manner by crack propagation at the middle of the tanker.

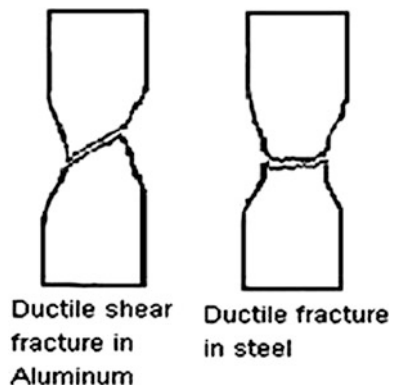
Ductile fracture is characterized by tearing of metal and significant plastic deformation. The ductile fracture may have a gray, fibrous appearance. Ductile fractures are associated with overload of the structure or large discontinuities. This type of fracture occurs due to error in design, incorrect selection of materials, improper manufacturing technique and/or handling. Figure 2.2 shows the features of ductile fracture. Ductile metals experience observable plastic deformation prior to fracture. Ductile fracture has dimpled, cup and cone fracture appearance.

Fig. 2.2 Ductile fracture in aluminum and steel after tensile testing

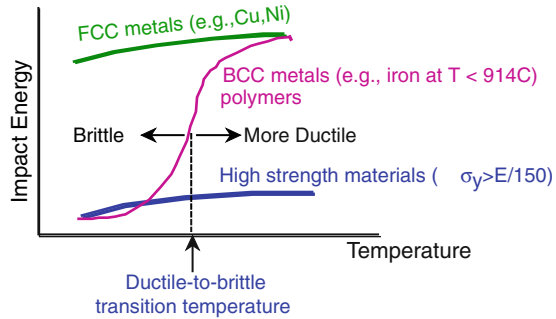
The temperature at which the component works is one of the most important factors that influence the nature of the fracture. Sharp ductile-to-brittle transition (DBTT) is observed in BCC and HCP metallic materials as shown in Fig. 2.3.

Fig. 2.3 Ductile–brittle transition temperature curve (Callister 2005)

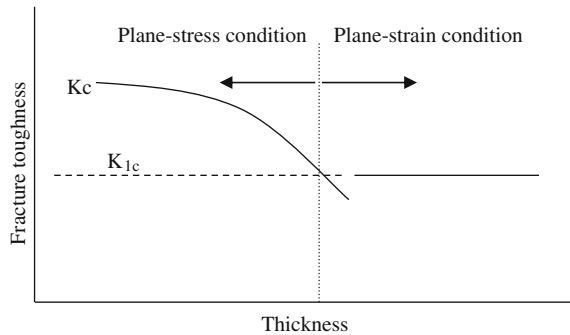
Fig. 2.4 Fracture toughness behavior: effect of material's thickness

Severe fracture occurs when this SIF reaches to a critical value as denoted by K_c . The relationship between K_I and K_c is similar to the relationship between yield strength and tensile strength whereby K_c is greater than K_I . Therefore, K_c is the maximum value that can withstand by the material without any final fracture and depends on both type of materials and its thickness. The smaller the value of K_c means the less tough the material. The critical stress intensity factor K_c is a function of the material and plate thickness concerned. The thickness factor is because the form of crack propagation is influenced by the thickness of the plate. The effect of thickness on the value of the critical stress intensity factor is shown Fig. 2.4.

At large thickness, the portion of the fracture area which has sheared is very small, most of the fracture being flat and at right angles to the tensile forces. This lower limiting value of the critical stress intensity factor is called the **plane strain fracture toughness** and is denoted by K_{Ic} . This factor is solely a property of the material. It is the value commonly used in design for all but the very thin sheets; it being the lowest value of the critical stress intensity factor and hence the safest value to use. The lower the value of K_{Ic} means the less tough the material is assumed to be. Table 2.2 shows difference between stress intensity factor (SIF) and fracture toughness (FT).

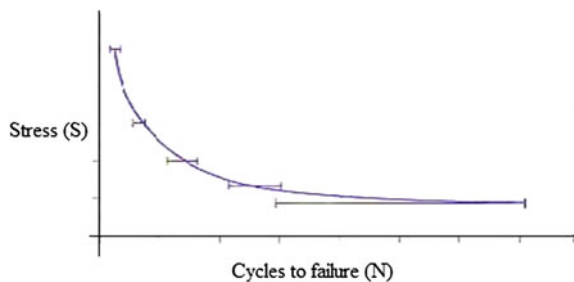
Metal fatigue is caused by repeated cycling of the load. It is a progressive localized damage due to fluctuating stresses and strains on the material. Metal fatigue cracks initiate and propagate in regions where the strain is most severe. Figure 2.5 shows typical S–N curve for the fatigue strength of a metal.

Fig. 2.5 Schematic of S–N curve showing increase in fatigue life with decreasing stresses

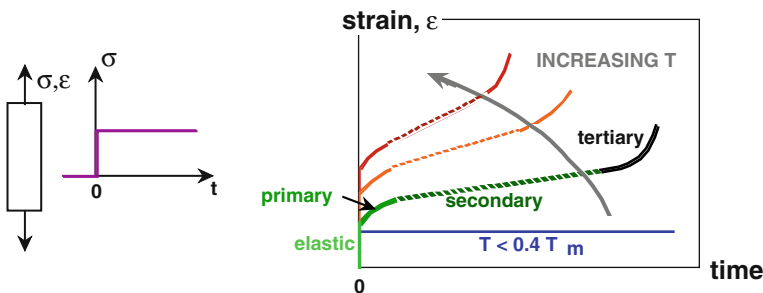
Fig. 2.6 Creep rupture envelop

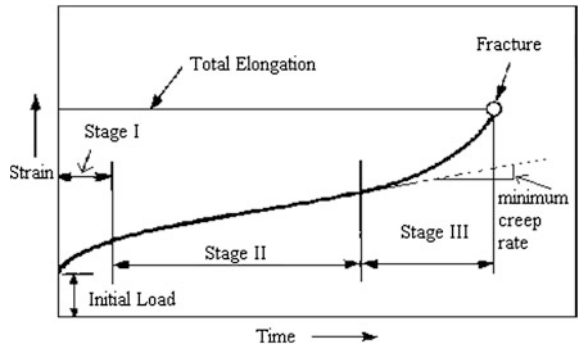
In a creep test, a constant load is applied to a tensile specimen maintained at a constant temperature. Strain is then measured over a period of time. The slope of the curve, shown in Fig. 2.7 is the strain rate of the test during stage II or the creep rate of the material. Primary creep (known as stage I) is a period of decreasing creep rate. Primary creep is a period of primarily transient creep. During this period deformation takes place and the resistance to creep increases until stage II. Secondary creep (or stage II) is a period of approximate constant creep rate. Stage II is referred to as steady state creep. Tertiary creep (stage III) occurs when there is a reduction in cross sectional area due to necking or effective reduction in area due to internal void formation. Subsequently, increase in creep rate leading to the creep fracture or stress rupture.

Fig. 2.7 Strain rate (typical creep curve) of material under creep test

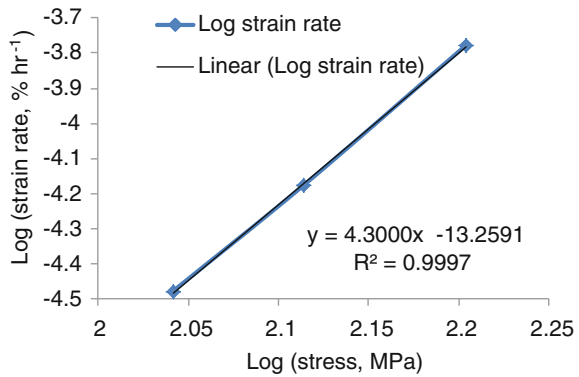
- The creep rate is related to stress by $\dot{\epsilon} = A\sigma^n \rightarrow \log(\dot{\epsilon}) = \log(A) + n\log(\sigma)$.
The slope of the plot in Fig. 2.8 provides $n = 4.3$.
- (a) Raising temperature to 750 °C, Thermal strain = $15.8 \times 10^{-6} \times (750 - 20) = 1.15 \%$

Fig. 2.8 Log strain rate versus log stress

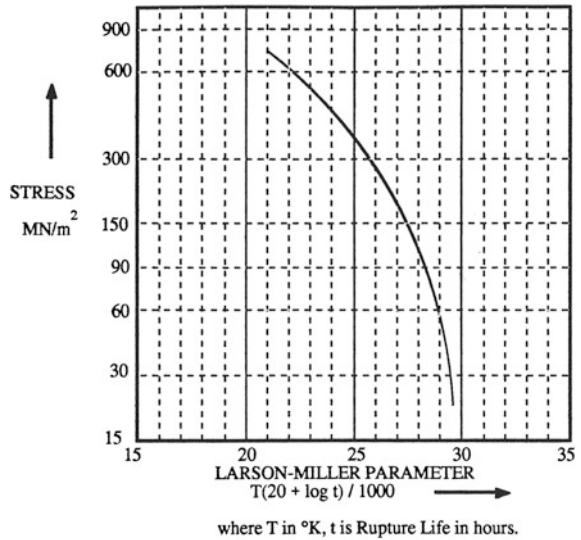
The creep rupture properties of nickel alloy (Nimonic 105) are shown in Fig. 2.9. Using Fig. 2.9, estimate the maximum operating temperature of a gas turbine blade made out of this material which is to withstand a stress of 150 MPa for a duration of 10,000 h.

Fig. 2.9 Stress versus Larson–Miller parameters graph

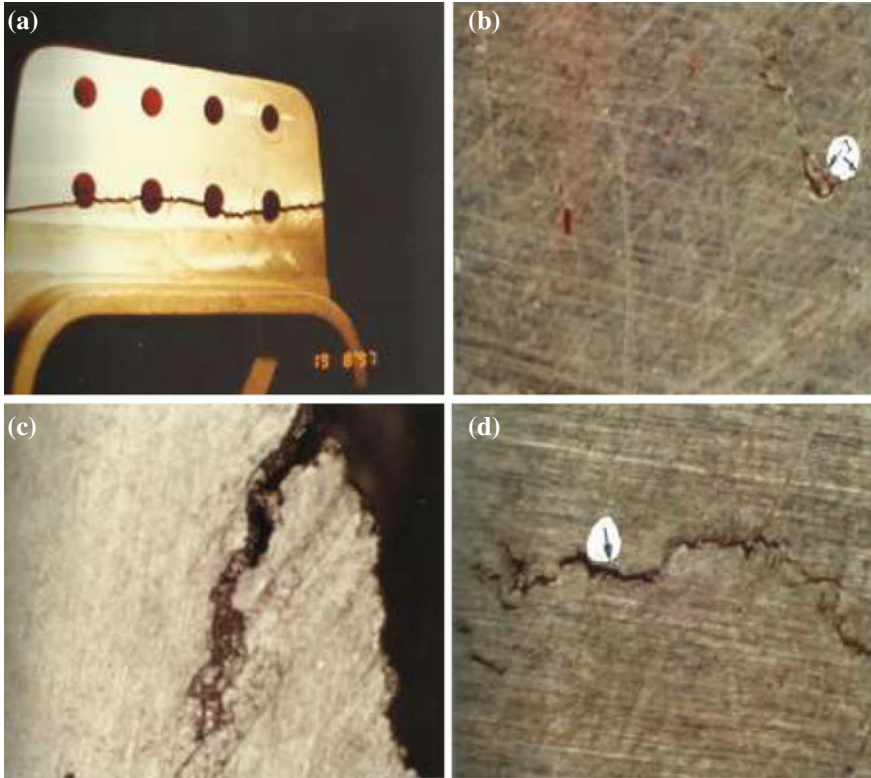
Fig. 2.10 **a** Fractured part of disconnect. **b** Crack pattern at the end of the fractured surface. **c** Extensive cracking at the bolt area. **d** Crack propagation at the inferior

- At the edge of the broken part as shown in Fig. 2.10a. In Fig. 2.10b, few cracks can be seen which were very close to the fractured surface, having extensive cracking.

- A wide and long crack nearby the fractured surface were found (as shown in Fig. 2.10c, d).
- Some voids or pored radiating from the surface of the part were also observed.

The nuts bolted with the hole had an interference fit where the bolts behave as integral parts. However, during installation or after installation, high force might acted on the component (such as base or blade) even if there is little movement or misalignment of the bushbar. Therefore, fracture or failure occurs towards downward direction.

- failure of the disconnecter occurred due to brittle fracture
- the major cracks on the vicinity of the fracture show that they were formed during installation and were not new cracks.

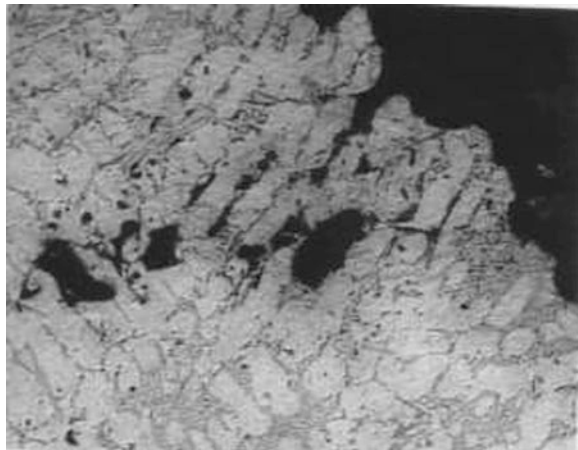
Fig. 2.11 Optical micrograph of materials. Showing α -aluminum dendrites, acicular silicon and primary silicon plates ($\times 100$)

be seen that the structure consist of α -aluminum dendrites, acicular silicon and primary silicon plates. Few inclusions and voids were noticed from the micro-structure of the specimen which causes inferior mechanical properties of the disconnector material.

The macro and micro examination tests showed that some inclusions and voids are distributed throughout the matrix which seemed to be flattened. The macroscopic examinations also shows that the color of at the fracture surface and around it is shiny and having granular appearance. The fracture surface seems to be flat without large undulation or gross irregularities which show that brittle fracture had occurred. This is probably because of high percentage of silicon content in the alloy. The high amount of Si resulted in the aluminium wrought alloy becoming brittle.

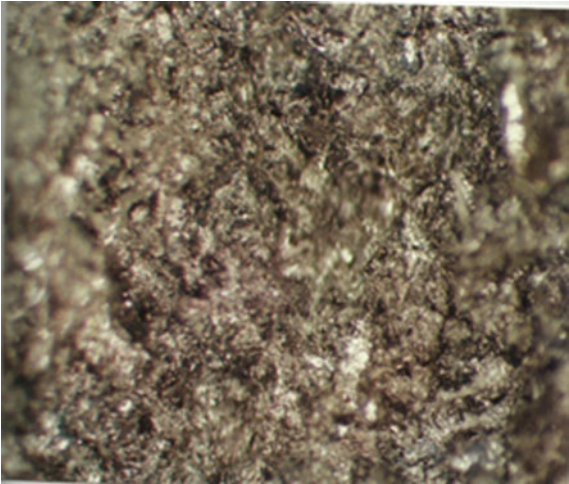
Fig. 2.12 Charpy fracture surface showing the shiny, granular surface which is the characteristics of brittle fracture

The fracture surface was very shiny, having granural appearance (refer to Fig. 2.12). However, the resulting fracture surface was relatively flat without large undulation or gross irregularities.

The charpy V-notch Impact Energy test results are shown in Table 2.4 (at the last colum). The average value of the change in potential energy was 3.00 J. From Table 2.4, it is obvious that the Disconnecter head is below capacity of the absorbed energy as far as the impact energy is concerned.

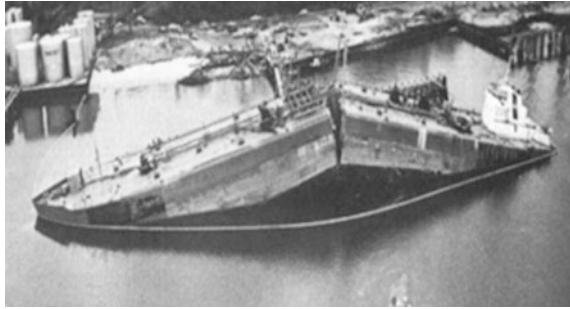
Fig. 2.13 Fracture of an oil tanker

- 2.12. Figure 2.13 shows the fracture of an oil tanker. Explain why and how such kind of fracture phenomenon occurs?
- 2.13. What do you mean by fracture toughness?
