Structural Behaviour and Retrofitting of Adobe Masonry Buildings

Keywords Adobe • Masonry • Seismic vulnerability • Mechanical characterization • Numerical modelling • Retrofitting solutions

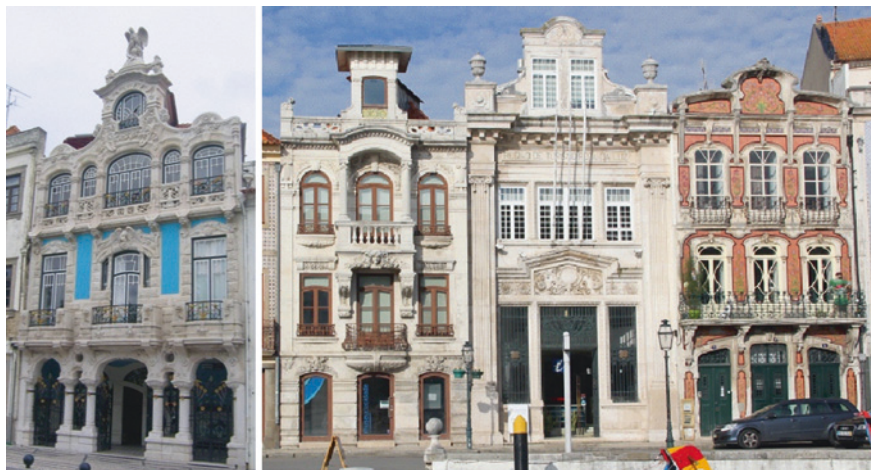
Fig. 2 Historical constructions in urban areas of Aveiro city

In Portugal, earth construction dates back to several hundreds of years ago, located mainly in the centre and south coastline [8–10]. These buildings are examples of the vernacular architecture, part of the Portuguese built heritage. In the district of Aveiro, a particular type of adobe was produced and used in construction. In this region, adobe blocks were stabilized with lime, to improve its mechanical strength and durability. In this region, the use of adobe in the construction was widely applied until mid of the twentieth century. After, the reinforced concrete as being used as the main building material/solution. The typical adobe houses in urban areas are two or three storey buildings (Fig. 2), sometimes covered with high valued tiling. In the city of Aveiro, it can be found several examples of buildings influenced Art-Nouveau architectural style [11, 12]. The majority of the constructions in rural areas are simpler and with only one storey, as can be seen in Fig. 3.

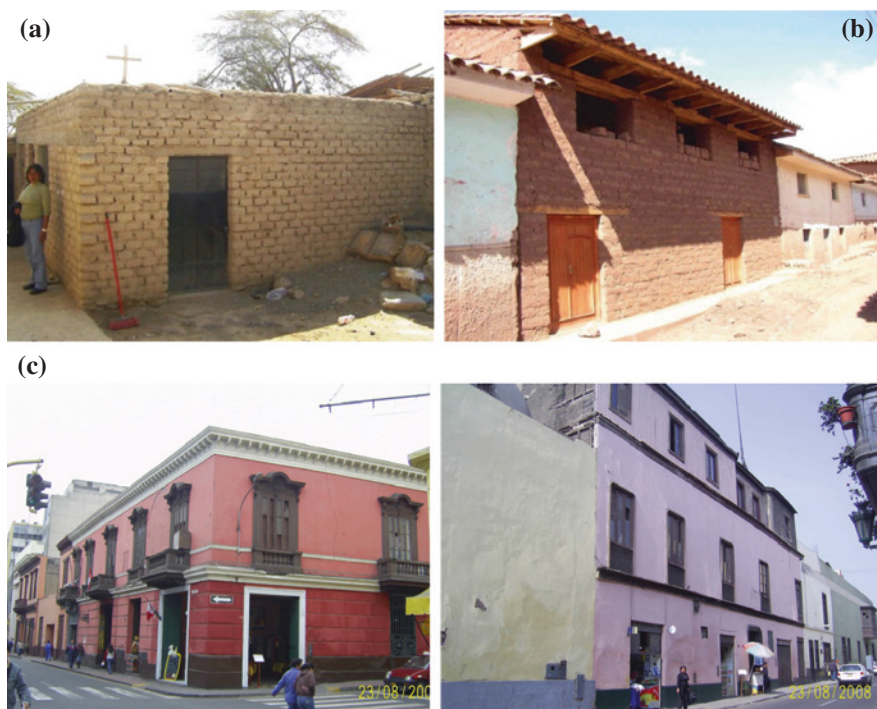
Fig. 4 Typical Peruvian adobe houses. **a** Adobe house located at the peruvian coast. **b** Adobe house in peruvian highland. **c** Colonial adobe houses of two and three storeys in Lima, Peru

In Peru, the percentage of the country's population living in earth dwellings has gone down from 54 to 43 % in the last 15 years [14] with most of the concentration in urban and coastline areas. Figure 4 shows some typical Peruvian adobe dwellings located at the countryside. But also in Lima, capital of Peru, some Colonial houses made of adobe can be found (Fig. 4c). These houses are typically characterized by a first floor made with adobe and clay bricks, and the second and third floors made with *quincha* (wooden frame with infill of mud and cane). Due to fragilities presented by adobe construction, some South American countries have been restricting its construction.

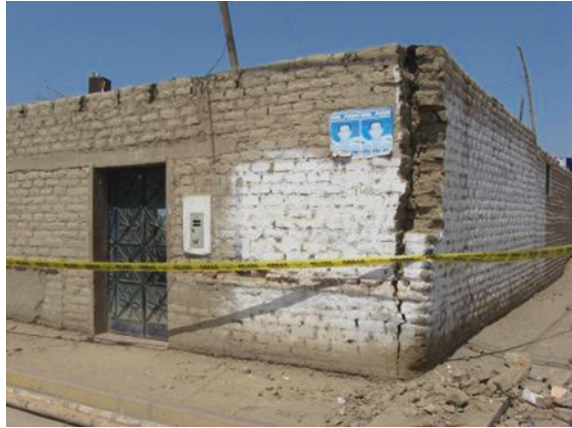
Fig. 7 Vertical crack at the corner of an adobe house, Pisco earthquake, Peru, 2007

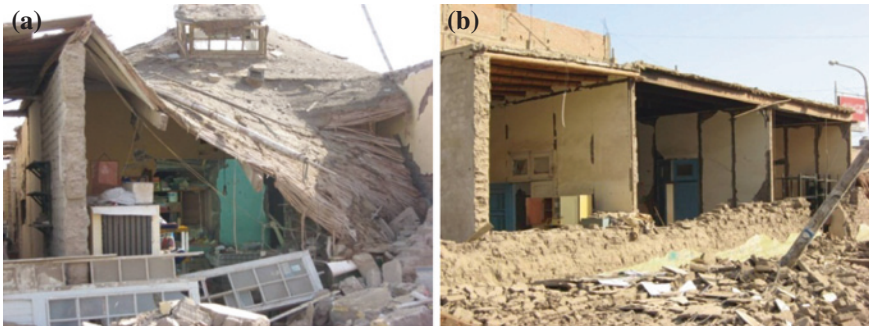
Fig. 8 Collapse of adobe houses during the Pisco earthquake in 2007, Peru. **a** Roof supported on the façade walls. **b** Roof supported by transversal walls

connection between the roof's wooden joists and the top of the façade walls. When the roof joists were supported by the façade wall, its collapse affects the roof support conditions, and finally the roof to collapse as well (Fig. 8a). If, on the other hand, the joists were supported by the walls that were perpendicular to the façade wall, the roof didn't fall apart (Fig. 8b).

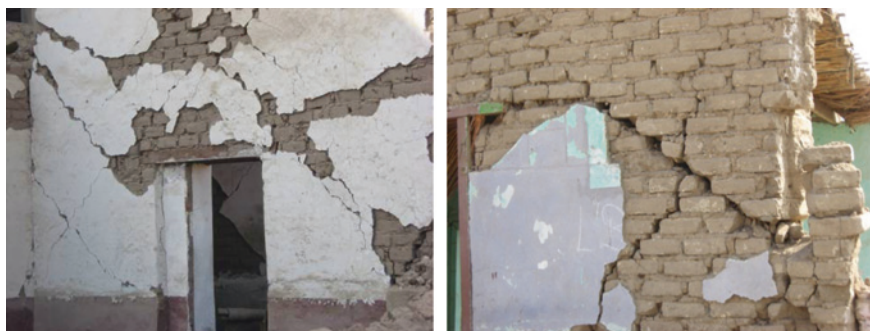
Fig. 9 Typical X-cracks on adobe walls due to in-plane actions

Lateral seismic forces acting within the plane of the walls generate shear forces that produce diagonal cracks, which usually—but not always—follow stepped patterns along the mortar joints. The diagonal cracks often start at the corners of openings, such as doors and windows, due to the stress concentration at these locations (Fig. 9). If the seismic movement continues after the adobe walls have cracked, the wall breaks into separate pieces, which may collapse independently in an out-of-plane mode.

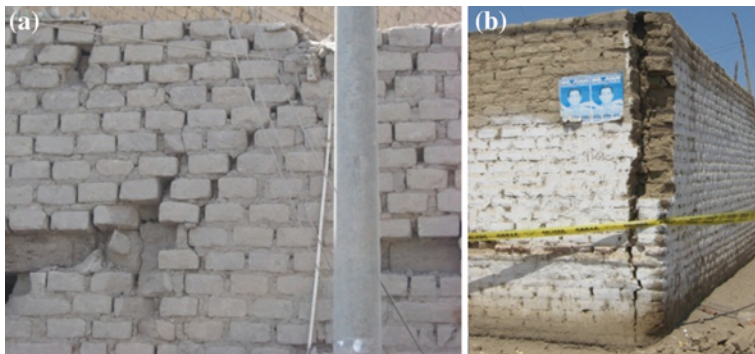
Fig. 20 Typical crack patterns in adobe masonry walls. **a** Stair crack shape (concentrated on mortar). **b** Vertical crack (fracture of bricks)

In addition, the cracking pattern observed in adobe walls subjected to horizontal loading is quite complex and difficult to predict. Generally, the mortar is weaker and softer than the bricks and therefore cracking tends to follow the mortar joints (Fig. 20a). However, sometimes failure of masonry may involve crushing and tensile fracturing of masonry units [31], in particular in adobe walls where the mortar has the same material properties as the bricks.

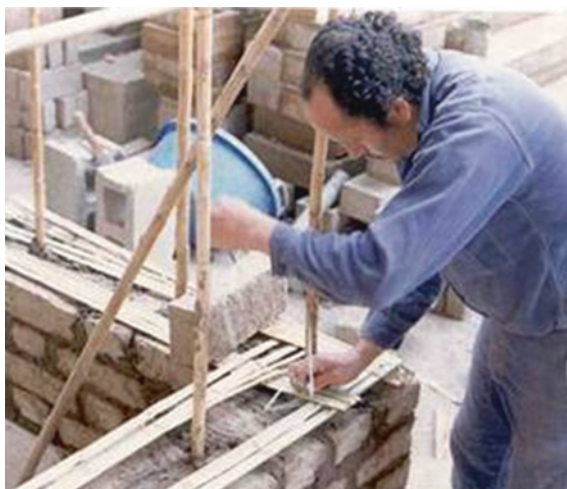
Fig. 27 Internal cane mesh reinforcement [77]

recommended for these reinforcements [76, 77]. It should be noted that this type of reinforcement can only be done in new constructions.

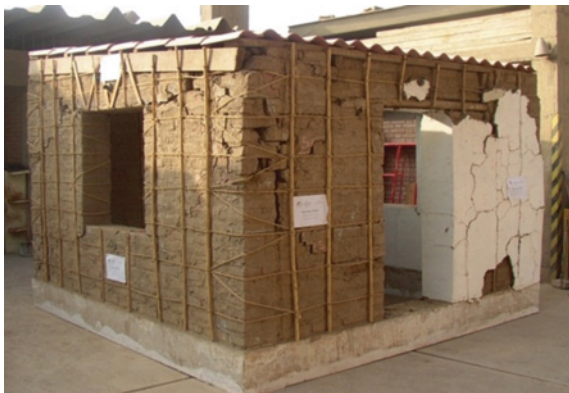
Fig. 28 External cane-rope mesh reinforcement [80]

Figure 28 shows an example of this type of reinforcement applied to a real-scale model tested at the PUCP, where only part of the structure was covered with plaster.
