Improvements to the Rescue Robot Quince Toward Future Indoor Surveillance Missions in the Fukushima Daiichi Nuclear Power Plant

Tomoaki Yoshida, Keiji Nagatani, Satoshi Tadokoro,
Takeshi Nishimura and Eiji Koyanagi

Field and Service Robotics

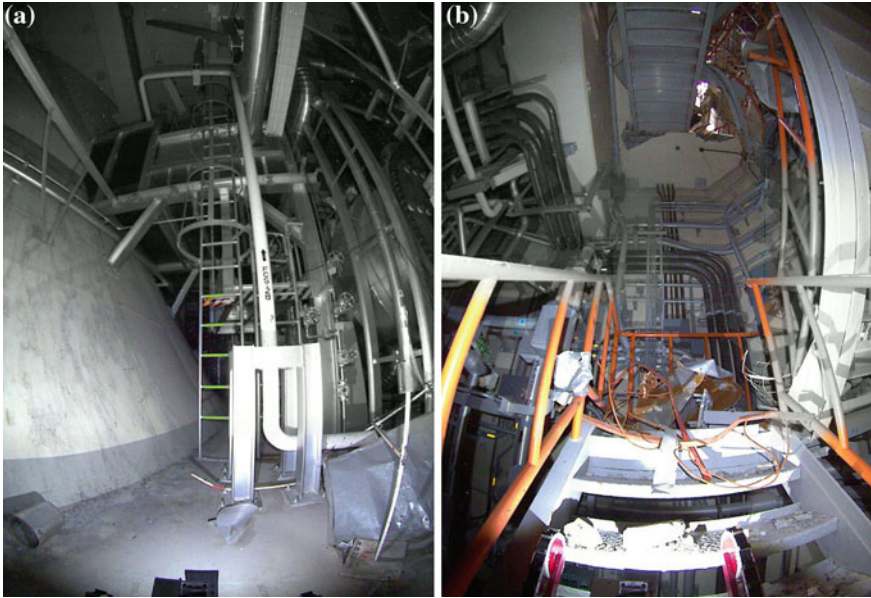
Fig. 1 High-resolution photos captured in the reactor building of unit 3. The *left* shows the piping of the core spray system and the *right* shows the rubble blocking the staircase to the third floor

Figure 1 shows the high-resolution photographs captured by the wide-angle camera on Quince 1. The left photograph shows the piping of the core spray system, which was located next to the primary containment vessel. The right photograph is of the staircase to the third floor, showing the rubble blocking the staircase.

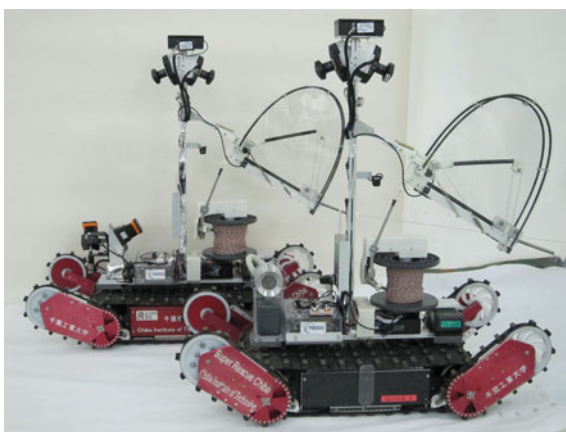
Fig. 2 New versions of Quince. The image on the *right* is Quince 2, which is equipped with an air dust sampler and the image on the *left* is Quince 3, which is equipped with laser scanners

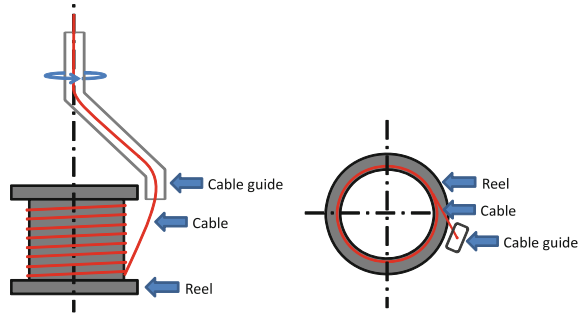
Fig. 3 A cable rewinding device on Quince 1. When the cable is pulled as Quince 1 moves, the cable guide rotates passively and releases the cable. When the operator instructs the device to rewind the cable, the guide is driven by the motor to rotate in the reverse direction, and the cable is rewound

The simple cable rewinding device present on Quince 1 encounters difficulties while rewinding long cables. This is because it does not have the capability to wind the cable evenly. Figure 3 shows the simple rewinding device on Quince 1. The cable is pulled and reeled out passively as Quince 1 moves, and it is rewound by rotating the cable guide by the motor. If the unreeled cable is too long, the rewound cable accumulates on the upper part of the reel. This is because the end of the cable guide arm is aligned at the top of the reel. The robot motion may shake the reel, causing the rewound cable to fall and become jammed. In this case, the reel would no longer be able to release the cable.

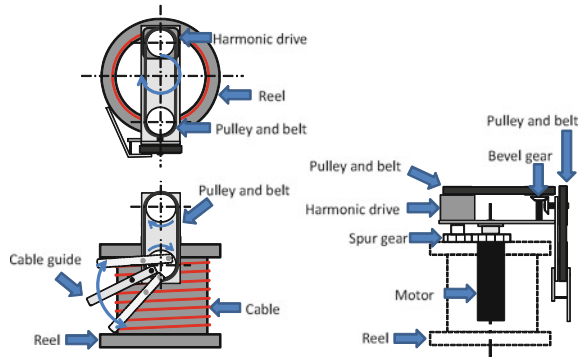
Fig. 4 Cable rewinding module on the reel. The module is driven by a motor located inside the reel. As it rotates around the reel, the cable guide swings up and down to evenly wind the cable

Figure 4 shows the new cable rewinding device. A motor rotates the cable rewinding module, which is shown in the upper part of the right figure, around the reel to wind the cable. While the module rotates around the reel, the cable guide arm is swung up and down to evenly wind the cable around the reel. One of the advantages of the system is that the module can be easily detached, so an operator wearing thick gloves can effortlessly change the cable reel.

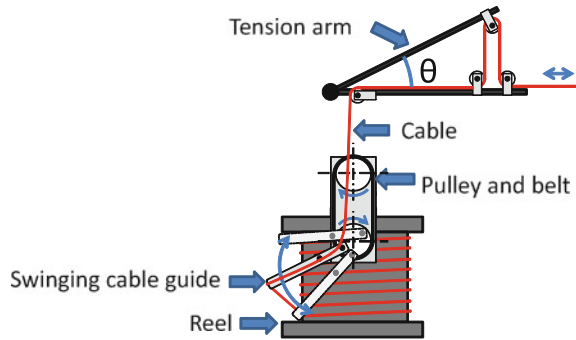
Fig. 5 Redesigned cable handling device. Tension in the cable can be measured by measuring the angle θ , and, by controlling the angle constant, the cable will be either released or rewound

To incorporate the automatic release and rewind functions, we implemented a tension control mechanism. Figure 5 shows the mechanism. The tension in the cable pulls down the upper arm that is supported by a spring located at the root. Thus, we can measure the cable tension by measuring the angle θ . By controlling the cable rewinding motor to keep the angle θ constant, the cable will be released or rewound as the robot moves.

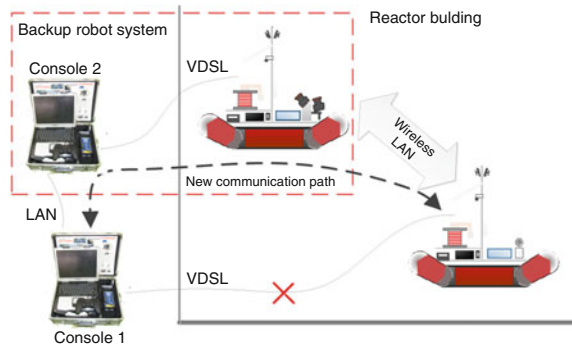
Fig. 6 Use of a secondary robot to restore the data link to the primary robot. The data link would be restored using the cable communication system of the backup robot and a wireless link between the two robots

Figure 6 shows the structure of the backup robot system. Both robots possess a VDSL cable communication system and a 802.11 g wireless LAN system. The primary robot conducts the mission using the cable communication system. If the cable fails, the backup robot is directed to the location, and it approaches the primary robot until a wireless connection is established between the two robots. Then, the data link to the primary robot is restored via the cable communication system of the second robot and the wireless connection between the robots.

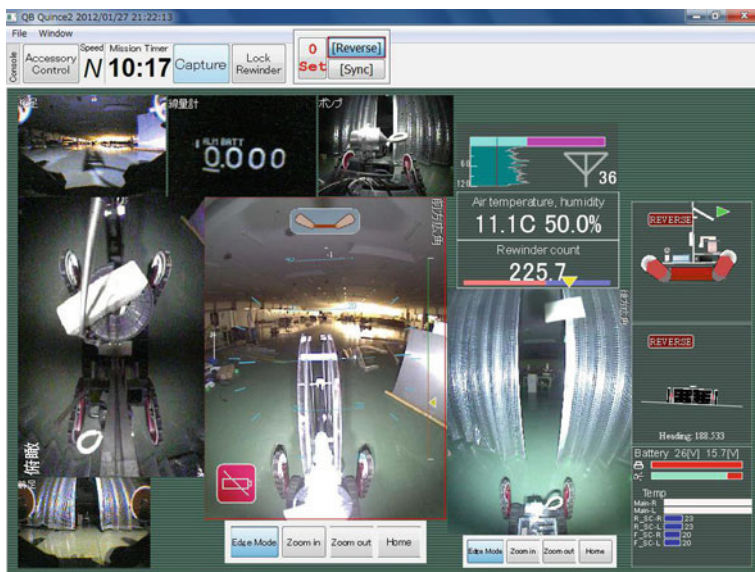
Fig. 7 Improved operator console screen for Quince 2. Status indicators for information such as the amount of cable remaining, temperature, and wireless signal strength, and some alert signals were added

The new operator console was improved to consider the feedback given by the operators of the missions conducted by Quince 1. Figure 7 shows the new console screen. The major improvements in response to the feedback were as follows:
