Chapter 2

Causes of Beach Erosion

Beach Renourishment

Bird, E.; Lewis, N.

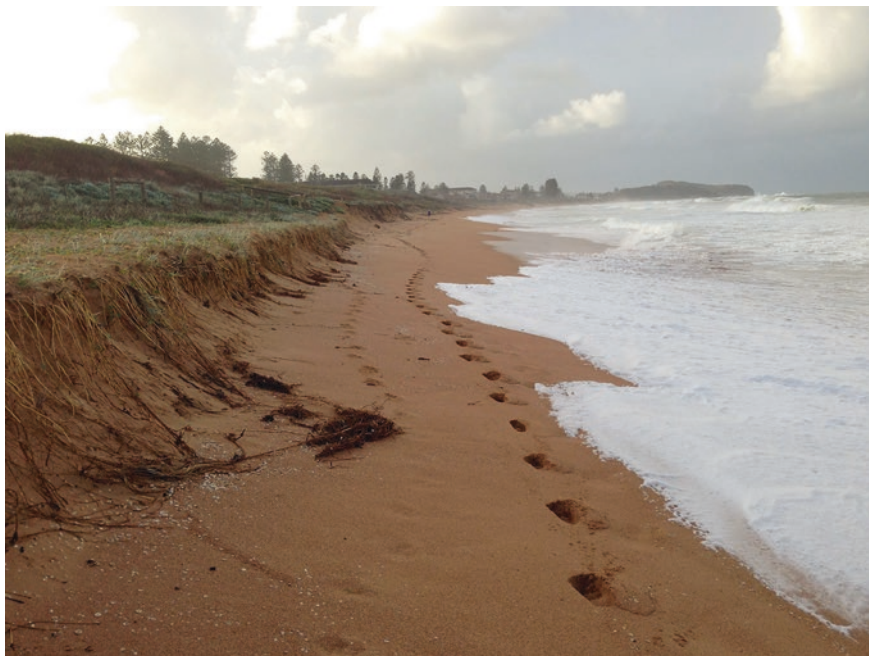
Fig. 2.2 Microcliff (erosional scarp) on Collaroy-Narrabeen Beach, NSW, Australia, cut by a number of late summer storms in 2013. © Nick Lewis

Beach erosion is usually marked by the evolution of a concave-upward shore profile, whereas accreting (prograding) beaches typically have convex-upward shore profiles. There is sometimes a receding microcliff (an erosional scarp), a metre or more in height, where an upper convex beach is being undercut as a lower concave profile becomes established (Fig. 2.2). Backshore dunes are often cliffed behind beaches that have been lowered and cut back by erosion, as are backshore terraces, and in both cases vegetated land surfaces are truncated as erosion proceeds.

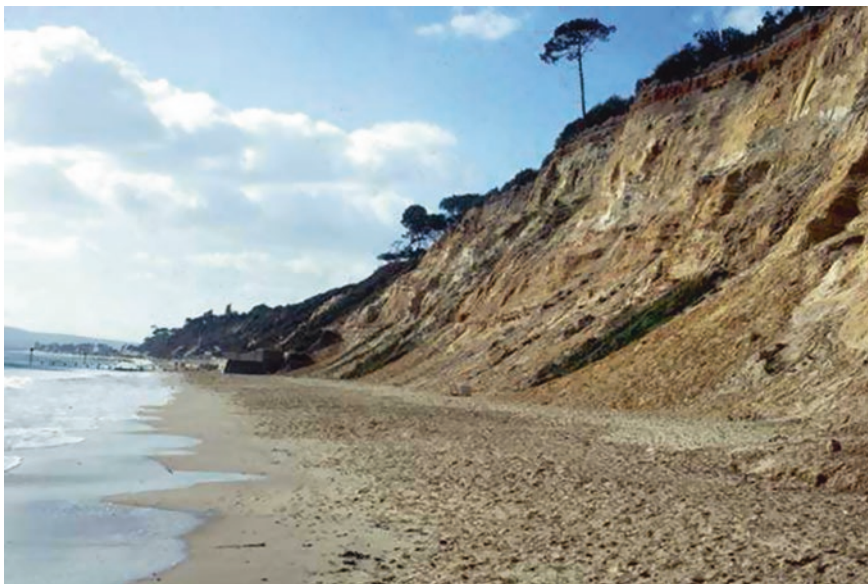
Fig. 2.3 Canford Cliff, Bournemouth, Dorset cut in Tertiary sandstones capped by Pleistocene gravel, as it was in 1950. Sand and gravel eroded from the cliff by runoff and marine erosion was then being delivered to adjacent beaches. See Fig. 2.4. © Geostudies

coast of Bournemouth in southern England after a concrete promenade built along the base of eroding cliffs cut in soft sandstone and gravel (Figs. 2.3, 2.4) cut off the supply of sand and gravel to the beach, which then gradually diminished. The promenade was built partly for the benefit of seaside holidaymakers, but it was also intended to halt cliff recession and preserve coastal properties. The coastal slope was artificially landscaped and planted with vegetation, but by the 1970s Bournemouth beach was severely depleted, and it was decided that it should be re-nourished (Sect. 4.2.7, p. 49).

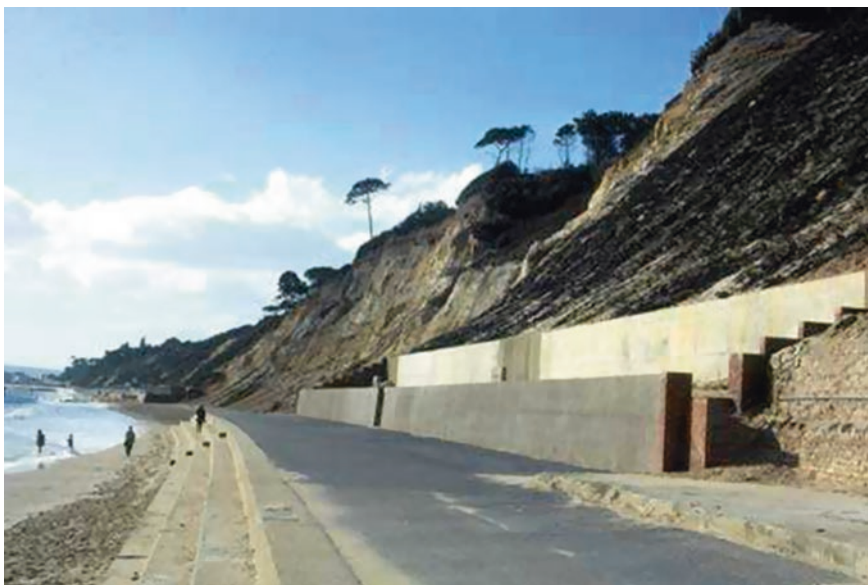
Fig. 2.4 Canford Cliff after the construction of a concrete esplanade along the base of the cliff. This halted marine erosion, but also reduced the supply of sand and gravel to adjacent beaches, which became depleted by marine erosion. © Geostudies

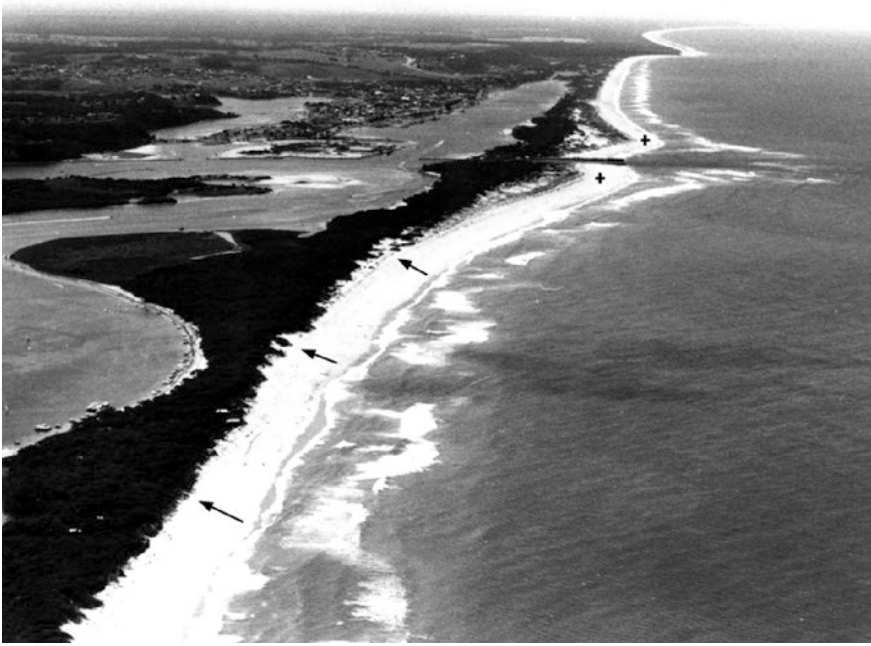
Fig. 2.6 Erosion (*arrowed*) of the Ninety Mile Beach, on the outer barrier of the Gippsland Lakes in SE Australia, with accretion (+) on either side of the Lakes Entrance breakwaters.
© Geostudies

The sequence portrayed in Fig. 2.6 is illustrated on the Ninety Mile Beach in south-eastern Australia, which borders a sandy coast that formerly prograded by accretion of sand supplied from the adjacent floor of Bass Strait, and is now being cut back by marine erosion, except in a sector of continuing accretion alongside breakwaters at Lakes Entrance (Fig. 2.6). There is still plenty of sand in the nearshore area, but the transverse profile has become smooth and concave, and there is no longer shoreward drift of sand to this beach, except at the SW end, sheltered by the granitic upland of Wilsons Promontory, where there are still nearshore sand shoals.

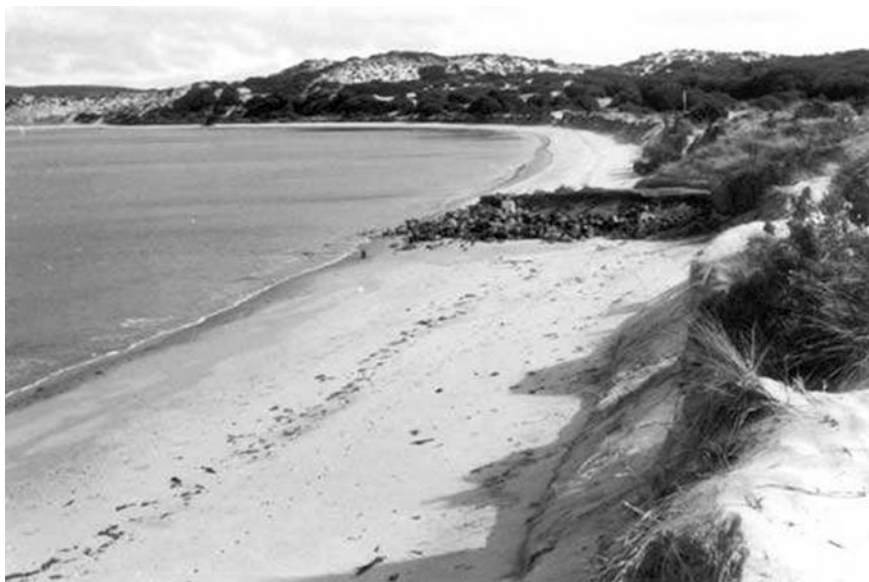
Fig. 2.8 Depleted beach and backshore erosion on the shore of Cleeland Bight, Phillip Island, following the stabilisation of dunes that previously supplied sand to this beach. © Geostudies

establishment of a vegetation cover on formerly drifting dunes, or the extinction of the dunes that had been drifting to the coast. On Phillip Island, Australia, partial stabilisation of dunes that had been spilling eastward across the Woolamai isthmus to renourish the beach in Cleeland Bight (Fig. 2.7) was followed by beach erosion (Fig. 2.8).

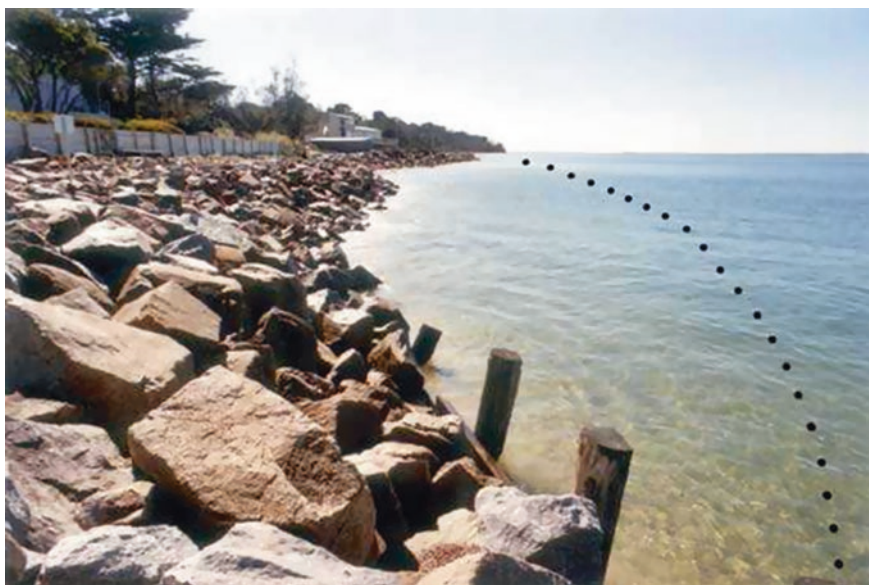
Fig. 2.9 The yacht club at Somers, Western Port Bay, Australia, was built on a sand lobe (out-line: dotted line) that had migrated to this position, and then moved on along the coast. A boulder rampart has been inserted to halt erosion here. © Geostudies

along the coast in the predominant direction of longshore drift, and at any particular point there is accretion as each lobe arrives, and erosion as it moves on. At Somers, on the coast of Western Port Bay, Australia, a yacht clubhouse was built on one such lobe in the 1970s, and was threatened by beach erosion that developed as that lobe moved on (Fig. 2.9).

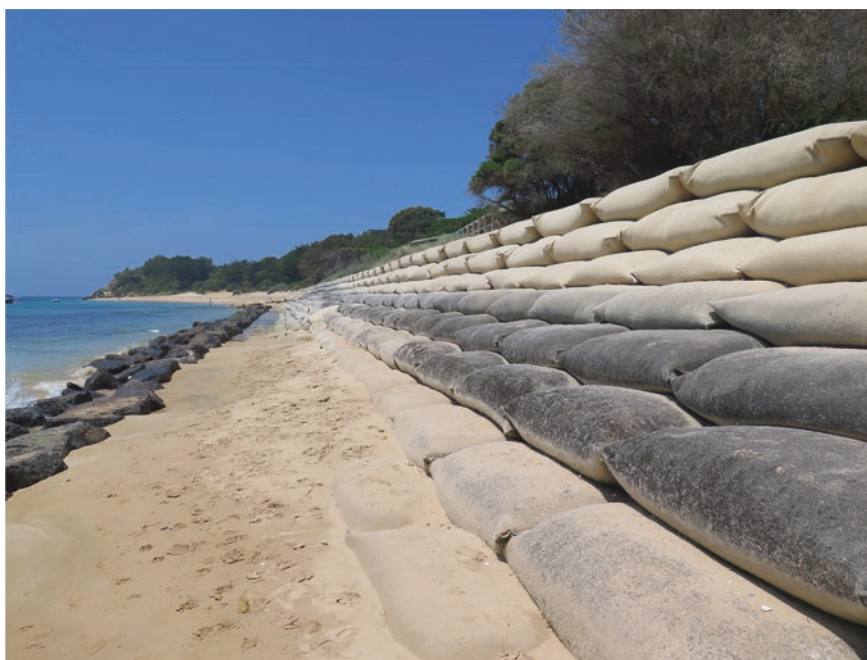
Fig. 2.11 A sandbag rampart marks the site of beach erosion at Portsea, Port Phillip Bay, Australia, in 2013. © Geostudies

Attempts to blame the erosion of Portsea Beach in 2010 on the dredging of a deeper and straighter entrance to Port Phillip Bay in 2008 failed because of evidence that episodes of beach erosion occurred at several times prior to entrance deepening, and because wave refraction diagrams drawn for configurations before and after dredging showed no change in the pattern of waves or wave energy at Portsea (Cardno 2011). The beach was renourished, but the deposited sand quickly drifted away to the east, and the coast at Portsea was then armoured with sandbags to halt recession (Fig. 2.11).

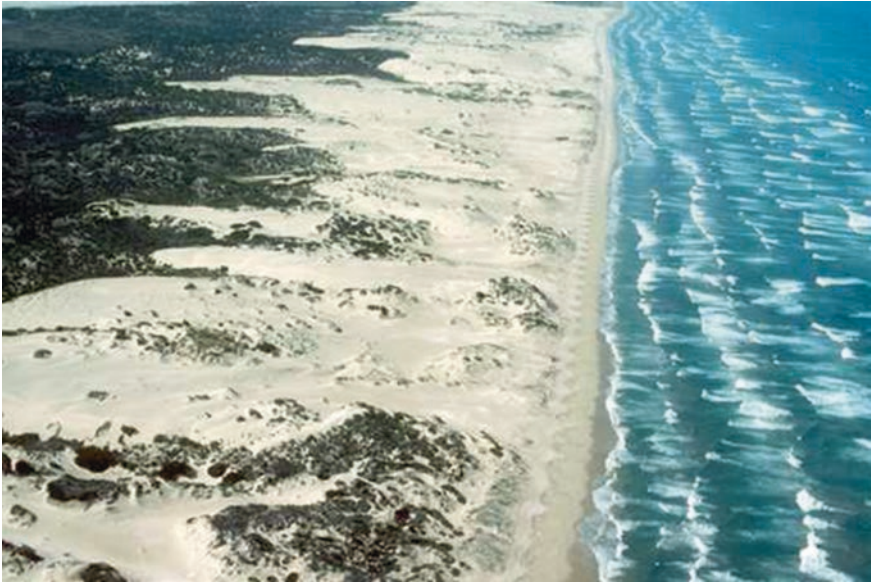
Fig. 2.13 Sand is moving inland from a beach as drifting (transgressive) dunes on the shore of Encounter Bay, South Australia. The lowered backshore is then cut back quickly because of the diminished volume of sand to be removed by wave attack. © Geostudies

Sand is swept from the beach to the backshore by strong onshore winds (Fig. 2.13), or when storms wash beach sediment beyond the back of the beach, or over into lagoons, swales or swamps, or the mouths of rivers. If losses from the

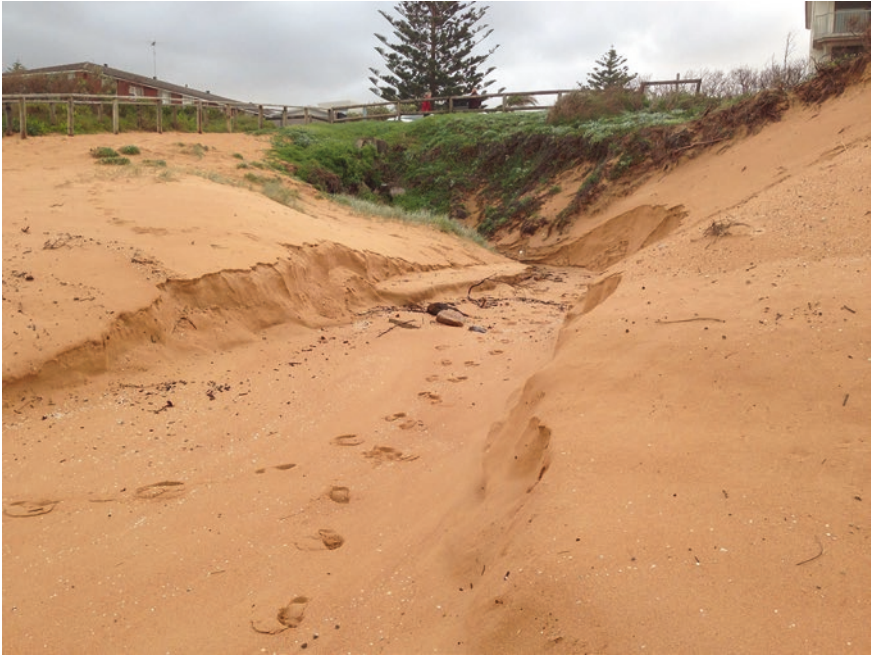
Fig. 2.14 A channel cut through the beach and dune on Collaroy-Narrabeen beach, Sydney, Australia caused by storm water discharging from a drainage outfall. © Nick Lewis

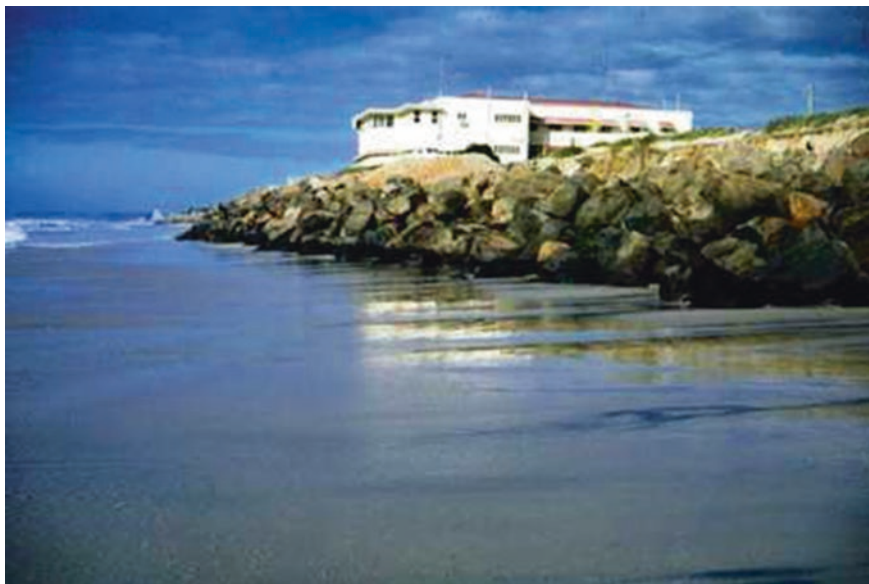
Fig. 2.16 Beach at Surfers Paradise, Queensland, lowered by large waves reflected from a boulder wall during a tropical cyclone. © Geostudies

Waves breaking against a solid shore structure, such as a sea wall built of concrete, stone blocks, boulder ramparts, steel sheeting or timber, are reflected, and generate seaward currents that carry sediment away from the foot of the wall (Fig. 2.15). This reflection scour is prevented as long as a beach is high and wide enough to stop waves reaching and reflecting from the solid structure, but beach erosion occurs rapidly once waves reach the backing wall (Fig. 2.16).

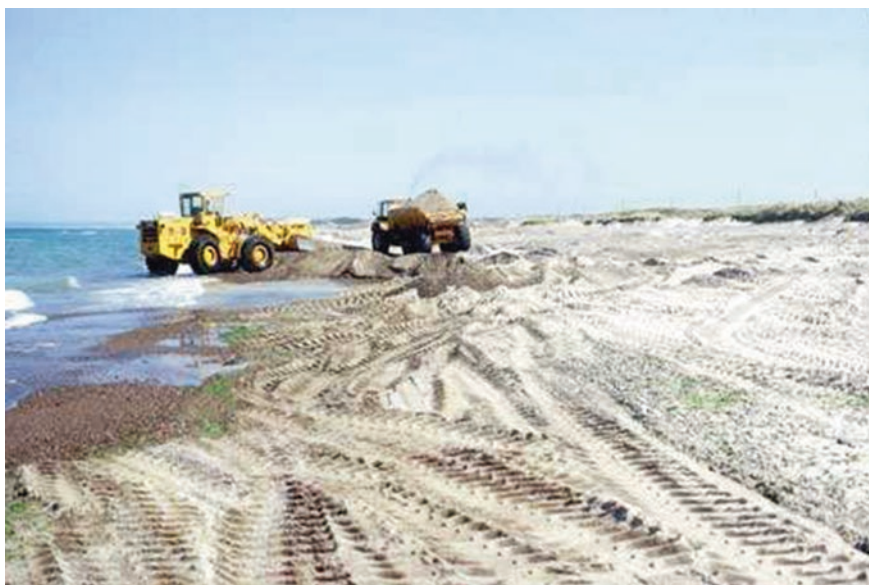
Fig. 2.17 Extraction of *sand* and *gravel* from the beach at Klim in Denmark. © Geostudies

Sand or gravel has been quarried from many beaches for use in road and building construction (Fig. 2.17), and the result of lowering the shore profile is to allow larger waves to attack the beach more strongly during storms. Beaches in Jersey and Guernsey were much reduced by the extraction of sand from beaches by the German occupying forces during the Second World War for use to build bunkers

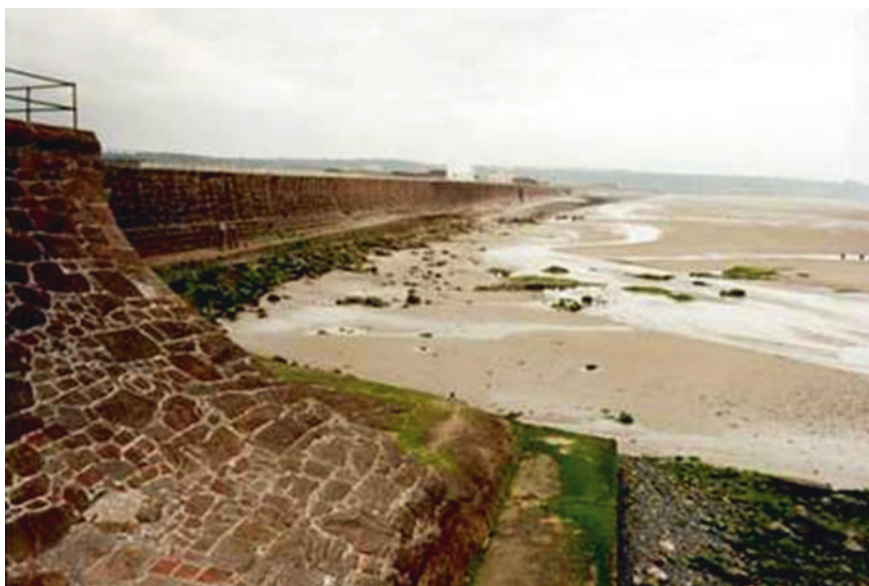
Fig. 2.18 The sea wall at St Ouen's Bay, Jersey, with the beach lowered by reflection scour.
© Geostudies

and gun emplacements, and massive sea walls were then constructed. These resulted in reflection scour, eroding the remaining beach, which is now completely submerged at high tide in St Ouen's Bay, Jersey (Fig. 2.18).
