Chapter 2

Service Life and Durability of Assemblies

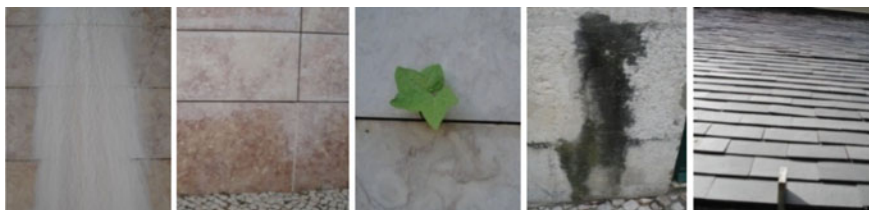
Fig. 2.2 Visual or surface degradation defects in natural stone claddings (from *left* to the *right*): efflorescence, localized stains (rising damp), parasitic vegetation, biological growth and flatness deficiencies

- **Visual or surface degradation** (Fig. 2.2)—these defects generally affect the cladding, not contributing to the failure of the cladding system, and do not represent a risk to its integrity. These are the most common defects, appearing prematurely in some cases due to design or execution errors;

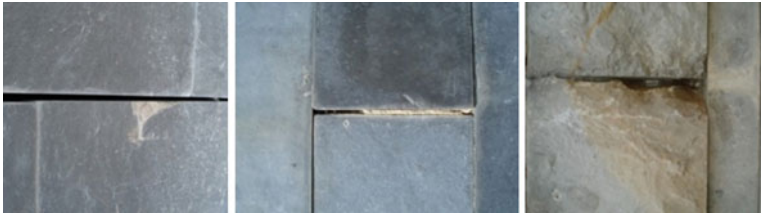
Fig. 2.3 Joint defects (from *left* to the *right*): lack of linearity between the joints of stone plates, material loss—open joint and scaling of stone near the joints

- **Joint defects** (Fig. 2.3)—which include situations in which the cladding's joints do not function adequately and may even lead to the occurrence of new defects;

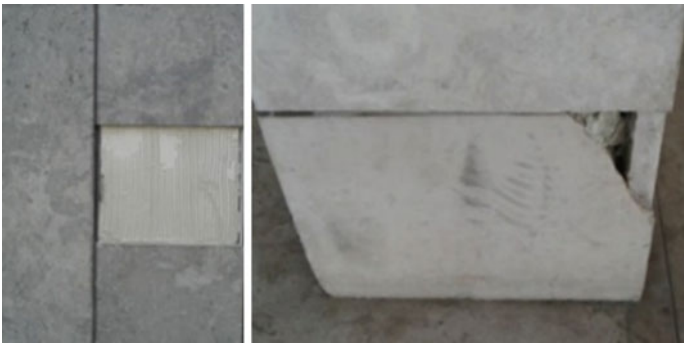
Fig. 2.4 Bond-to-substrate defects in natural stone claddings (from *left* to the *right*): loss of an element in the stone cladding and partial loss of stone material

- **Loss of bond to the substrate** (Fig. 2.4)—which characterize the situations when stone material is lost either in small proportions (scaling) or significant proportions (loss of adhesion); these defects usually compromise the integrity of the cladding, jeopardizing the safety demands of the cladding and sometimes constitute a risk for people and property;

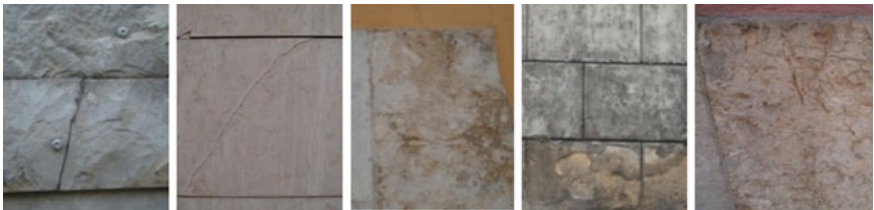
Fig. 2.5 Loss-of-integrity defects in natural stone claddings (from *left* to the *right*): fracture, cracking, erosion, exfoliation and alveolarization of stone plate

- **Loss of integrity** (Fig. 2.5)—which affects irremediably the stone, due to the alteration of the physical and chemical properties of the natural stone, also leading to the visual deterioration of the cladding.

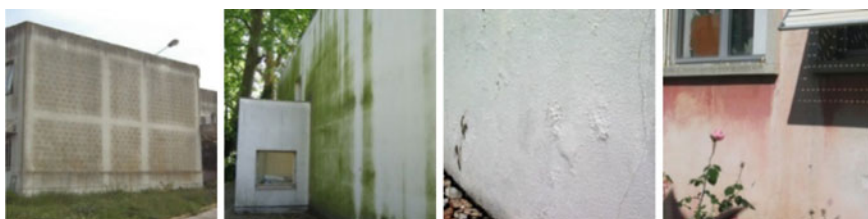
Fig. 2.6 Visual or surface degradation defects in rendered façades (from *left* to the *right*): thermophoresis, biological growth, efflorescence, colour change (data sourced from Gaspar 2009)

- **Visual or surface degradation defects** (Fig. 2.6)—essentially characterized by the presence of stains, often associated with the presence of damp (Chew and Ping 2003); these defects are the less severe, not compromising the claddings' service life;
- **Cracking** (Fig. 2.7)—these defects are more severe than staining, however, they do not usually jeopardize the claddings' safety and are a natural consequence of the claddings behaviour (Bone et al. 1989; Bonshor and Bonshor 2001);

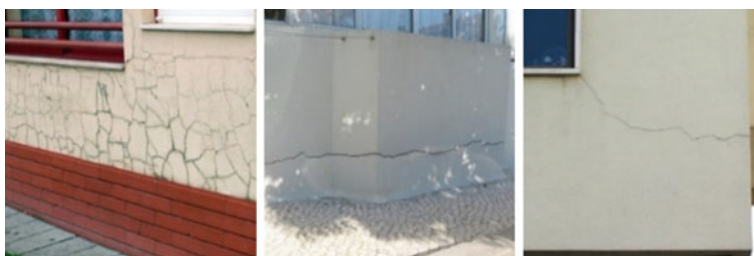
Fig. 2.7 Cracking defects: mapped cracking in rendered façades (*left*) and oriented cracking (*right*) (data sourced from Gaspar 2009)

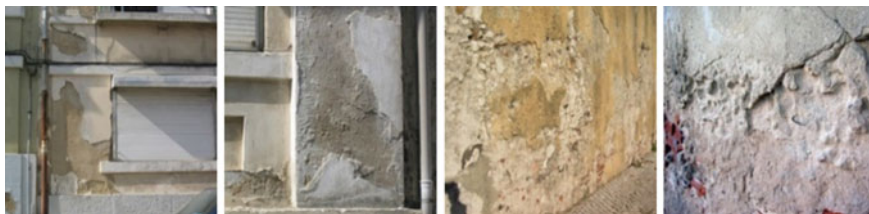
Fig. 2.8 Loss of adhesion or cohesion in rendered façades (from the *left* to the *right*): detachment, pulverulence, arenization, erosion (data sourced from Gaspar 2009)

- **Loss of adhesion or cohesion** (Fig. 2.8)—this group of defects corresponds to the most serious situations and are caused by different factors, such as the combination of cracking with the presence of water (Hansen et al. 1999), often leading to the end of the service life of the renderings.

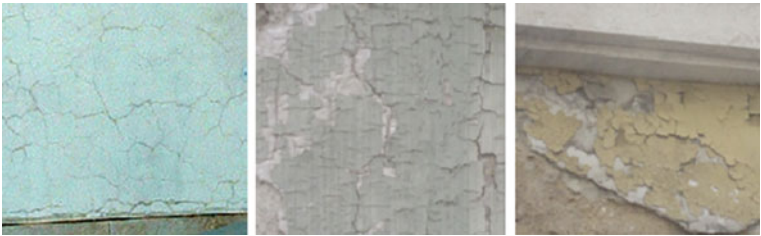
Fig. 2.10 Cracking defects in painted surfaces (data sourced from Chai 2011)

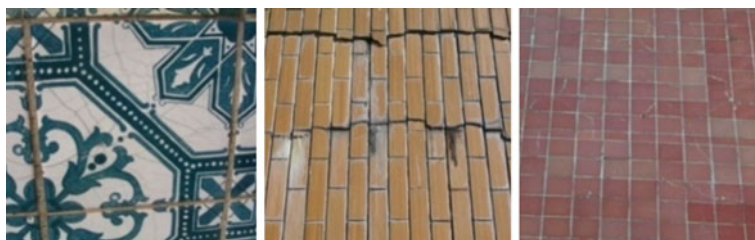
Fig. 2.13 Cracking defects in ceramic tiling systems (from *left* to the *right*): cracked glazing, markedly orientated cracking and with no predominant direction (data sourced from Bordalo 2008)

- Glazing cracking, looking like a spider's web, which is a surface problem being usually caused by the ageing of the tiles or by the difference between the thermal expansion coefficients of the glazing and of the inner body of the tile;

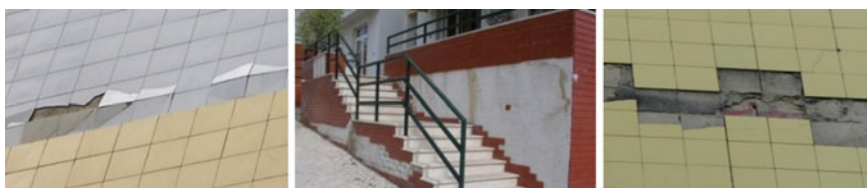
Fig. 2.15 Detachment defects in ceramic tiling systems: debonding (*left*) and detachment of ceramic tiles (data sourced from Bordalo 2008)

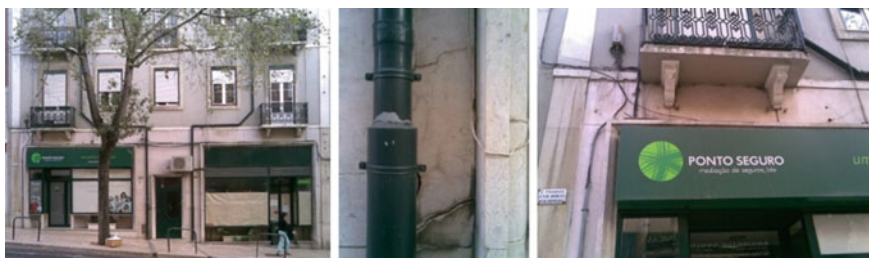
Fig. 2.16 Case study that illustrates the end of the service life of stone claddings (with a severity of degradation around 20 %) (data sourced from Silva [2009](#))

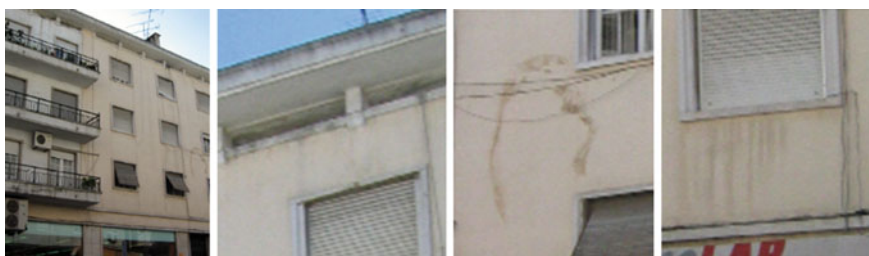
Fig. 2.17 Case study that illustrates the end of the service life of rendered façades (with a severity of degradation around 20 %) (data sourced from Gaspar [2009](#))

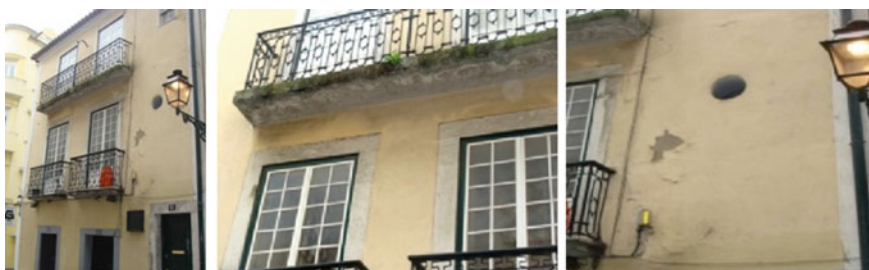
Fig. 2.18 Case study that illustrates the end of the service life of painted surfaces (with a severity of degradation around 20 %) (data sourced from Chai et al. [2014](#))

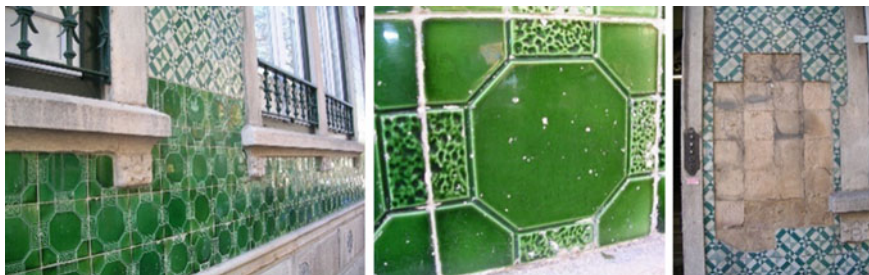
Fig. 2.19 Case study that illustrates the end of the service life of ceramic claddings (with a severity of degradation around 20 %) (data sourced from Bordalo 2008)
