Pathology Analysis and Intervention at the Pavilhão Mourisco Roof Terraces—Rio de Janeiro, Brazil

Abstract The Pavilhão Mourisco, designed in Moorish revival, is the icon of Fundação Oswaldo Cruz. Listed in 1981 as National Heritage, the building nowadays holds the foundation's historical collections and makes room for some administrative personnel. The building is subject to severe wind conditions, acid rain and pollution, which all accelerate the deterioration rate of the building's external elements. The Department of Historical Heritage at Fundação Oswaldo Cruz has been developing emergency actions for safeguarding the building, but rainwater infiltration is a recurring issue. In order to develop an accurate plan to reverse this hazard, an analysis of the pathologies in place and of the department archives had to be carried out, as well the testing of the previous waterproofing solutions for that area. After that, the department developed a restoration project in order to restore the waterproofing system for the terraces, involving work on the external elements including decorative mortars, ceramic tiles and copper drip edges. The last physical intervention had the objective o

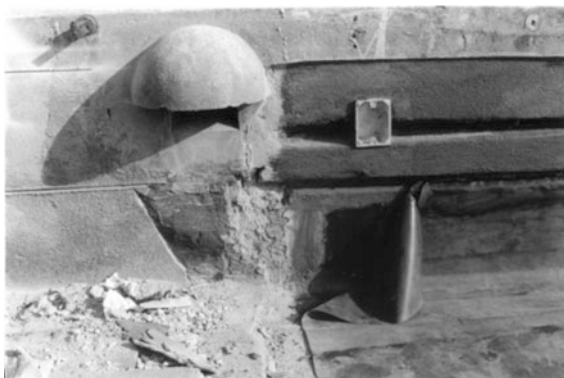
Fig. 10 Separation from the untreated surface (*on the left*) and the butyl rubber blanket (*on the right*) on the fifth floor (1988)

New flooring was set, this time using ceramic tiles, in the hopes they would resemble and work like the old Marseille ceramic tiles. The new industrial tiles were laid using a 1:3 cement–sand ratio mortar with waterproofing additive (at a 1:15 ratio). The expansion joints were protected with a polyurethane-based, single-component, elastic sealant (Figs. 10 and 11).

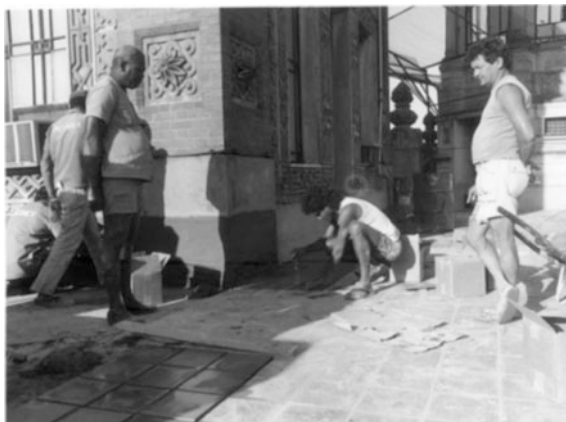
Fig. 11 Workers laying down the ceramic tiles on the fifth-floor terrace (1988)

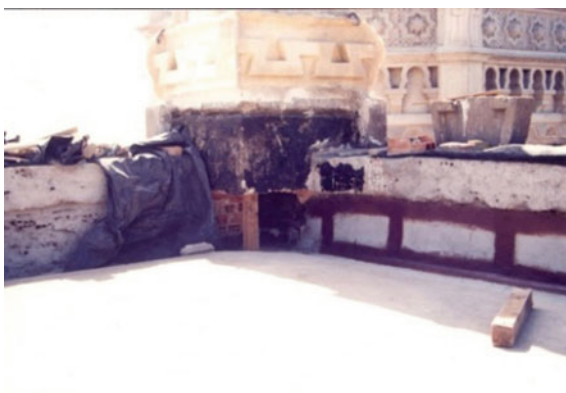
Fig. 12 North wing terrace on the seventh floor (1990)

In 1990, the same process took place on the seventh-floor terrace. This time, however, polystyrene plaques were added to the system before executing the butyl rubber blanket and laying the ceramic tiles, as an insulating solution, to try to reduce the heat transmission from the slab to the sixth-floor ceiling (Figs. 12 and 13).

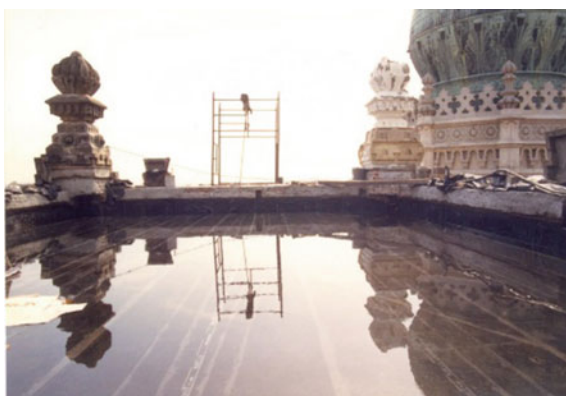
Fig. 13 Testing the new butyl rubber blanket with a layer of water over it for 72 h —seventh-floor terrace (1990)

One of the tests performed to verify the stanching of the new waterproofing system consisted on placing water on top of the butyl blanket for 72 consecutive hours, to verify leakage build up in unwanted places. During the 1990 intervention, a glass shelter was built to protect the skylight that brings light into the fifth-floor hall.

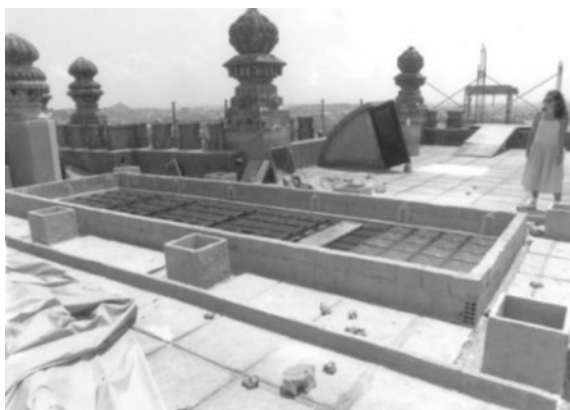
Fig. 14 Construction of the shelter dome for the skylight on the seventh-floor terrace (1990)

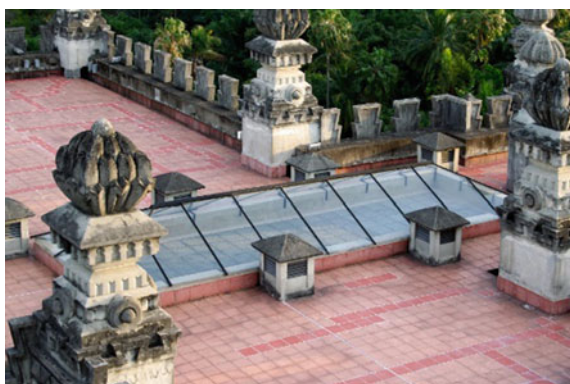
Fig. 15 View of the shelter dome on the seventh floor (Dec 2009)

uncoated and do not show any kind of stress or leakage points (Figs. 14, 15, and 16).

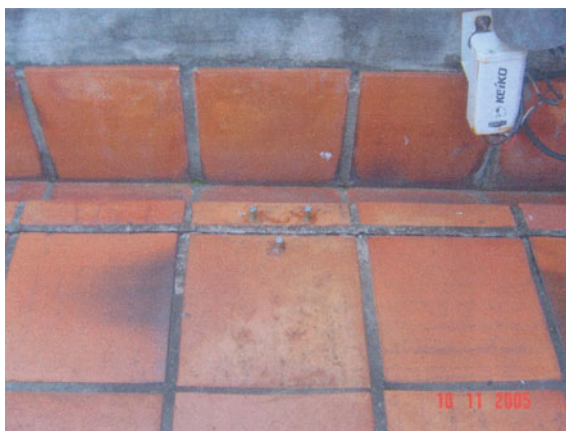
The report states that the cracks on the fifth floor result from thermal variation due to extreme temperatures in Rio de Janeiro and do not represent structural damage to the building. The report also shows that, on the seventh floor, the damage was related to the poor quality of the ceramic tiles used in the 1990s intervention (Cerne Engenharia e Projetos 2006) (Figs. 17 and 18).

Fig. 17 Monitoring station and pins fixed to the south terrace, fifth floor (Nov 2005 —Cerne Engenharia)

In 2005, due to cracks spotted on the terraces, the DPH personnel hired an engineering company to run a full structural evaluation of the building. They developed a survey on the area, mapped the damage on the terraces' elements, amongst other actions. They have installed two monitoring stations to track the deformation of cracks on both terraces.

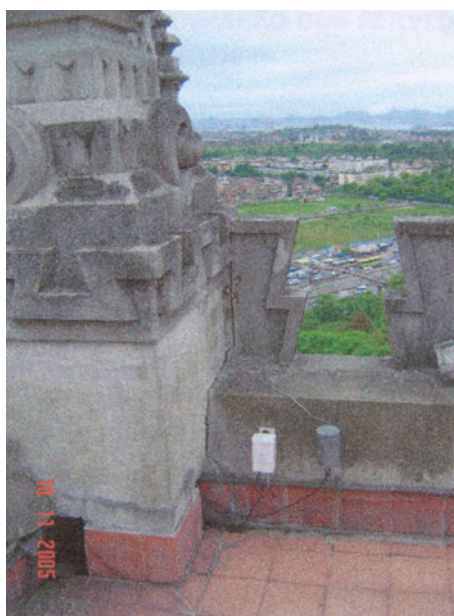
Fig. 18 Monitoring station placed by a turret on the seventh-floor terrace (Nov 2005 —Cerne Engenharia)

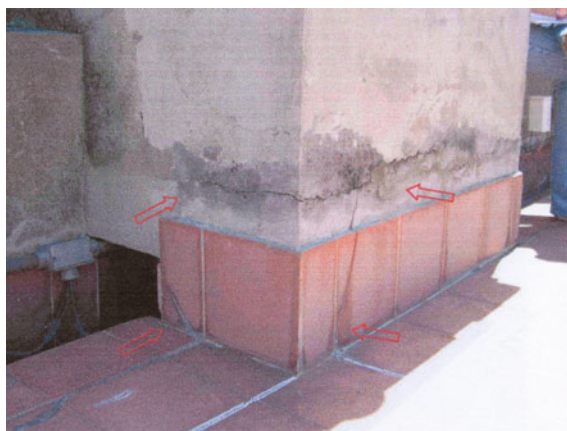
The engineering company noticed the displacement of the butyl blanket in some places over the slab due to intense thermal variation at the site, which led to the fraying of the blanket next to vertical surfaces (parapets), and the appearance of cracks. The company concluded that there were no evidences of infiltration of rainwater on the slabs. Infiltration occurred only in the areas close to the external perimeter, especially on the corners of the building, with some clogged drains (Cerne Engenharia e Projetos 2006) (Fig. 19).

Fig. 19 Cracks on the mortar indicating the displacement of the waterproofing blanket (Nov 2005 —Cerne Engenharia)

The first step should focus on repairing the cracks on the mortar and the terraces' external perimeter. In case said intervention does not solve the building's problems, a second step should follow, which would involve the substitution of the terraces' floor waterproofing system—working on the slab, its flooring, and casting or installing a new blanket.

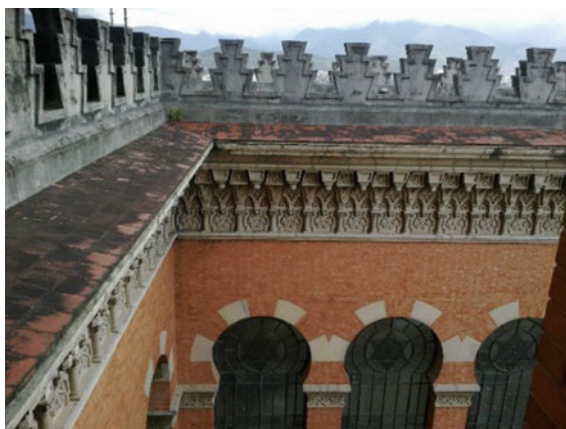
Fig. 22 Black crust on the external ceramic tiles (May 2014)

This intervention was the first of a two-step project, developed in 2012 and updated the following year. The intervention focused on repairing the cracks on the building's terraces' perimeters, and on reintegrating the architectural and ornamental mortar elements. The majority of the pathologies observed were fissures on the mortar surfaces, cracks on the parapets and black crust on the mortar and ceramic tiles that top the building's eaves (Figs. 21 and 22).

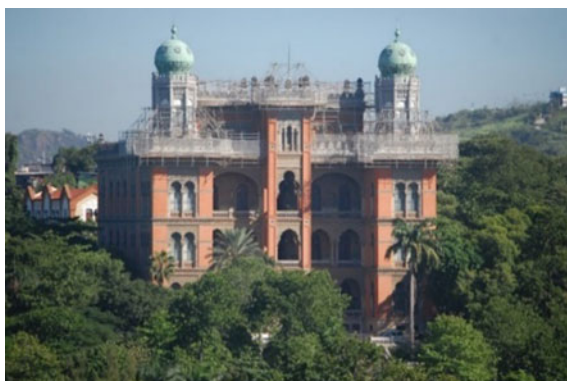
Fig. 23 Suspended scaffolds covering the front of the Pavilhão Mourisco's terraces, on the intervention's first phase (Apr 2014)

The conservation work treated the Pavilhão Mourisco's roof terraces external elements, including decorative mortars, ceramic tiles, and copper drip edges. The battlements and turrets did not show any extensive damage and did not represent any threat to the building's structure. So, they were simply cleaned and then painted with the same formula as the mortars (Figs. 23 and 24).

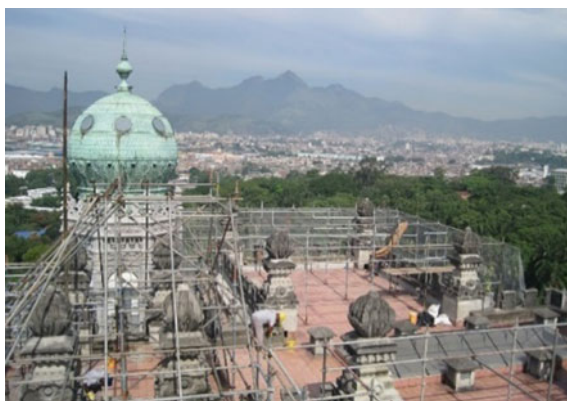
Fig. 24 Scaffolds on the seventh-floor terrace (May 2014)

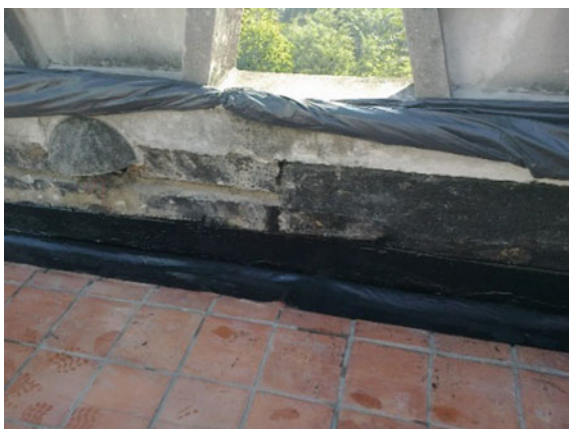
Fig. 25 Treating the edges of the butyl rubber blanket (Jun 2014)

A new cement mortar was laid over the waterproofing system, the paint formula to cover the new surface was determined through the analysis of the demolished mortar. The plastic membrane was also applied to every surface that could accumulate water (gutters, ornaments, etc.), and near the fissures and cracks. Some places were reinforced with a thin net below the new cement layer (Figs. 25 and 26).

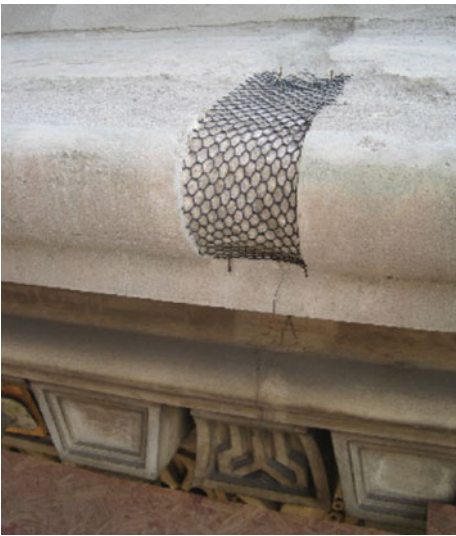
Fig. 28 Plastic screen used to reinforce the treatment of vastly damaged areas. The screen was installed between two layers of cement–sand mortar (May 2014)

In some places, the cracks were too deep and thus needed to be treated in a different way. The mortar on these areas was removed, the surface was treated with the elastic membrane, new cement–sand mortar was applied to the treated surface, and a plastic screen was installed to reinforce this new mortar. When the cracks were more than 1.0 cm apart, stainless steel clamps were stapled to the concrete structure, to prevent the cracks from expanding (Figs. 28 and 29).

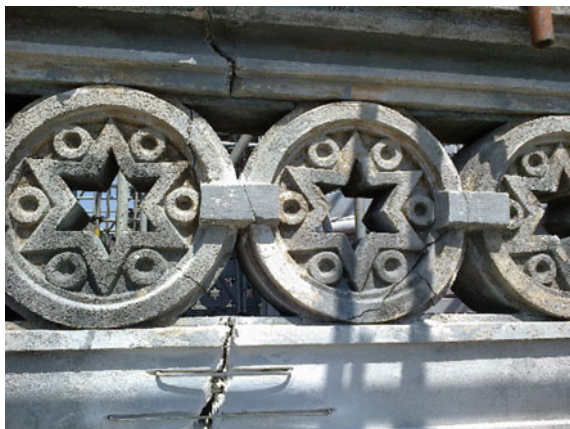
Fig. 29 Wide cracks in the structure, treated with stainless steel clamps (Apr 2014)

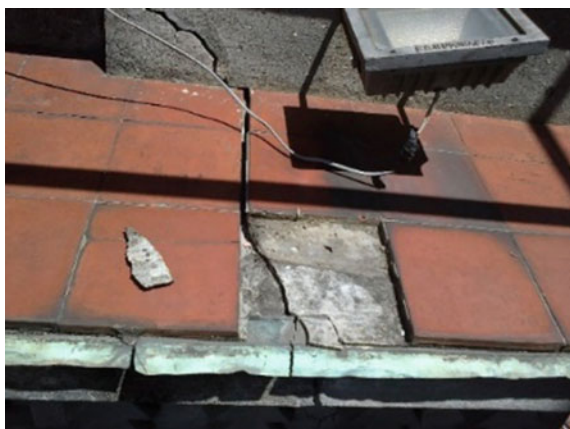
Fig. 30 Structural damage seen at the seventh floor, north wing, eave: crack opening, affecting also the copper plaque (Feb 2014)

The copper plaques located below the ceramic tiles on the eaves work as a drip edge for the building and were subject to physical intervention. The copper drip edges were removed, received anticorrosion treatment, and were finally put back in

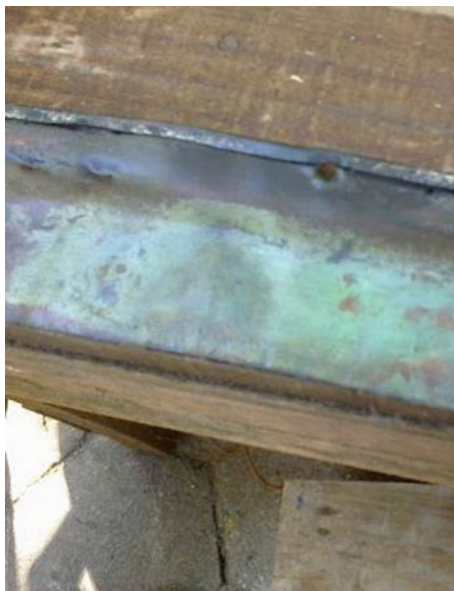
Fig. 31 Anticorrosion treatment to a copper plaque (Apr 2014)

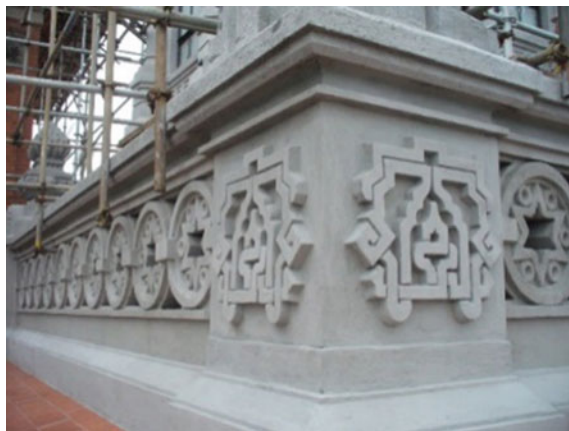
Fig. 35 Same ornament after restoration (Jul 2014)

New ornaments were fashioned to substitute those extremely damaged (as shown in Figs. 34 and 35, above). First, the team identified the ornament in better conditions to be replicated. From this piece, a silicon mould was cast in situ to shape new ornaments. The new pieces were cast using a 1:2.5 ratio cement–sand mortar—determined after laboratorial analysis on existing material. In total, four ornaments were substituted—one on the frontal north wing, and three on the back of the south wing, all of them in the fifth-floor terrace (Fig. 35).

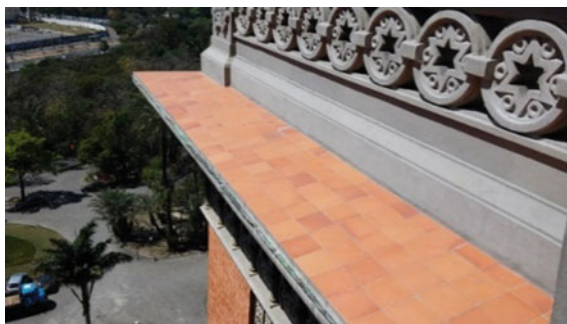
Fig. 37 External aspect of the parapet and the eave after the intervention—fifth-floor terrace (Sep 2014).

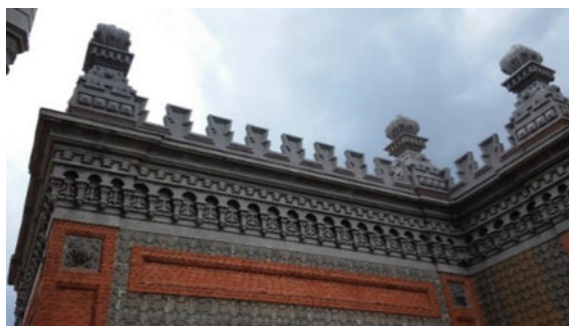
Fig. 38 External aspect of the parapet and the eave after the intervention—seventh-floor terrace (Oct 2014)

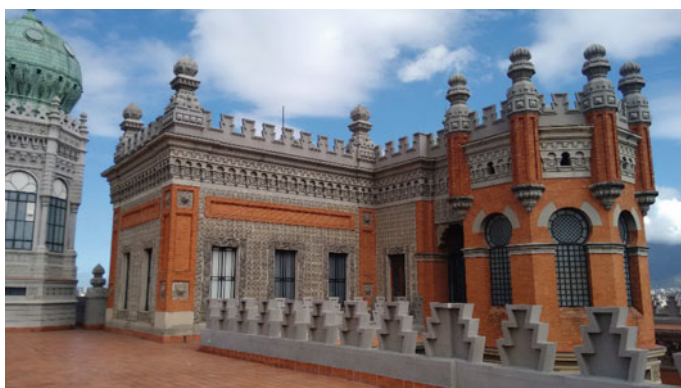
Fig. 39 Today's aspect of the fifth-floor terrace, north wing (Oct 2015)

One year afterwards, the intervention has ended; it is possible to see that its objectives were achieved (Fig. 39). One cannot see infiltration signs on the ceilings from the third and fifth floors of the Pavilhão Mourisco. It is a sign that the past intervention managed to stop rainwater from finding a way through the building's perimeters, and the waterproofing system on its roof terraces is satisfactory.
