# Long-Term Performance of Specialized Fluid Dampers Under Continuous Vibration on a Pedestrian Bridge

**Abstract** In 2001, Taylor Devices Inc. developed special Viscous Dampers for use on the Millennium Bridge in London, England. These dampers were specified and designed to be used for mitigating the dynamic response of the bridge due to pedestrian traffic. Prior to the integration of the dampers, the bridge had experienced unacceptable movements, especially during periods when larger crowds of people were on the bridge. The result was that the bridge had to be closed until a solution was found. Much research was done and several papers were published about the nature of that problem and the ensuing solution. After successful component level testing and the installation of 37 Taylor Viscous Dampers, the bridge was re-opened to the public in February, 2002. Tests with approximately 2000 people demonstrated a much improved dynamic response. Since that time, the dampers have been subjected to almost constant dynamic input, some more than others. Due to the location of the bridge in central London, there has been nearly constant pedestrian traffic on the bridge each day and even thr

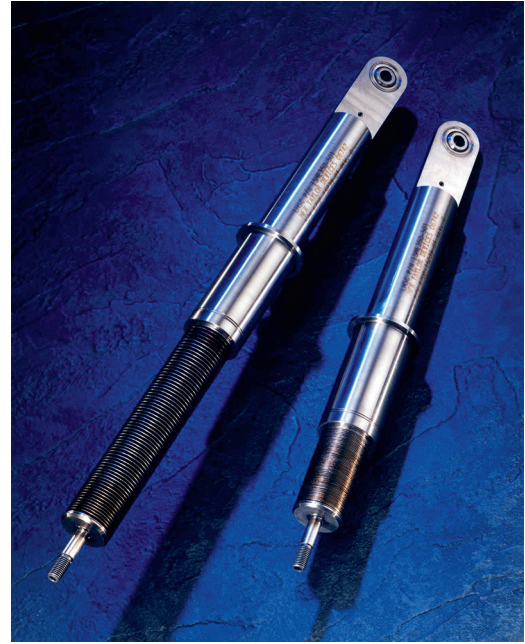
**Fig. 2.2** Space satellite dampers

Taylor Devices' Fluid Dampers with metal bellows seals had been previously used exclusively by NASA and other U.S. Government agencies for space based optical systems. These previous applications had similar requirements for long life and high resolution at low amplitudes, but required relatively low damper forces from small, lightweight design envelopes. Figure 2.2 is a photograph of a pair of typical dampers of this design, used in space on more than 70 satellites to protect delicate solar array panels. This figure also shows the metal bellows seals; one in the compressed position and one in the extended position. This type of seal does not slide, but rather flexes without hysteresis as the damper moves. This patented design is known as a Frictionless Hermetic Damper.

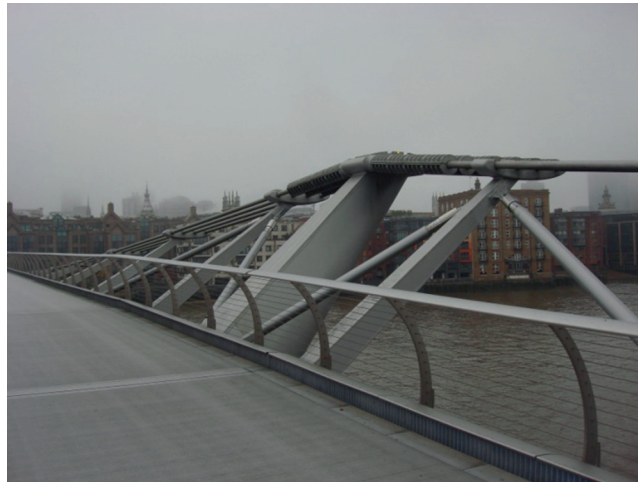
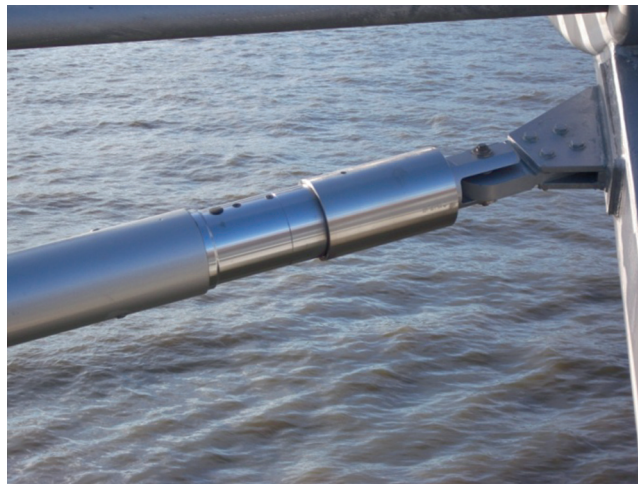
Description: Two Pier Dampers are located on each side of each of two piers on both the east and west side of the bridge, for a total of eight dampers per pier. Damping coefficient values for the eight dampers connected directly to the center span of the bridge are significantly higher than the other Pier Dampers. Dampers have varying over-all lengths due to the

location of the attachment points, the longest being 8.3 m long. These dampers are quite apparent to pedestrians when crossing the bridge as illustrated in Figs. 2.4 and 2.5 below.

**Fig. 2.4** 4 of 16 pier dampers

**Fig. 2.5** Moving end of pier damper over the River Thames

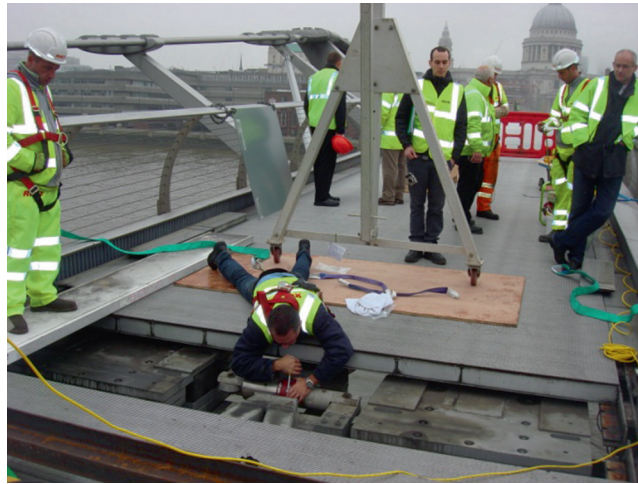
Description: The Deck Dampers are located under various deck sections. A very limited number can be seen from under the north end of the bridge. Most deck dampers are not visible since they are situated directly under the deck panels. Lateral motions of the bridge are transmitted to the dampers through pairs of relatively long V-shaped chevron braces as shown in Figs. 2.6 and 2.7 below.

**Fig. 2.6** Deck damper shown with chevron connection

**Fig. 2.7** Deck panels removed deck damper showing

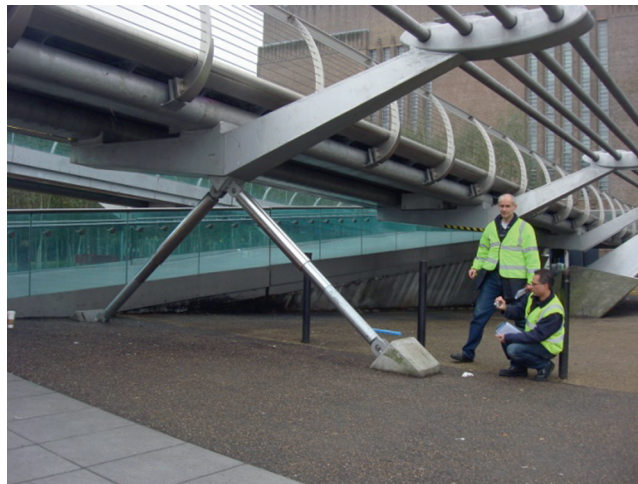
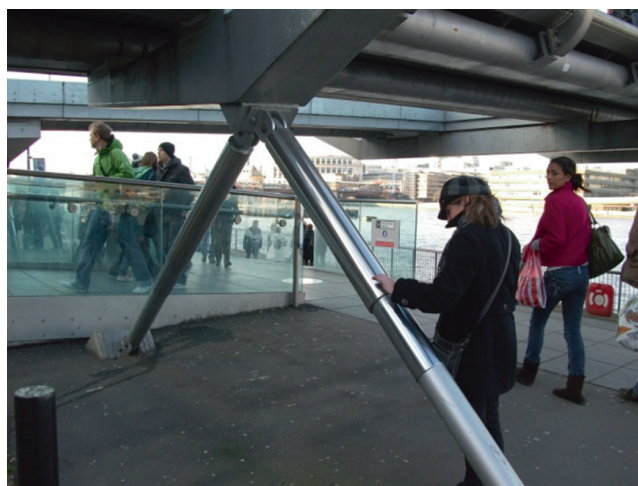
Description: Vertical Dampers are located in two pairs under the south end of the bridge with damper ends connected between a structural arm and the ground. As illustrated below in Figs. 2.8 and 2.9, the dampers are directly accessible to pedestrian traffic. Nearly continuous damped motion is felt and observed with even low to moderate pedestrian traffic on the bridge overhead.

**Fig. 2.8** Inspection of vertical damper pair

**Fig. 2.9** Vertical damper pair with pedestrian access

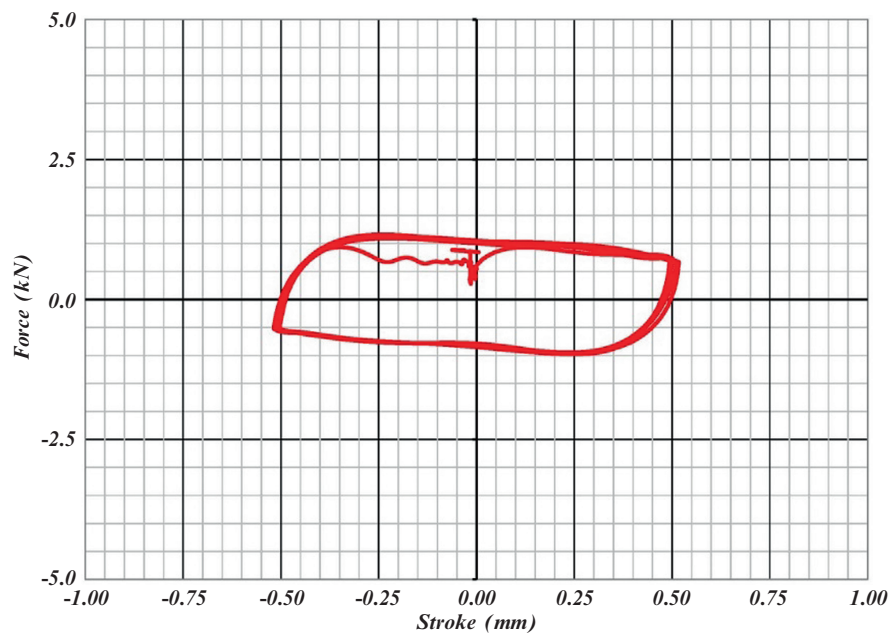
Figures 2.13, 2.14 and 2.15 demonstrate the results of the Low Amplitude Tests for each of the three dampers that were tested. Note that in each case, the hysteresis loops (force vs. displacement) show no signs of free-play, loss of fluid, excessive friction, wear or degradation of any sort. It should be noted that the dampers were tested with their spherical bearings in place and their end attachment brackets still connected. Therefore, no degradation to these components has occurred and the bearings have maintained their tight fit requirement that is necessary to produce damping for very low displacements.

**Fig. 2.13** Low amplitude test results of deck damper 2012

**Fig. 2.14** Low amplitude test results of deck damper 2012

**Fig. 2.15** Low amplitude test results of vertical damper 2012
