Chapter 2

Influence of Sulfur Ions on Concrete Resistance to Microbiologically Induced Concrete Corrosion

Luis Emilio Rendon Diaz Miron and Maria Eugenia Lara Magaña

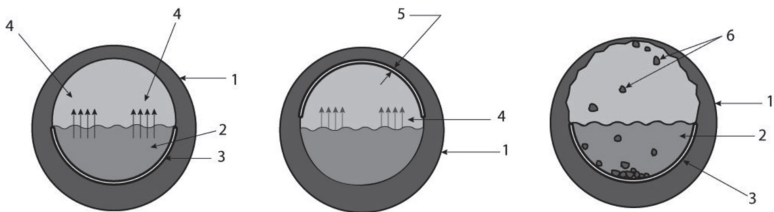
Fig. 2.1 Biodeterioration mechanism illustration: (1) concrete pipe, (2) wastewater stream, (3) anaerobic biofilm with sulfate-reducing bacteria, (4) internal atmosphere saturated with H₂S, (5) biofilm with sulfur-oxidizing bacteria (SOB), (6) concrete debris with gypsum and ettringite remains that fall to the bottom of the pipe and enrich the silt with sulfates [14]

The biodeterioration of concrete sewers is the end result of a sequence of processes involving biochemical transformations of organic and inorganic sulfur compounds, by the action of anaerobic and aerobic bacteria. The submerged surface of a sewer pipe is typically coated with a film comprised of a diverse microbial community. Anaerobic conditions can develop in such films, providing a suitable environment for the growth of sulfate-reducing bacteria. Sulfate reducers oxidize organic acids and alcohol, generated as end products of many types of anaerobic fermentation, with the concomitant reduction of sulfate to sulfide [21]. Sulfide diffuses out of the film into the bulk liquid flow. At the pH of most wastewater, aqueous sulfide divides involving hydrosulfide (HS^-) and dissolved hydrogen sulfide (H_2S). Dissolved H_2S readily evolves into the sewer inner space, subsequently reaching the pipe crown. There the gas can be metabolized to sulfuric acid by sulfur-oxidizing bacteria. The sulfuric acid dissolves calcium hydroxide and calcium carbonate in the cement binder; then bacteria can reach inner cement sulfates a new source of sulfur, increasing corrosion and compromising the structural integrity of the pipe [19], see Fig. 2.1.

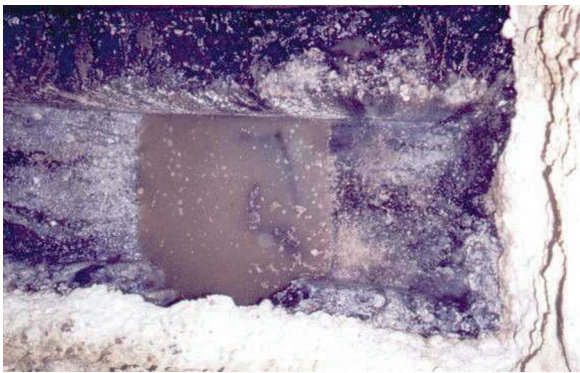
Fig. 2.2 Expanded residue of CaSO₄ on the concrete surface

The microbial environment at the concrete surface is three-dimensional. Concrete is porous, and often it ends up coated by a porous layer of corrosion product (Fig. 2.3). Compounds and organisms are distributed throughout a volume that extends beneath the exposed surface. Dissolved sulfide at the surface diffuses into the concrete in both liquid and gas phases. Microbial oxidation of sulfide occurs throughout the depth of penetration. Sulfuric acid diffuses inward, dissolving and neutralizing alkaline substances as they diffuse outward from the underlying concrete, leaving an expanded residue of CaSO_4 on the surface, see Fig. 2.2.

Table 2.1 shows that in the concrete samples without sulfates mass lost was very low, despite the fact that all samples were settled down under the same conditions. The sulfuric acid responsible for the corrosion of concrete sewer systems is generated by a complex microbial ecosystem. Several species capable of oxidizing sulfur compounds colonize exposed concrete. When sulfates are present anaerobic microbial processes in the sewage lead to the formation of hydrogen sulfide, which is released to the atmosphere through turbulence. On the crown surface of the sewer pipe, hydrogen sulfide is chemically oxidized to sulfur under aerobic conditions; bacteria of the genus *Acidithiobacillus* oxidize sulfur to sulfuric acid (Fig. 2.1) dissolving the concrete, and losing mass while searching for more sulfates. Furthermore, if the cement of the concrete contains large amounts of calcite as filler, it will be easily dissolved by the sulfuric acid; more mass will be lost making the concrete porous, with porous layers of corrosion product coating it, Fig. 2.2.

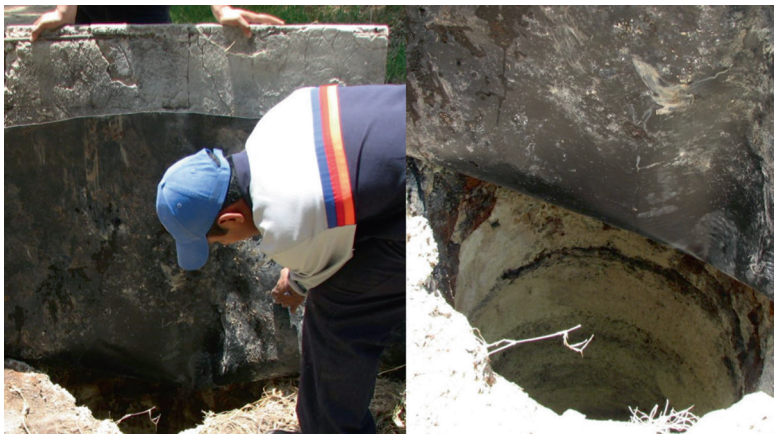
Fig. 2.3 Sulfur deposits at the visiting manholes of experimental site

Investigations of the causes of biogenic sulfuric acid corrosion of concrete particularly in the sewer pipes follow three criteria to diagnose MICC at the sewers: low pH measurements, the detection of neutrophilic sulfur bacteria in the pipes, and, associated with that, the observation of sulfur deposits at the visiting manholes, see Fig. 2.3. In a remarkable report, Rohwerder and Sand [18] proposed a biochemical model for elemental sulfur and sulfide oxidation in *Acidithiobacillus*. In this model, free sulfide is oxidized to elemental sulfur by a separate sulfide: Quinone oxidoreductase, and because this enzyme has only been isolated from neutrophilic

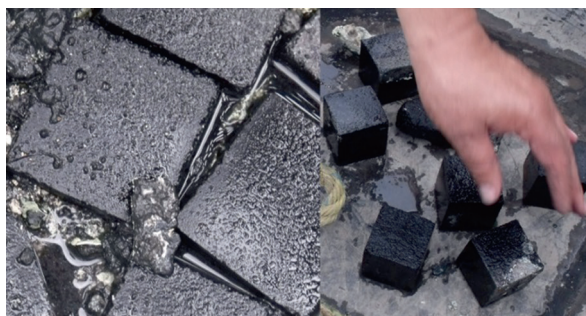
Fig. 2.4 Samples reviewed after a couple of months in experimental site

we know that correcting the composition of *Portland* cement and concrete is difficult, and complicated for two reasons: first, cement manufacturers are convinced that sulfur is beneficial for cement, and second, to remove all sulfur compounds from raw material can be difficult and costly. To mitigate biodeterioration eliminate or minimize sulfur content or look for a substitute. Nonetheless, MICC is a fact Fig. 2.4 shows the aspect of some of the different composition samples after only 2-month exposition to the biodeterioration process.
