Rupestrian World Heritage Sites: Instability Investigation and Sustainable Mitigation

Claudio Margottini, Peter Bobrowsky, Giovanni Gigli, Heinz Ruther, Daniele Spizzichino, and Jan Vlcko

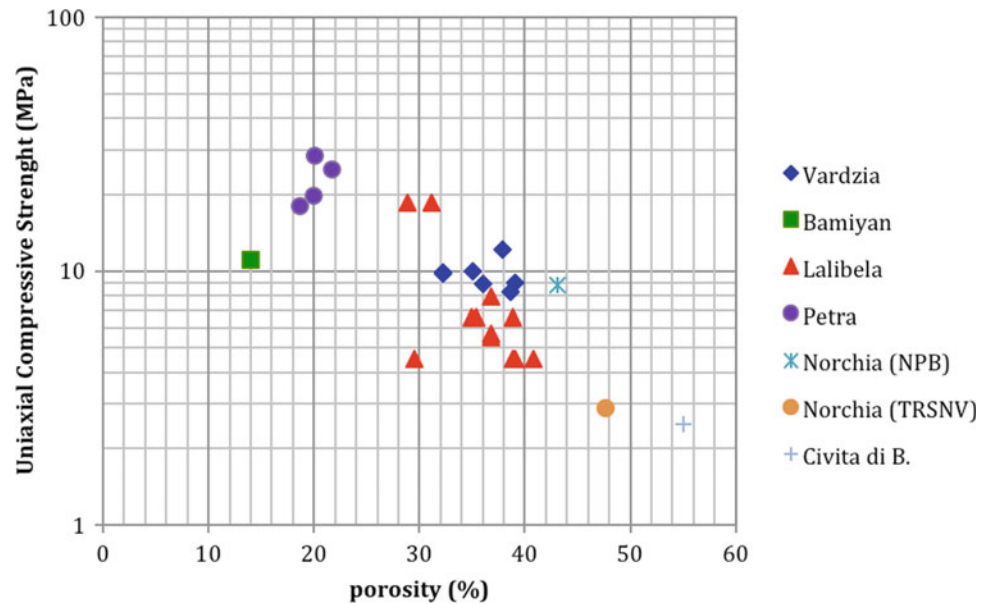
Fig. 1 The relationship between Uniaxial compressive strength and porosity for some of the case studies discussed in this paper

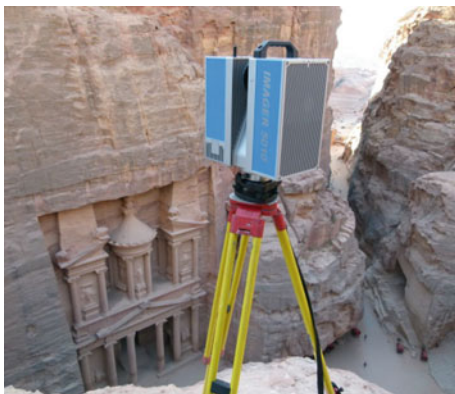
Fig. 2 Laser scanner (Z&F) above Al Khazneh (Petra, Jordan)

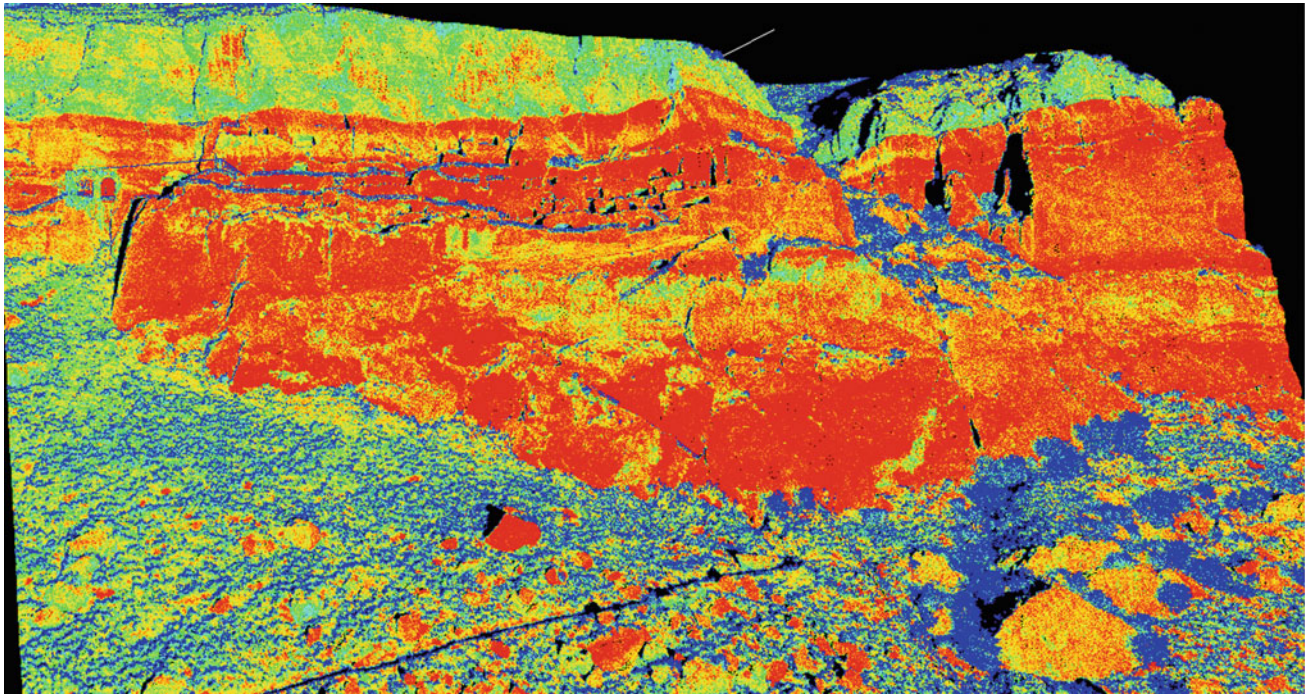
Fig. 3 Textured 3D model and reflectivity map of the cave monastery of Vardzia (Georgia) from TLS techniques

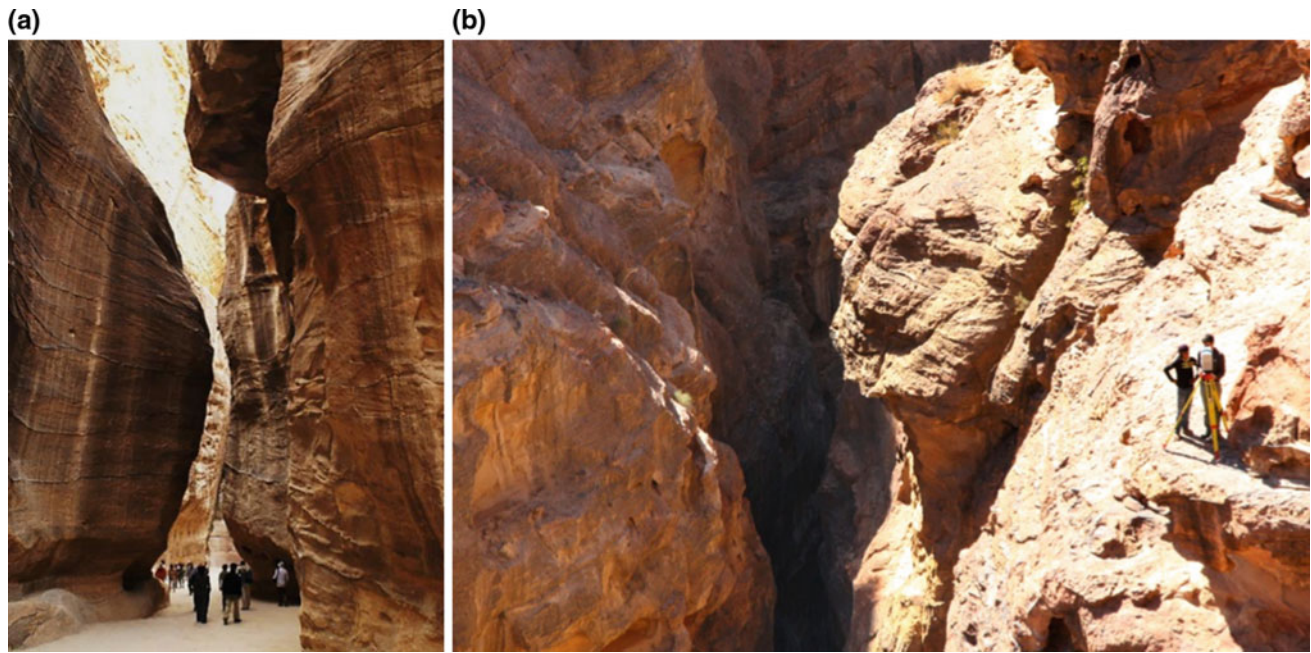
Fig. 5 Narrow passage in the Siq which makes the acquisition of upper parts of the slopes by TLS impractical if not impossible (a) and scanner positioned at one of the few places where scanning from the top was possible (b)

For the Siq survey, the scanner was positioned on the Siq floor at intervals of not more than 10 meters (Ruther et al. 2014). The lower wall areas over the entire length of the Siq were thus captured up to a height varying from 20 to 80 m, depending on visibility (Fig. 5a). In addition to this, a

number of scans could be taken from points at the upper edge of the Siq (Fig. 5b). The scans at high elevations provided, in some cases, surface data from Siq floor to the top of the rock walls. The total number of scans in the Siq was 220 with an average point interval of approximately 3 cm, resulting in a point cloud of five billion points. This is only a part of the complete point cloud which the Zamani team acquired for the Siq, Wadi Musa and Wadi Farasa. This collective point cloud comprised 25 billion points. The relative accuracy of points, i.e. the accuracy of neighbouring points is estimated to be in the order of a cm or better, whereas the absolute accuracy, i.e. the accuracy of points over the entire length of the Siq is in the one or two decimeter range. The final model (example in Fig. 6) can be viewed in 3D viewing and processing software. Coordinate and dimension measurements can be taken in applications such as the open source system Meshlab (meshlab.sourceforge.net). The 3D model and the GIS are referenced to UTM coordinates on WGS 84 (ITRF8) determined via GNSS survey by the Zamani team.

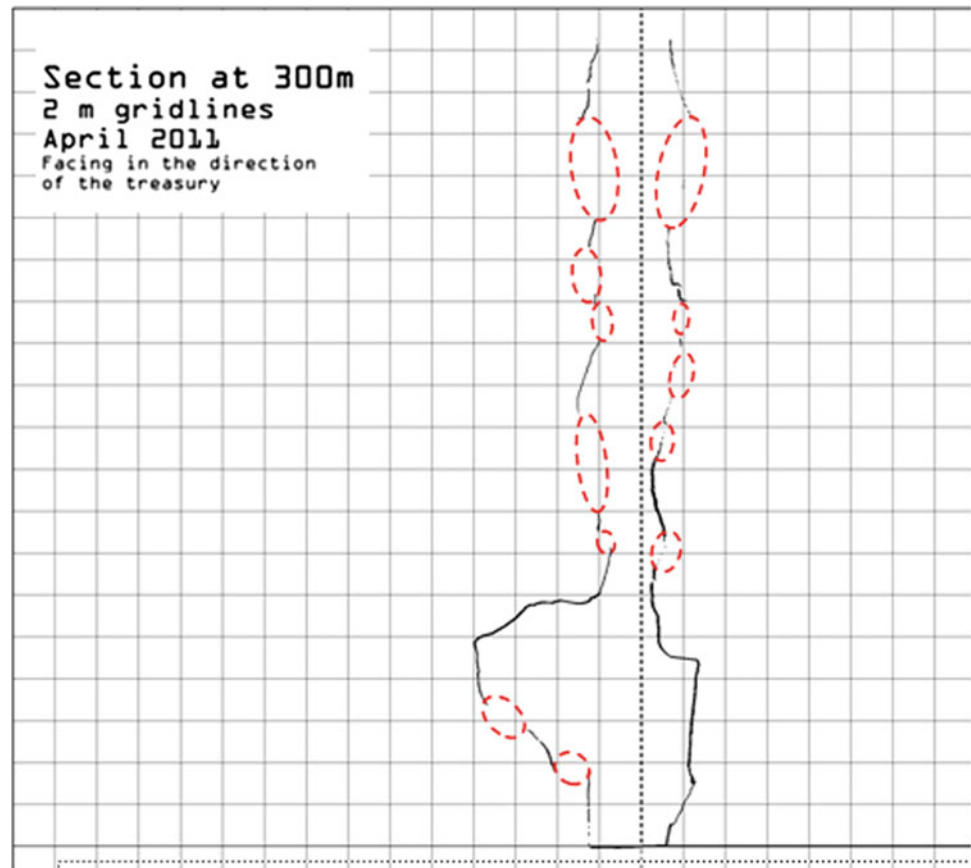
Fig. 7 Cross-section through the Siq. Invisible areas are indicated in red

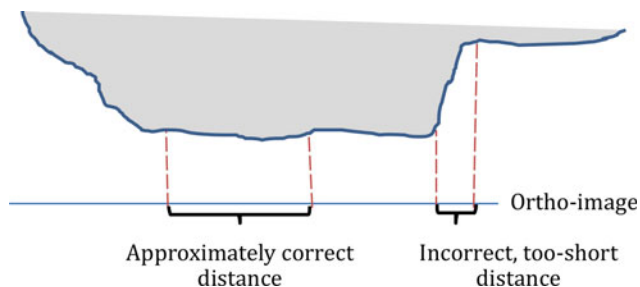
Fig. 8 Distortions in ortho image due to irregular surface shapes

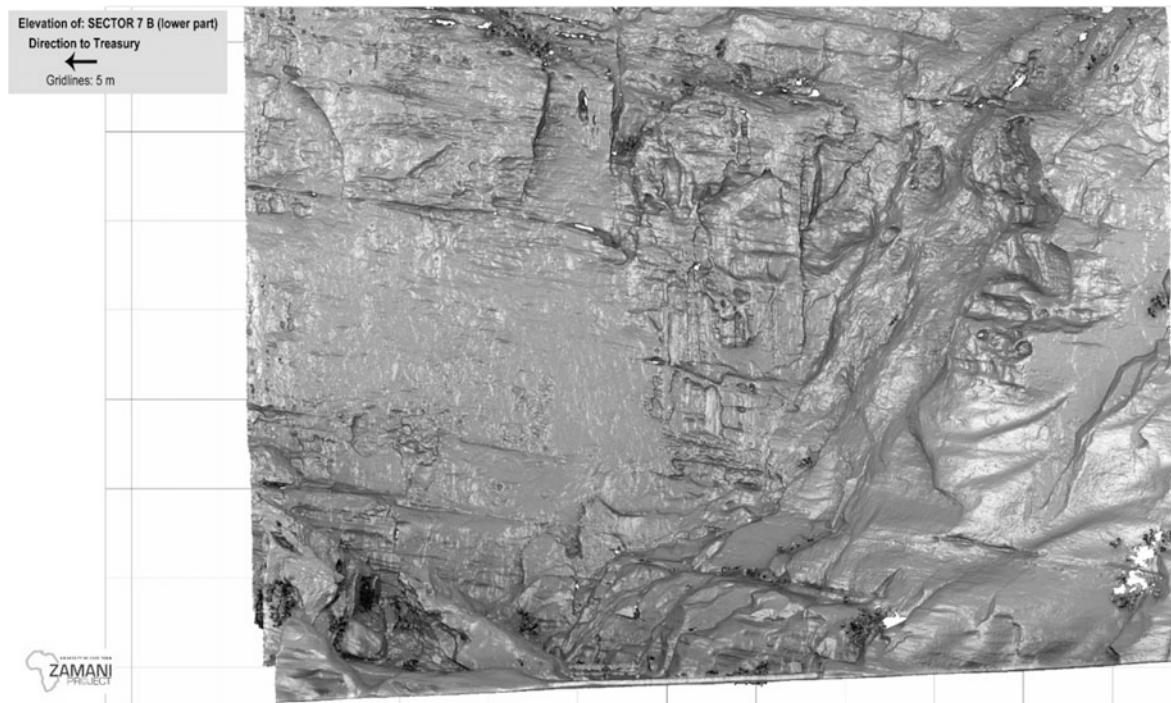
Fig. 9 Ortho image of rock wall showing surface details

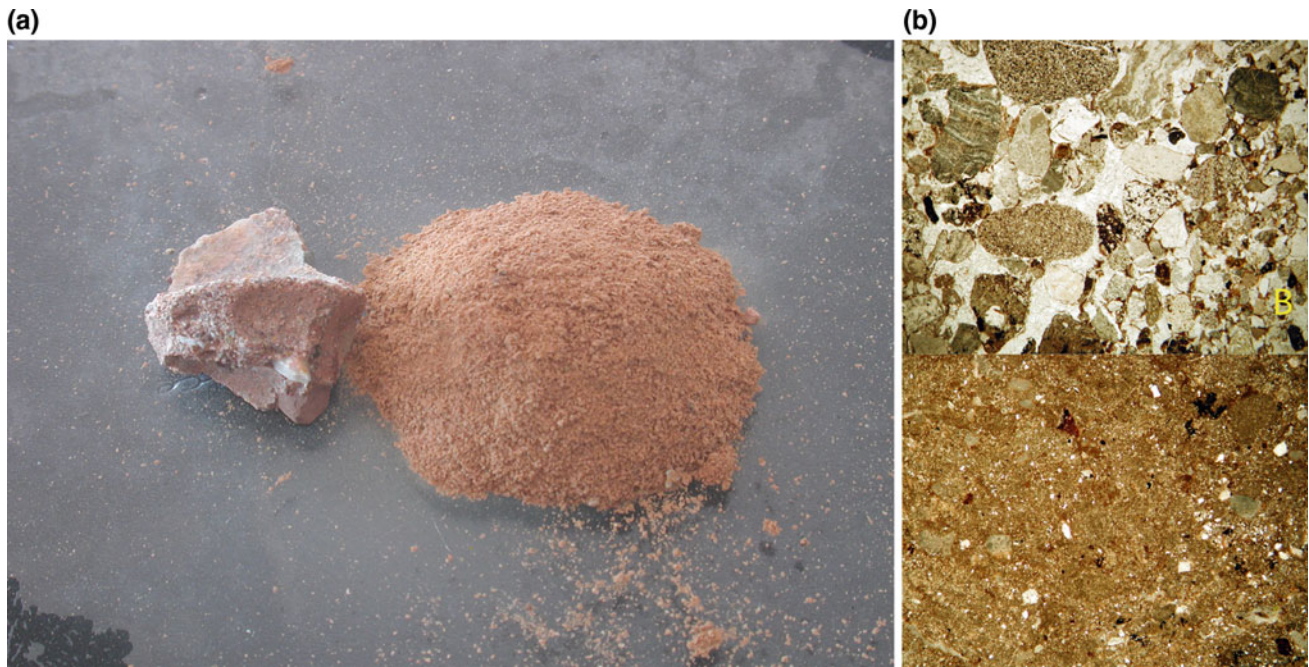
Fig. 11 Stability of conglomerate (*left in a*) and degradation of siltstone (on the *right in a*) when saturated. Thin section of conglomerate with white carbonate cement (**b**) and thin section of siltstone (**c**) (Margottini 2014a, b)

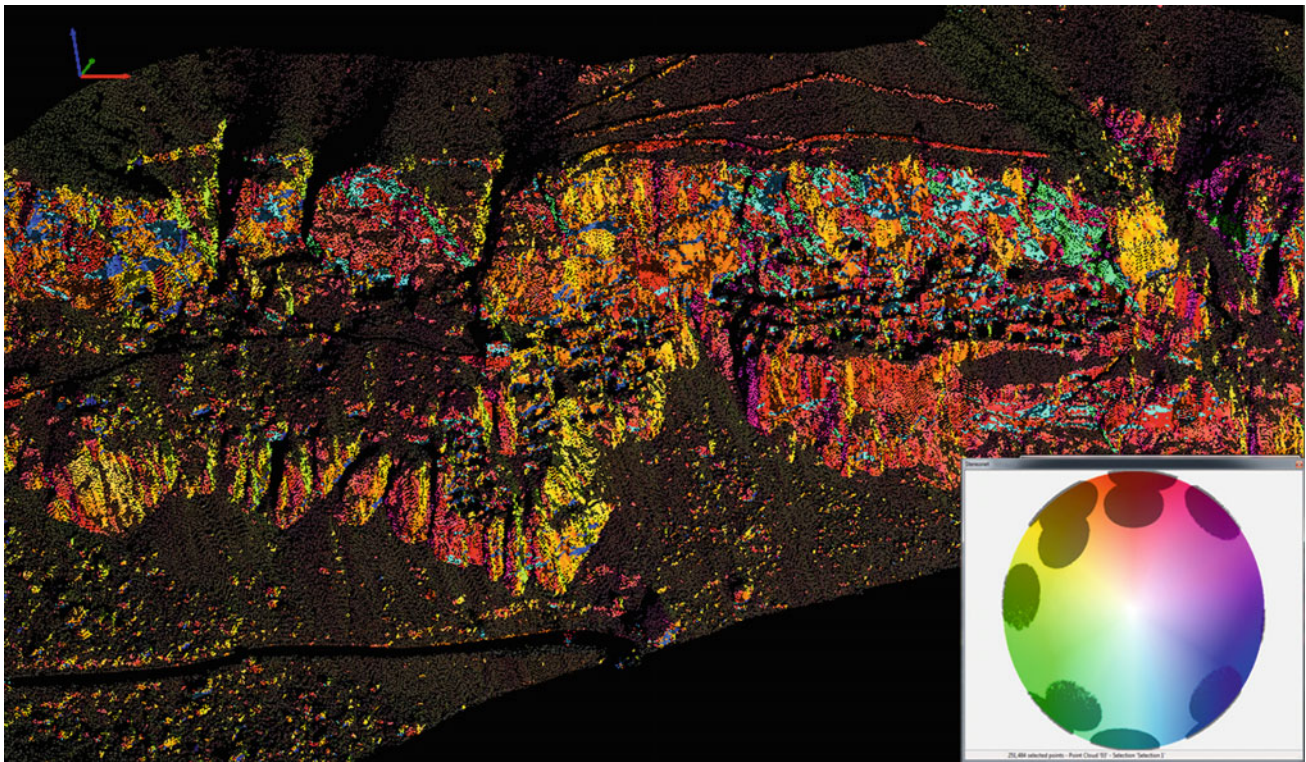
Fig. 13 The exposed rock faces of Vardzia cliff and detected slope aspect and slope angle, also on a Schmidt-Lambert stereonet (Margottini et al. 2016a, b, c, d)

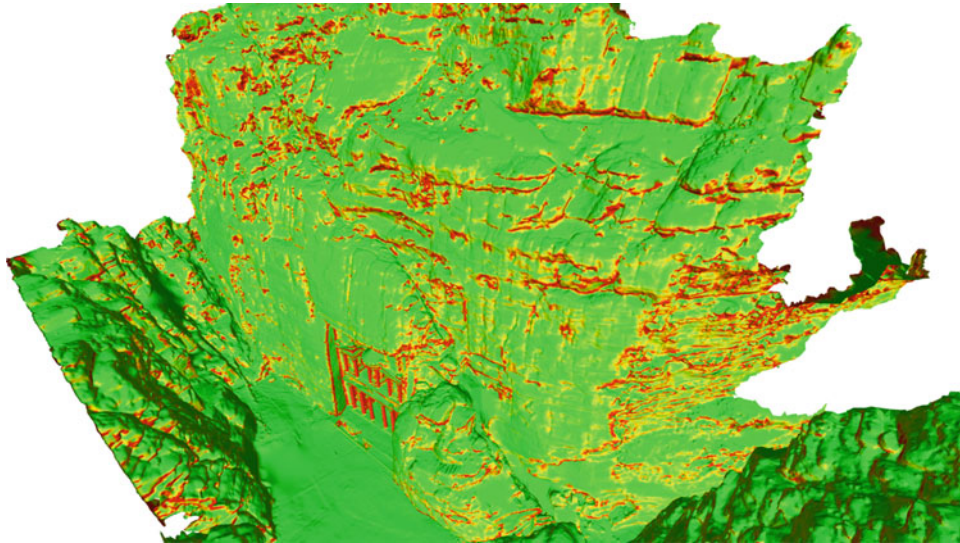
Fig. 14 Integrated result from the 3D individual kinematic analysis for the different analyzed instability mechanisms (block toppling, flexural toppling, wedge failure, plane failure and free fall) in the

Treasury area (Petra, Jordan). The probability of occurrence (hazard) is expressed following a common colour scale (0–30% of probability to be involved in a kinematic process)

A synthetic view was also provided, integrating all the different probability of occurrence for the different kinematic conditions, into a single evaluation. This elaboration, as in Fig. 14, may help in the general management of the site, identifying the most endangered places, however a detailed case by case investigation is still required.

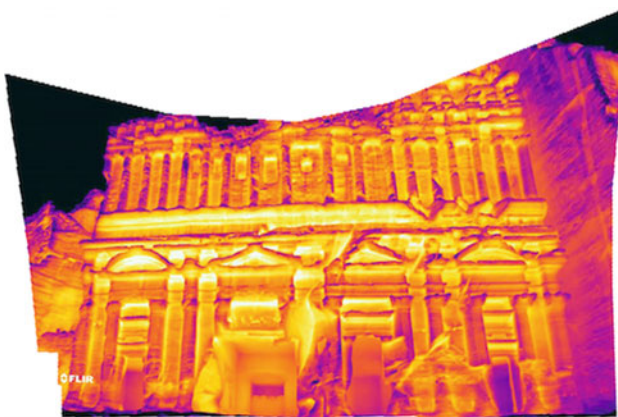
Fig. 15 Thermal image of the Palace Tomb in Petra, compared with the image as seen by a normal camera

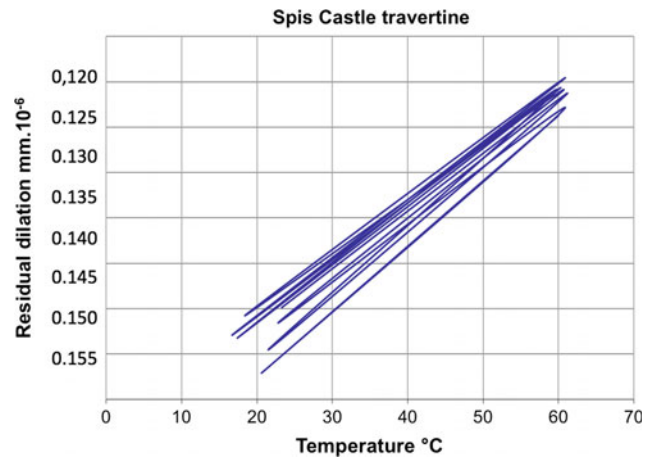
Fig. 17 Residual dilation vs temperature determined in thermodilatometer by multiple test performed within the temperature range 20 – 60 °C

The highest value of linear thermal residual strain or plastic deformations (in some papers assigned as residual dilation) was determined with the max value $\Delta L_r = 3.9 \times 10^{-6}$ m, which means that 10% of recorded rate of displacements are triggered by the temperature fluctuations. If we calculate that in the natural conditions volumetric (three dimensional) deformation is the usual case, the percentage is even higher.

Since the maximum rock face temperature reaches the difference in temperature of 35 °C several times per year one must conclude that the permanent dilation or plastic deformations significantly contribute (up to 20%) to rate of movements, that despite the fact that lateral spreading is the representative mode of failure at the Spis Castle.

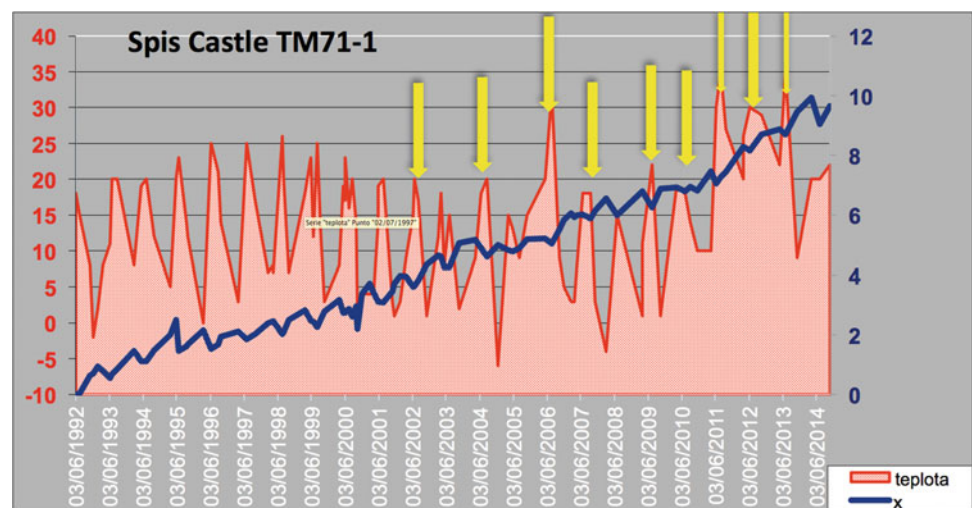
Fig. 16 Temperature versus displacements

As an example we may present our experience with Spis Castle (UNESCO site) from eastern Slovakia where since 1980 and 1992 three TM-71 type crack-gauges (TM-71) installed at the castle subgrade operate. Within this period mean annual displacement recorded at this site reached the value of 0.3–0.9 mm (mean value 0.33 mm/yr). According to the rate of displacements the slope movements maybe assigned as extremely slow (Varnes 1978). Significant for the monitoring records is that regardless of rainfall data as the most frequent slope movements trigger, the increment in the rate of displacement is quasi “stable” and as can be seen corresponds to the cyclic temperature variations (Fig. 16).

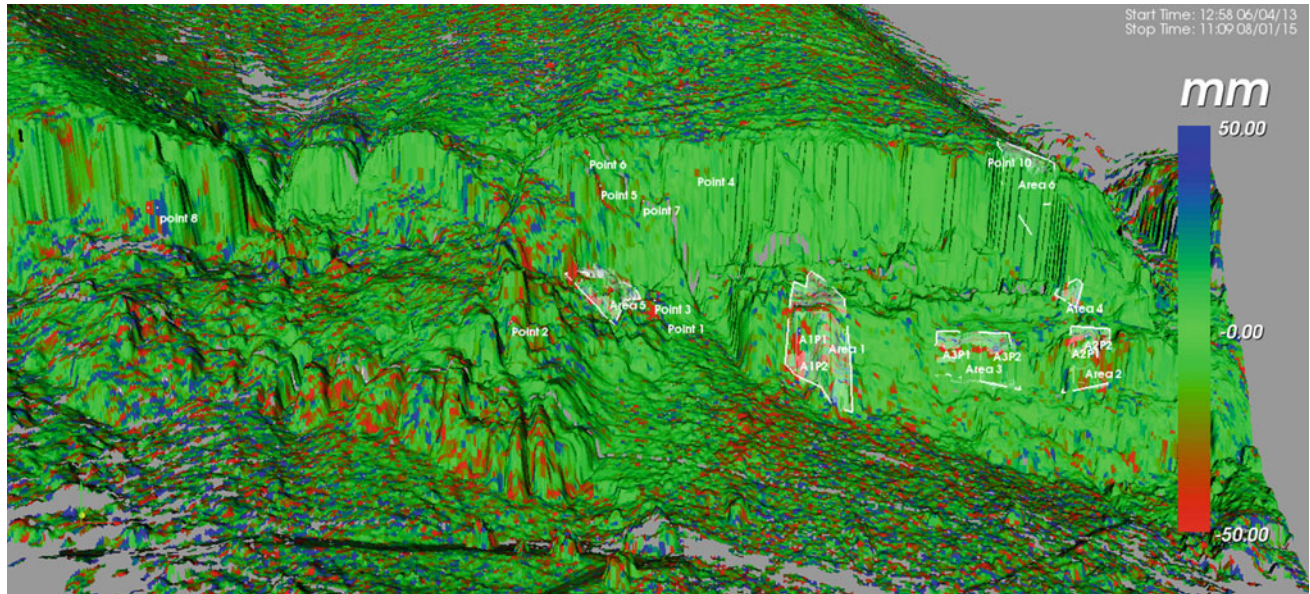
**Fig. 18** Displacement detected from ground based radar interferometry on the rock cliff of Vardzia in the period 6 April 2013–8 January 2015. Displacements are plotted against distance from the Radar installation

With the exception of some ostensible changes in individual control points (mainly due to noise factors related to vegetation) the investigated area is stable and under control (Fig. 18). In the next 6 months on site verification of the main critical outcomes of the monitoring systems will be carried out along the cliff in order to calibrate and correct the results and define the most active zones in which down-scaling of the landslide hazard and risk assessment is recommended.

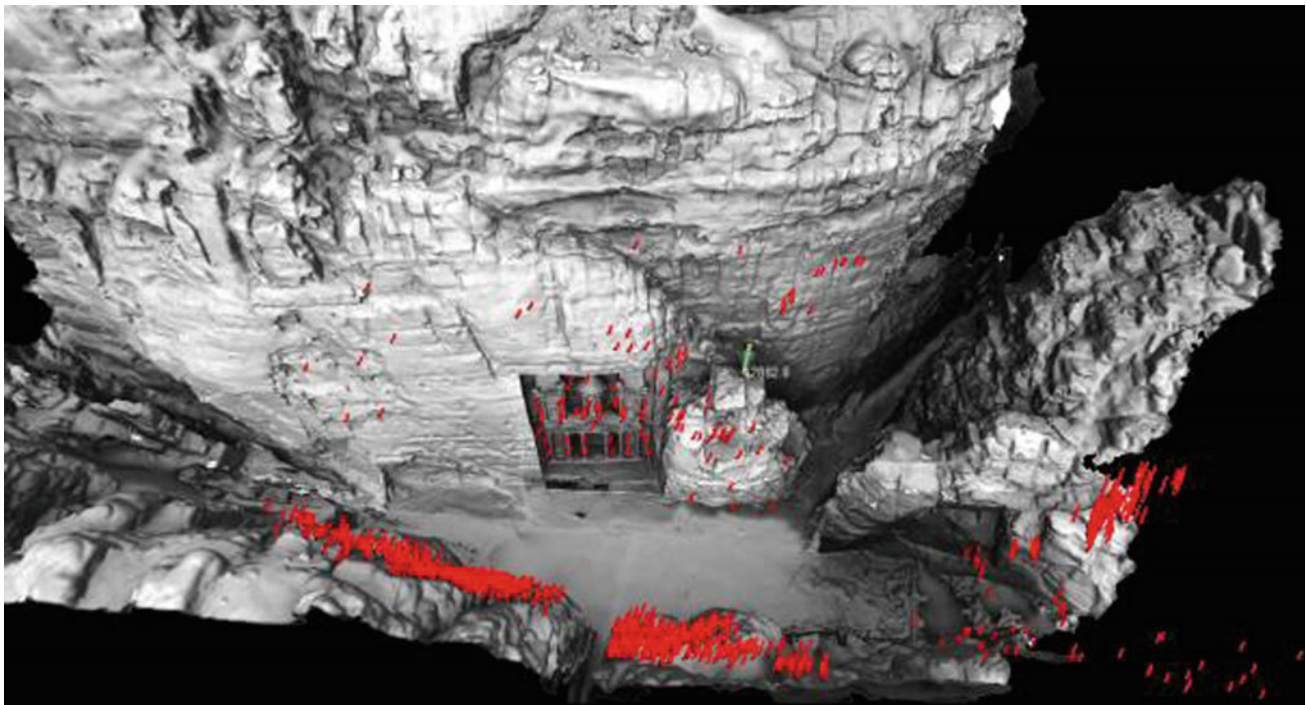
Fig. 20 Reflector-less surveyed points in the Treasury area (Petra, Jordan), superimposed on the terrestrial laser scanner

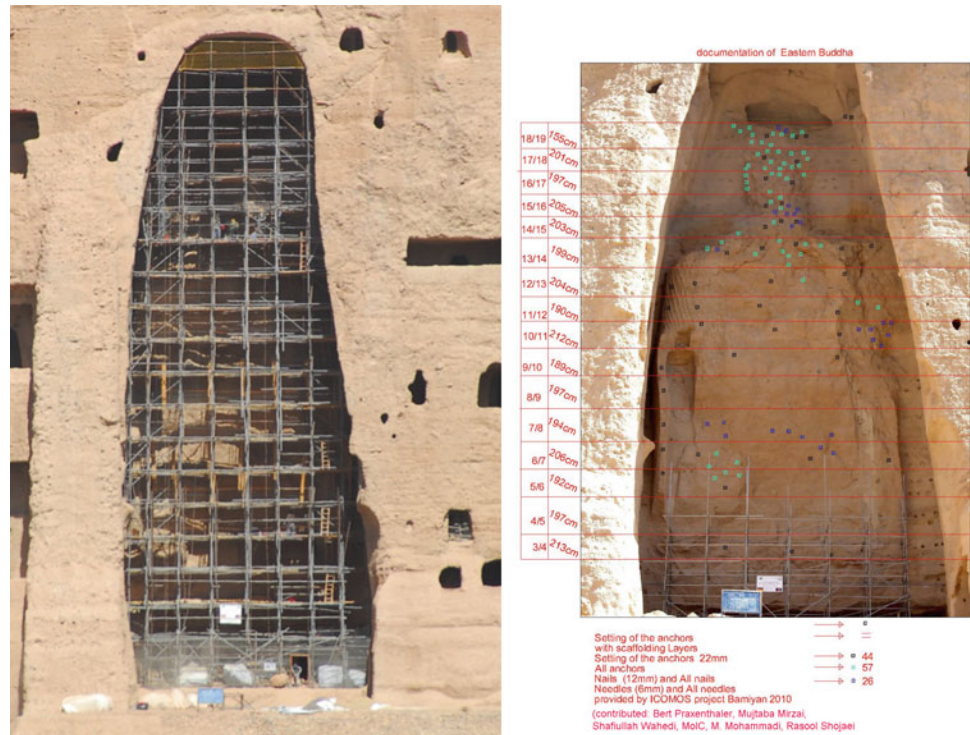
Fig. 24 The scaffolding for the stabilisation of back wall shear zone and the position and typology of installed anchors (diam. 22 mm, 12 mm, 6 mm)

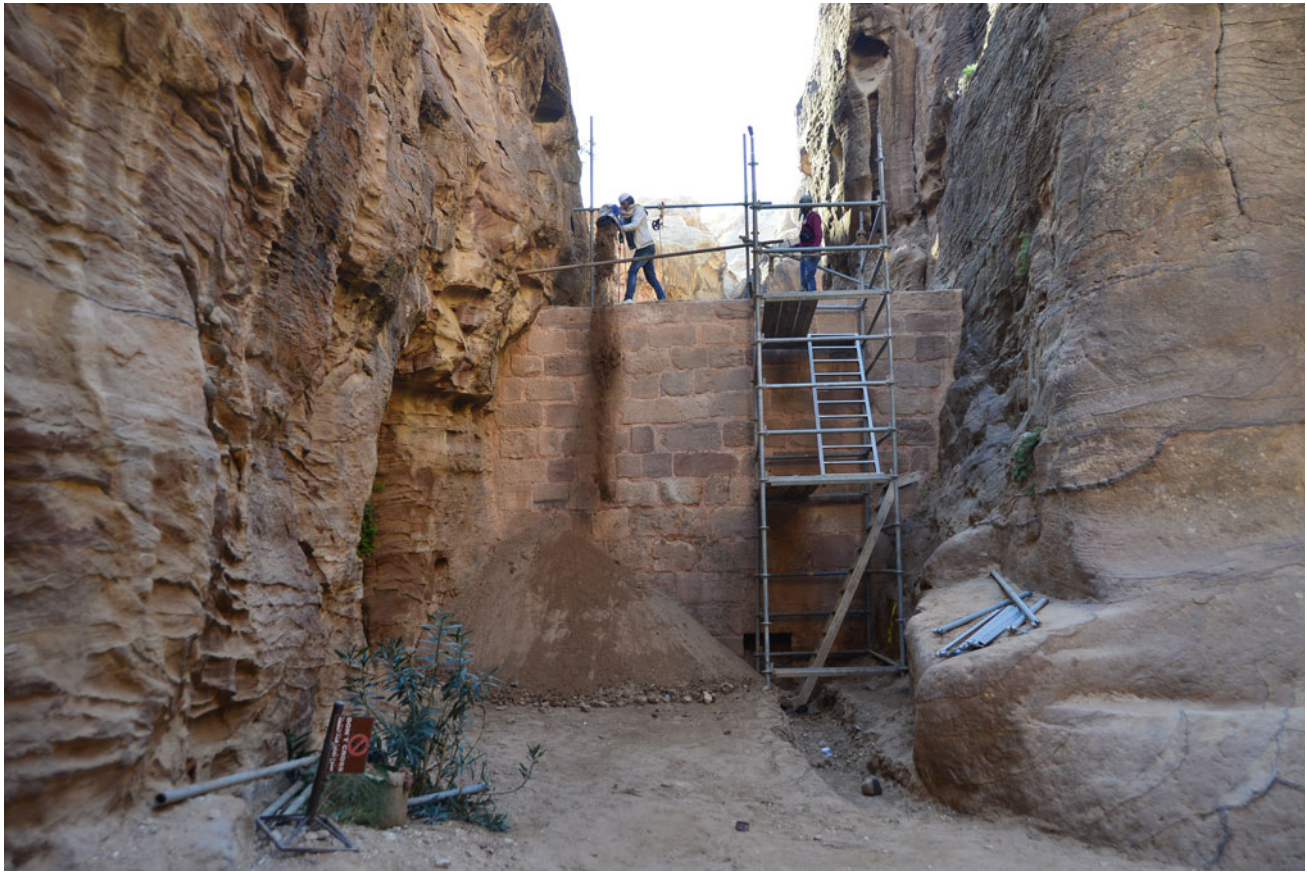
Fig. 26 Manual and proper cleaning of stone dams, to protect the Siq of Petra from flash flood

Depending on typology and volume, several kinds of mitigation works have been suggested. In any case, such techniques cannot be applied without a local investigation on the site. In detail, the selection of potential working typologies has to take into account their impact on the peculiarity of the site geo-cultural environment (geomorphology, landslide types, presence of archaeological remains) so that only some specific typologies of consolidation interventions are recommended. Clearly, any intervention has to take into consideration the minimization of the environmental/visual impact of works, the local sustainability and feasibility, and the transfer of know-how to the local system. All these details are included in specific Guidelines (Margottini 2015) for the benefit of Jordanian authorities. Particular attention is given to the traditional techniques and the proper maintenance of such practices (Fig. 26).

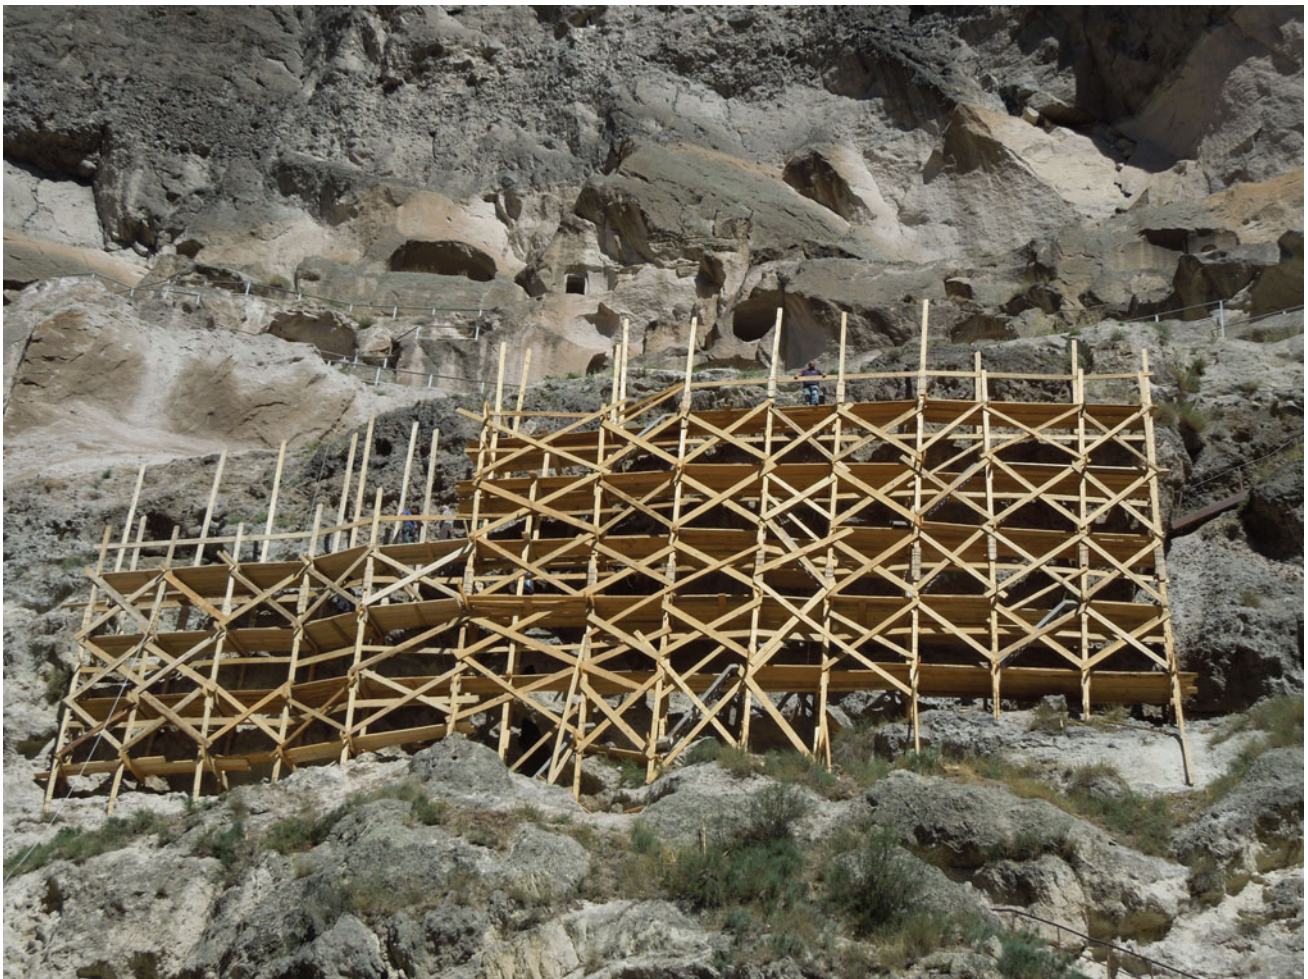
Fig. 30 The wood scaffolding realised in Vardzia

Cultural Heritage Preservation of Georgia. An Italian engineer with considerable field work experience then accompanied the purchasing of equipment and the field work, including the construction of the scaffolding. The final successful result is shown in the following figure showing the realized wood scaffolding and the 48 installed dowels (Figs. 30 and 31).

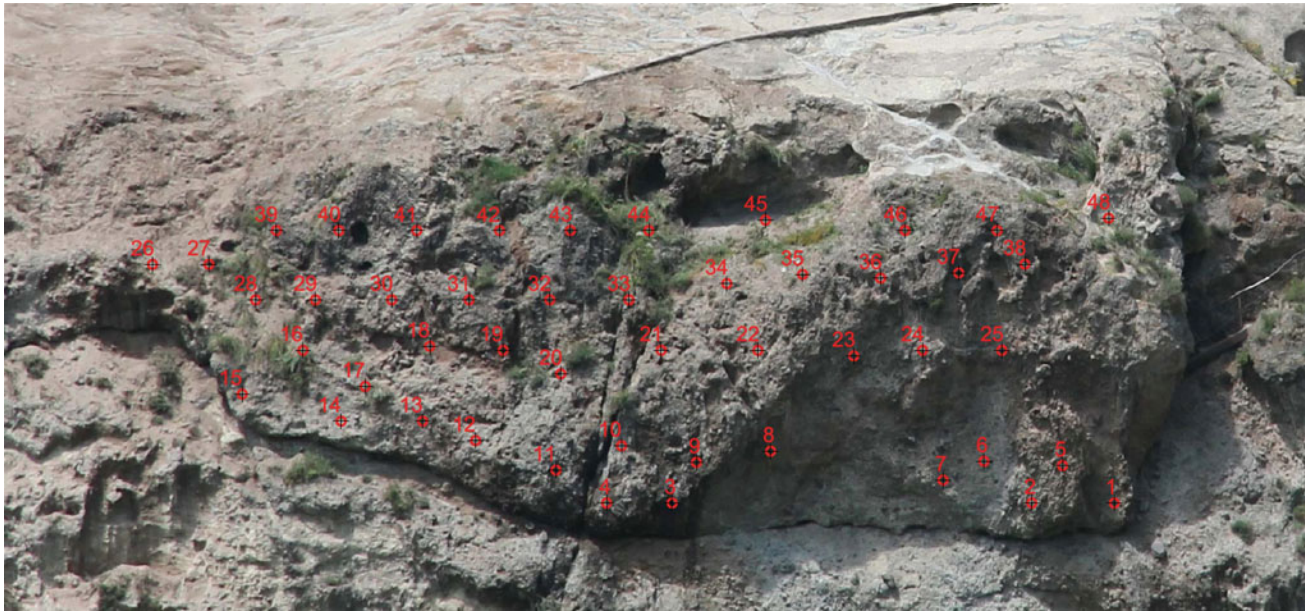
Fig. 31 Positioning of the the 48 installed dowels
