Cultural Heritage Monuments and Historical Buildings: Conservation Works and Structural Retrofitting

Romeu Vicente, Sergio Lagomarsino, Tiago Miguel Ferreira,
Serena Cattari and J.A.R. Mendes da Silva

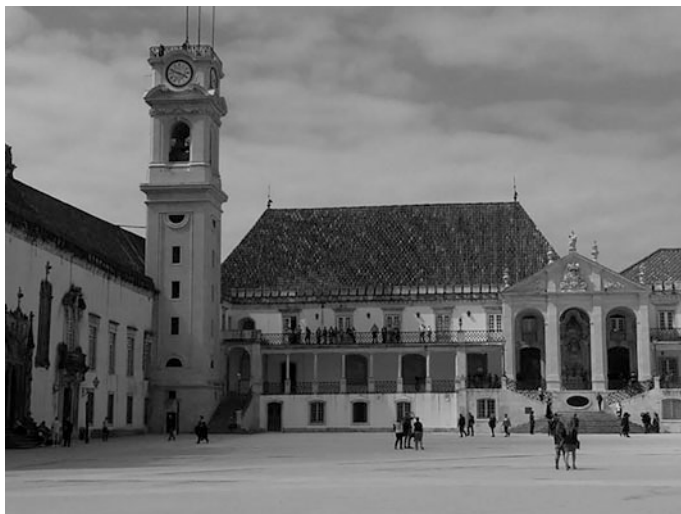
Fig. 2 Tower of the University of Coimbra and Via Latina

The 34-meter-high Tower, also known as Tower of the University of Coimbra, was planned during the reign of João V and it is considered one of the most original examples of Portuguese eighteenth century Baroque architecture. Started to build in 1728 and finished in 1733, about 22 years before the great Lisbon earthquake, during its history it suffered no more than a few and limited non-structural maintenance and restoration interventions.

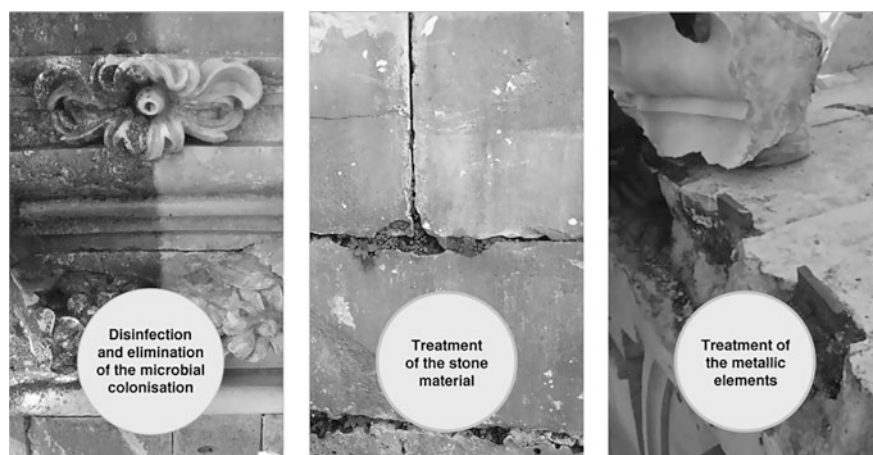
Fig. 6 Conservation works performed

The conservation and restoration works took place from March 2010 to August 2010. Besides the main action of cleaning and treatment of all surfaces, assumed as ordinary planned maintenance, other reactive maintenance actions aiming at restoring the stability conditions and the cohesion of the architectural elements, as well as of ornamentation elements that presented signs of instability and risk of imminent fall, were also taken. The suppression or mitigation of the action of agents responsible for the degradation of materials and the attainment of better conditions

to resist the action of external atmospheric agents were other maintenance actions carried out [11]. It is worth highlighting that the specific nature of this intervention entailed the adoption of individual strategies and methodologies, not only during the preparation works, but also during the accomplishment of the different tasks. Figure 6 schematises the conservation works performed, which are herein grouped and described in the following paragraphs.
