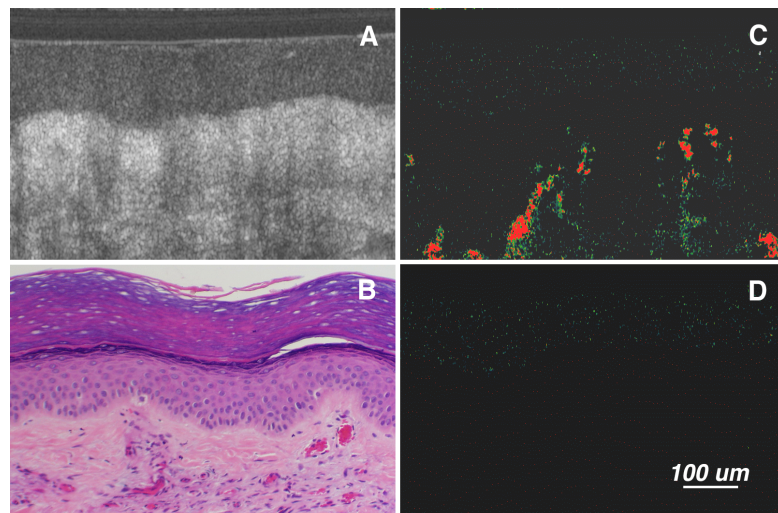
Page 63. Figure 6. Doppler OCT images taken *in situ* from PWS human skin. A: structural image; B: histological section; C: image before laser treatment; and D: image after laser treatment (from Ref. [23]).
