TRACES OF LIQUEFACTION UNDER THE SHINANO RIVER BANK DURING THE 1964 NIIGATA EARTHQUAKE

Motoki KAZAMA¹, Yuko SHIMIZU², Tomohiro MORI³, Noriaki SENTO⁴, Ryosuke UZUOKA⁵

ABSTRACT

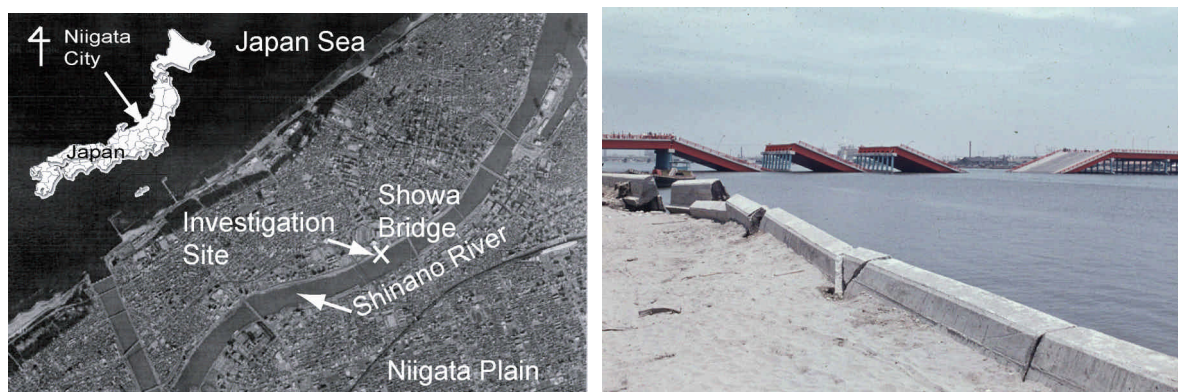
Figure 1. Showa Bridge collapsed at the 1994 Niigata earthquake and the location (taken by Emeritus Prof. Kuranishi, Tohoku University, Japan)

Figure 1 shows the investigation site location and a photograph of the collapsed Showa Bridge. The Showa Bridge is located at the Shinano River mouth in Niigata city. Damage to the bridge was especially concentrated on the left-bank side, affecting both its superstructure and substructure: the five span simple girders collapsed and plastic deformation of the pier piles was apparent (JSCE report, 1966). According to an eyewitness account, the collapse of girders occurred one to two minutes after the end of the main shock. The impression of the witness was that the seismic motion might have caused the toppling of the first collapsed girder, but there was a marked time delay before the other girders collapsed. The photo is believed to have been taken from the left bank of the river, near the investigation site.

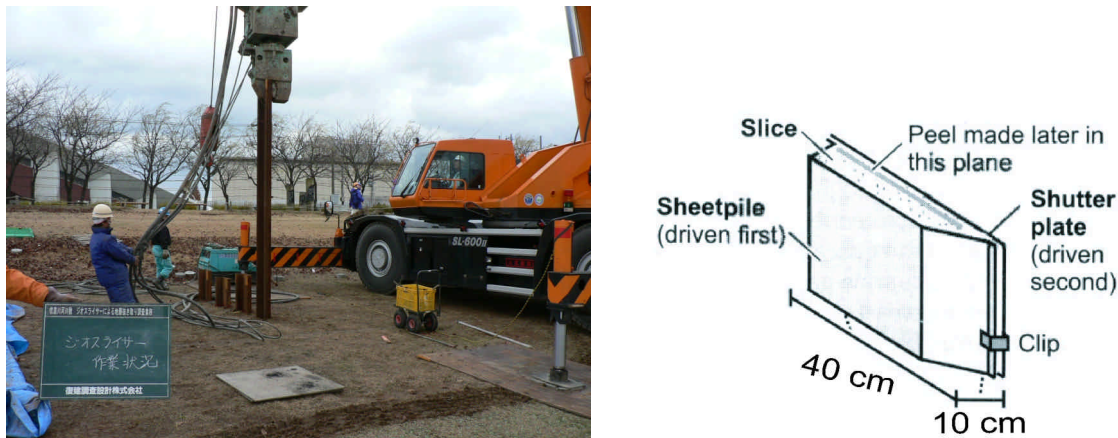
Figure 4. Photographs of sheet pile driving and a schematic diagram of the sampling system

Figure 4 shows photographs of the soil investigation device, called the Geoslicer. This technique was developed in Japan and has been used for geological investigations of landslides, faults, and liquefaction identification (e.g., Nakata and Shimazaki, 1997, Haraguchi et al., 1998, Takada and Atwater, 2004). An outline of the procedure is as follows:

- 1) A steel sheet pile is inserted into the ground using a weighted vibrator, as shown in the left panel of the figure. Figure 5 shows that this sheet pile plays a role as a sample tray after it is pulled out. Generally, all the sheet piles are driven in first.
- 2) A shutter plate is then driven in to cover the sample soils, as shown in the right panel. The dimensions of the sheet pile used in this study are shown in the figure.
- 3) Figure 5 shows that the sheet pile and shutter plate are pulled out together from the ground and that the shutter plate is removed after being placed on the ground surface.
- 4) After removing the disturbed surface of the soil sample, the soil profile can be observed directly. A peel can be also made in order to keep the samples, if necessary.
