VULNERABILITY OF ADOBE BUILDINGS UNDER EARTHQUAKE LOADING

Rachel TETLEY¹, Gopal MADABHUSHI²

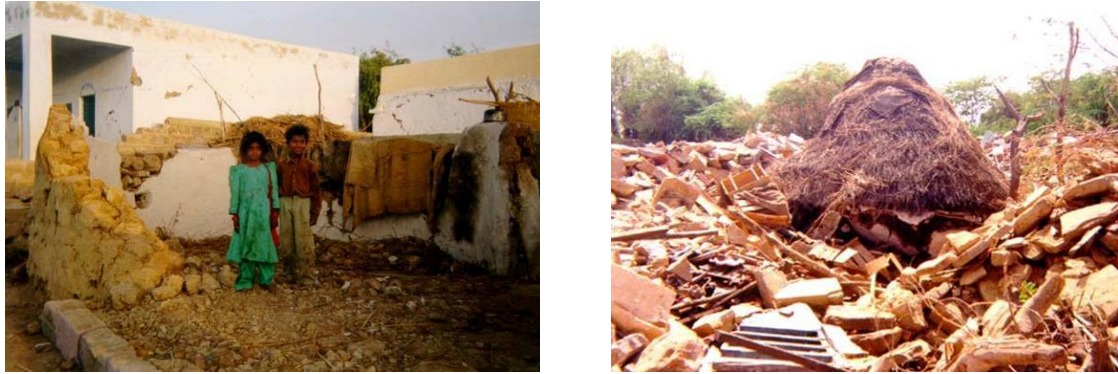
Figure 1: Typical Collapse of Adobe Buildings in the 2001 Bhuj Earthquake, Choudhary et al (2002)

Adobe construction is used throughout India and the 2001 Bhuj earthquake destroyed many buildings. Typical collapses can be seen in Figure 1.

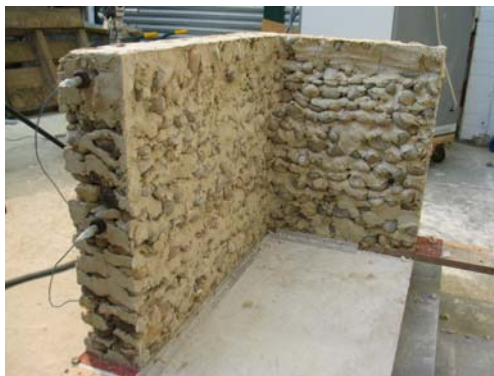
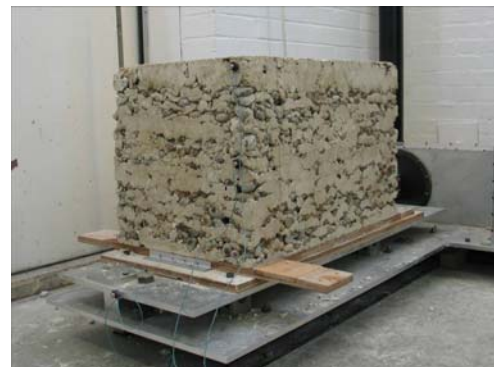
Figure 2a,b: Joint model before testing

The corner joint had dimensions such that it was made up exactly of the single wall tests performed. Construction took 2 days and the model was allowed to dry for 5 days. It was anticipated that the failure should be between 0.32g and 0.49g (the failure accelerations for the in-plane and transverse walls when tested alone). The transverse wall should have failed first either at the corner or by toppling if it was to mimic the behaviour of full size adobe buildings.

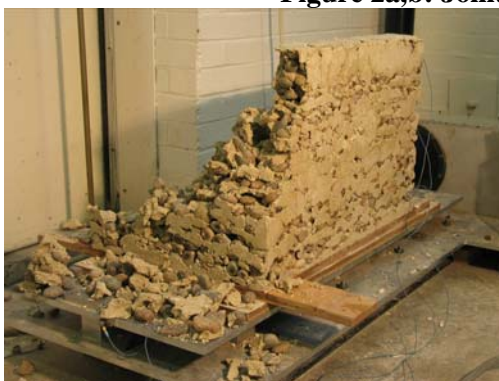
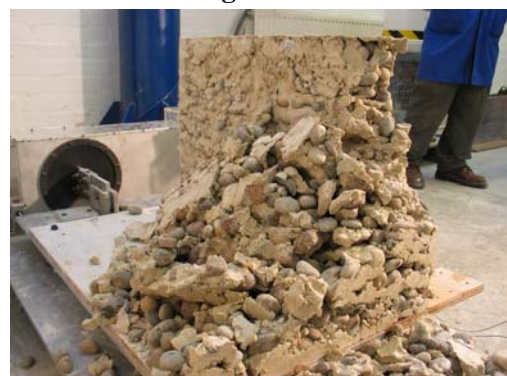
Figure 2c,d: Collapse at 0.32g

Failure occurred by the transverse wall rotating about the corner causing a vertical crack to open up. This was deemed to be total collapse even though part of the in-plane wall was still standing because if this was a full size building the roof would have inevitably collapsed at this point. Also the wall failed in such a way that it would have crushed any inhabitants of the building. The failure was at 0.32g – the same as the single transverse wall tested which failed by toppling.

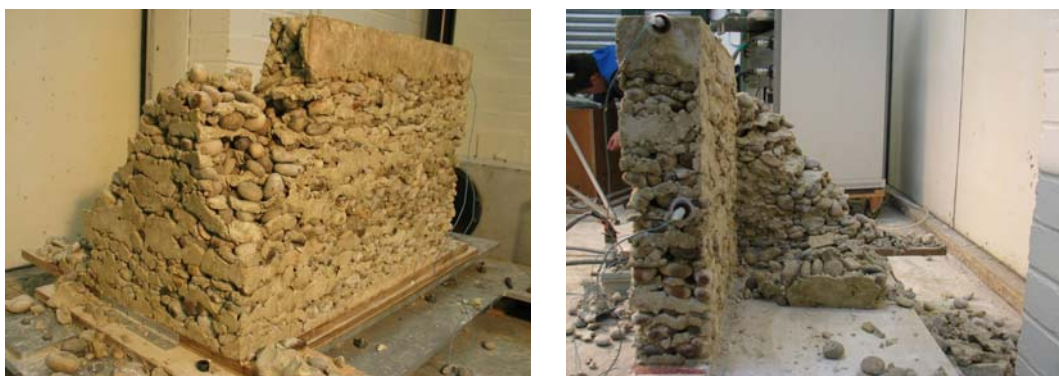
Figure 4: Failure at 0.32g

Even though the addition of cement probably increased the strength of the mortar there was no increase in failure acceleration. This may be because there was no increase in ductility and as such the

failure mechanism of the transverse wall rotating about the corner was not remedied. Thus the failure occurred in an identical way and at exactly the same acceleration as the unimproved model.

2% by weight of the mortar mixture was Ordinary Portland Cement. Other than this the composition of the model was identical to the unimproved model. The performance of the 2% cement model is summarised below. Photographs of the failure can be seen in Figure 4.

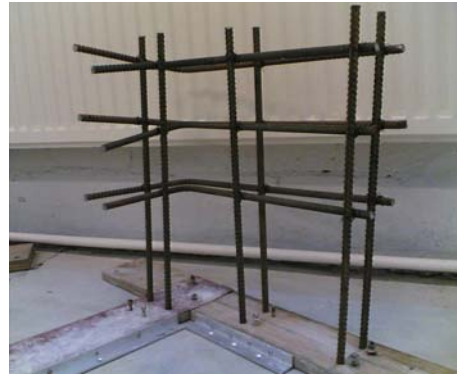
Figure 5: Reinforcement Details

The bars used were: 3No. 380 x 200 x 10mm Ø “L” Bars, 3No. 330 x 150 x 10mm Ø “L” Bars, 6No. 440 x 10mm Ø Bars.

In this test a combination of “L” bars and vertical bars were used at the corner. Bars used were 10mm in diameter, and a total of length 5.82m was required for the 1:5 scale model. It was hoped that the “L” Bars would resist the rotation of the transverse wall about the corner and that the vertical bars would resist the toppling mechanism of the transverse wall. The bars were bent and tied together first, 10mm holes were bored in to the wooden base and the straight bars hammered in, to mimic embedding in the foundations. The wall was then built up around the bars as normal.

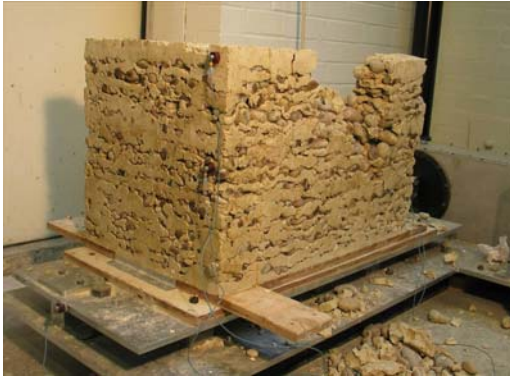
(a)

Figure 6a: Moderate damage to in-plane, unreinforced wall at 0.39g

In this test only the corner of the model was reinforced as this was where previous models had failed. However this induced movement in the in-plane wall where the “L” bars were terminated, leading to the collapse of the in-plane wall at a lower acceleration than the unimproved models. The failure mechanism was the perpendicular wall trying to topple which caused the reinforcement in the in-plane wall to lift up and down leading to the formation of large cracks in the in-plane wall. Thus if this improvement is to be successful reinforcement would need to be placed throughout the structure so that large stresses are not induced where bars are terminated.

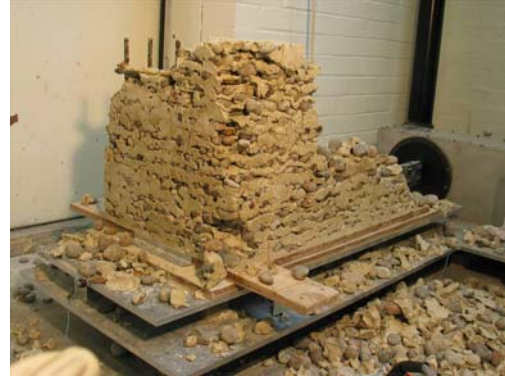
(b)

Figure 6b: Collapse of unreinforced in-plane wall at 0.45g

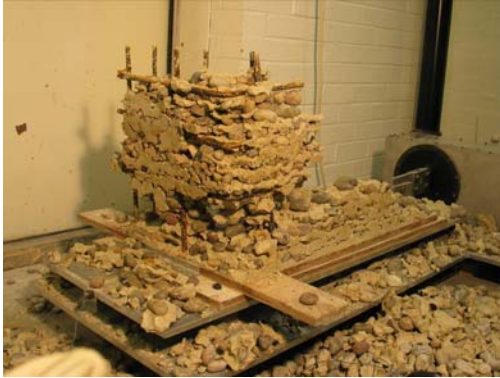
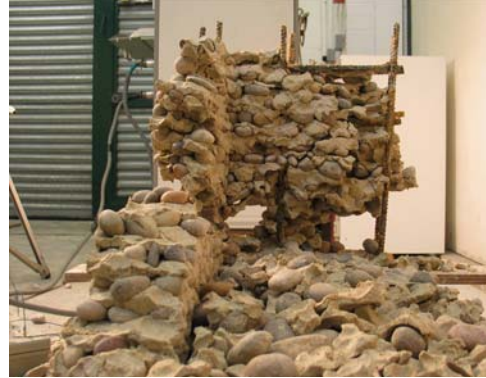
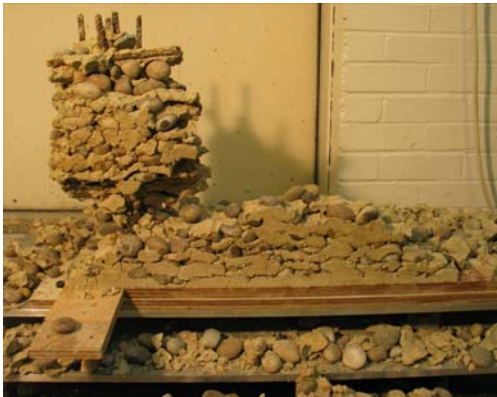
Figure 6c,d,e: Parts of model confined by reinforcement still standing after 1.02g

Where the reinforcement was placed it was very successful. The confinement and tensile strength provided by the reinforcing bars was enough to allow parts of the model to survive at 1.02g.

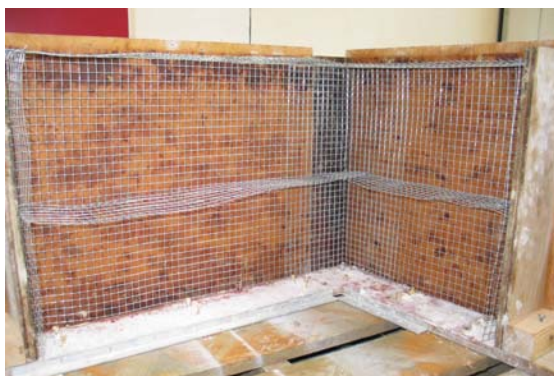
(a)

Figure 7 a: Part of Mesh Cage in Mould

The cage was constructed from flat sheets of mesh and the wall built up inside the cage. Once complete the adobe mortar was used to plaster the mesh to the surface of the wall. The wire mesh used here scales to 65mm square at prototype scale.

In this test a cage that fully encased the wall was constructed out of 13mm×13mm steel mesh. Mesh was fixed to the base with simple tacks, to mimic either burying in the foundations or pegging into the ground. It was hoped that the mesh would have two benefits; firstly to increase the ductility and tensile strength of the model; secondly to contain the collapse when it occurred.

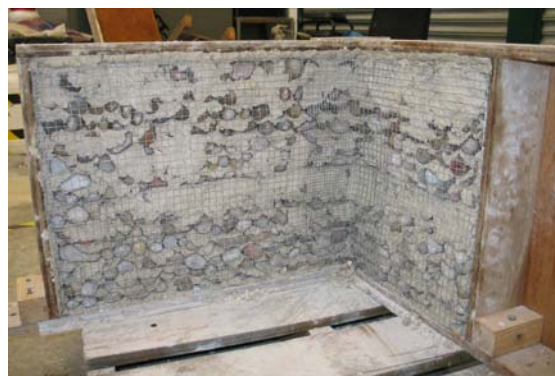
(b)

Figure 7b: Wall Built Up in Cage before Plastering

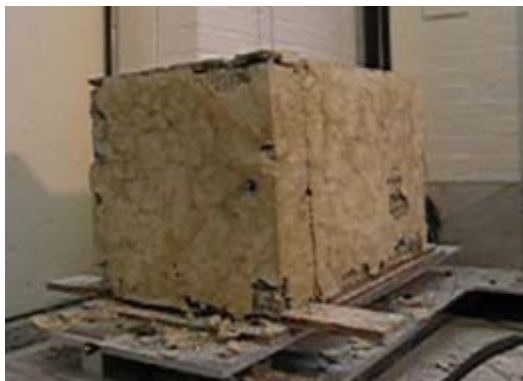
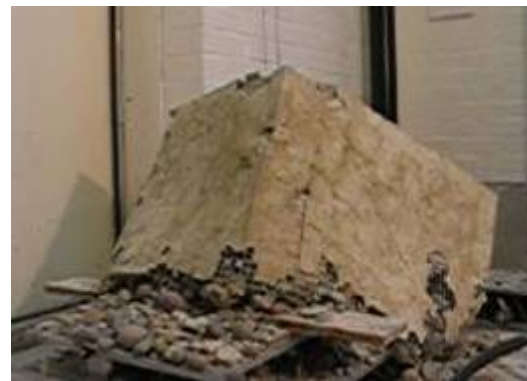
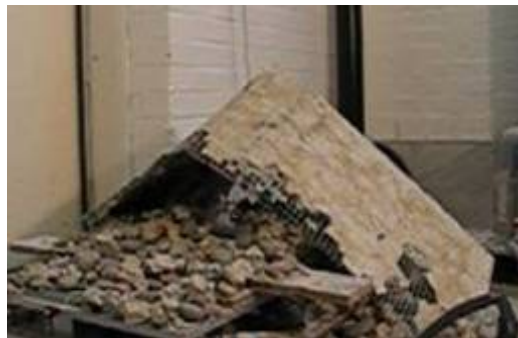
Figure 8 Failure mechanism at 1.02g of Test C with wire mesh reinforcement

This improvement was very successful and increased the ultimate capacity of the model by more than three times. The eventual failure was due to the mesh becoming detached from the base. A repeat test would be required to investigate the level of fixing required to prevent failure at 1.02g.

The addition of mesh resulted in an increase in strength and a significant increase in ductility indicated by the large deformations viewed without damage occurring. If the mesh were better fixed to the base then it could be possible to prevent loss of life by containing the collapsed wall inside the cage.

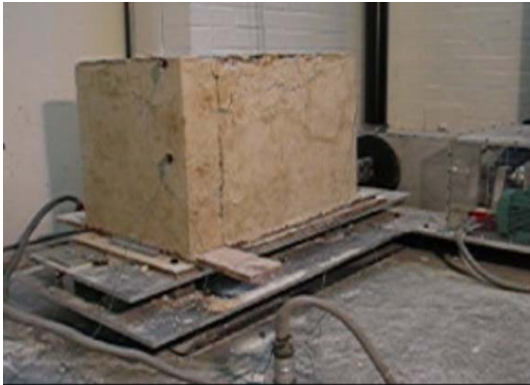
(a)

Figure 10a: Improvement D: Use of carrier bag mesh- No damage up to 0.32g

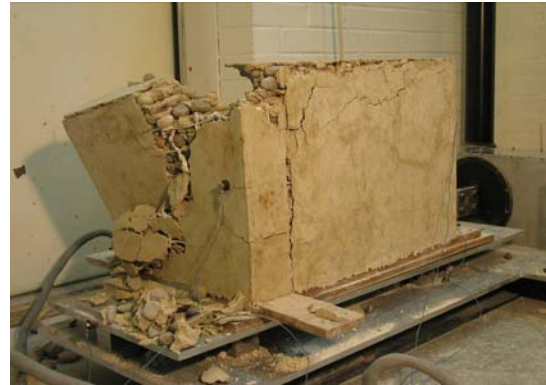
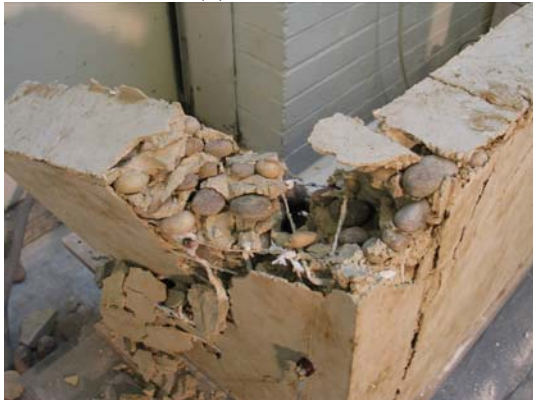
Figure 10b,c: Damage restrained by mesh at 0.45g

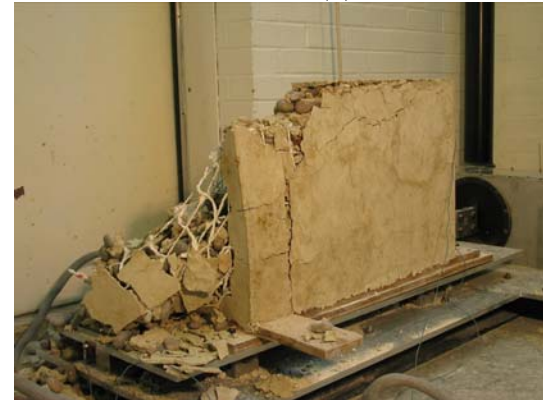
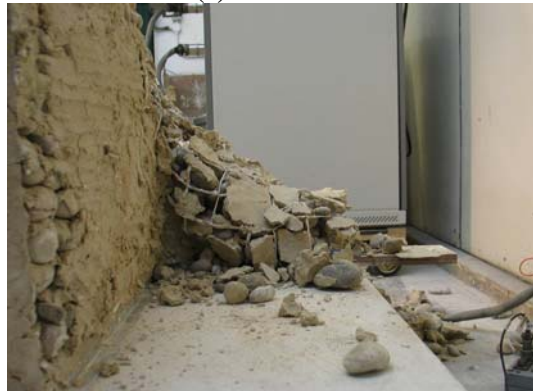
Figure 10d,e: Collapse of transverse wall at 0.64g, in-plane wall undamaged

The addition of the carrier bags clearly made the model more ductile and there was also an increase in strength. The transverse wall failed at 0.64g, double the acceleration at failure of the unimproved model. Similarly the in-plane wall totally collapsed at 1.02g, double the collapse acceleration the unimproved in-plane wall.

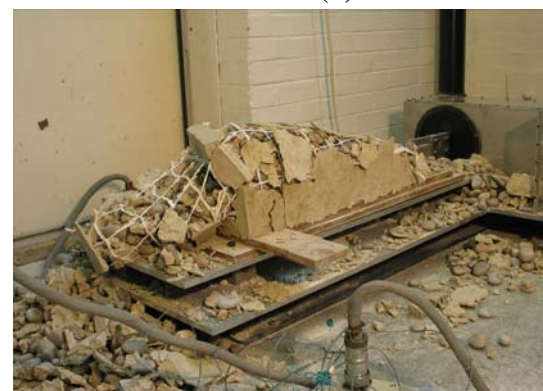
(f)

Figure 10f: Complete collapse at 1.02g
