THE ROLE OF GEOTECHNICAL FACTORS ON DAMAGE MODES AND DISTRIBUTION: LESSONS LEARNED FROM ADAPAZARI

B. Sadık BAKIR¹ and M. Tolga YILMAZ²

ABSTRACT

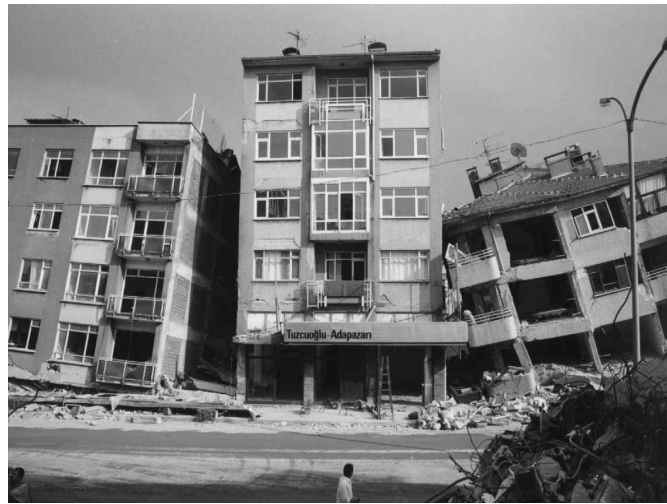
Figure 3. Building damage in the form of bearing system failures at stiff sites

Two distinct and mutually exclusive modes of building damage were observed in the city: structural system failures and foundation displacements (failures) in the forms of settlement, tilting and lateral movement (Figures 3 and 4). Occurrence and severity of foundation displacements were evidently associated with factors such as strength of foundation soils, building height, foundation aspect ratio and presence of adjacent buildings. Displacements were more pronounced in the case of taller buildings with poor foundation aspect ratios and in general decreased with decreasing story number. In the blocks of adjacent buildings, the displacements were relatively less and commonly in the form of uniform settlements up to about 25 cm, whereas the buildings at block ends typically experienced excessive tilts. Foundation displacements exceeded tolerable limits in numerous buildings; the mat foundations however, remained intact even in the cases of extreme tilting and settlement. Remarkably, those buildings which were subjected to foundation displacements did not sustain any structural damage, irrespective of the form and extent of the displacements.

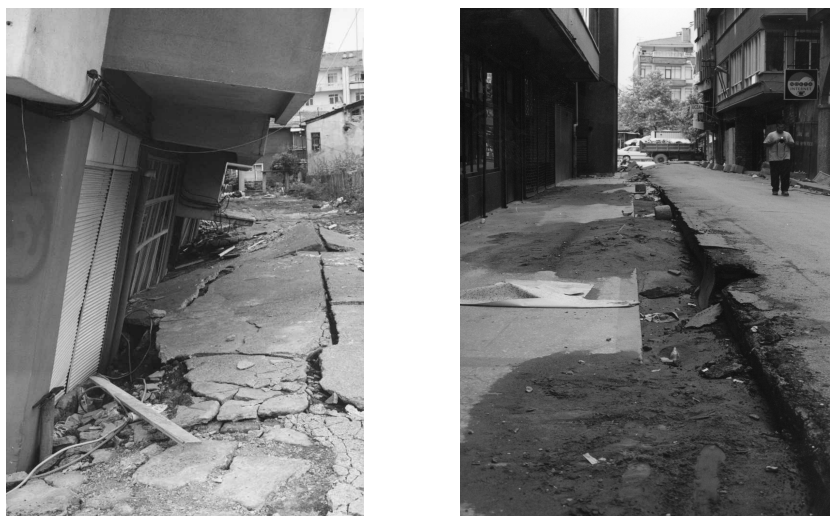
Figure 4. Building damage in the form of foundation bearing failure at soft sites

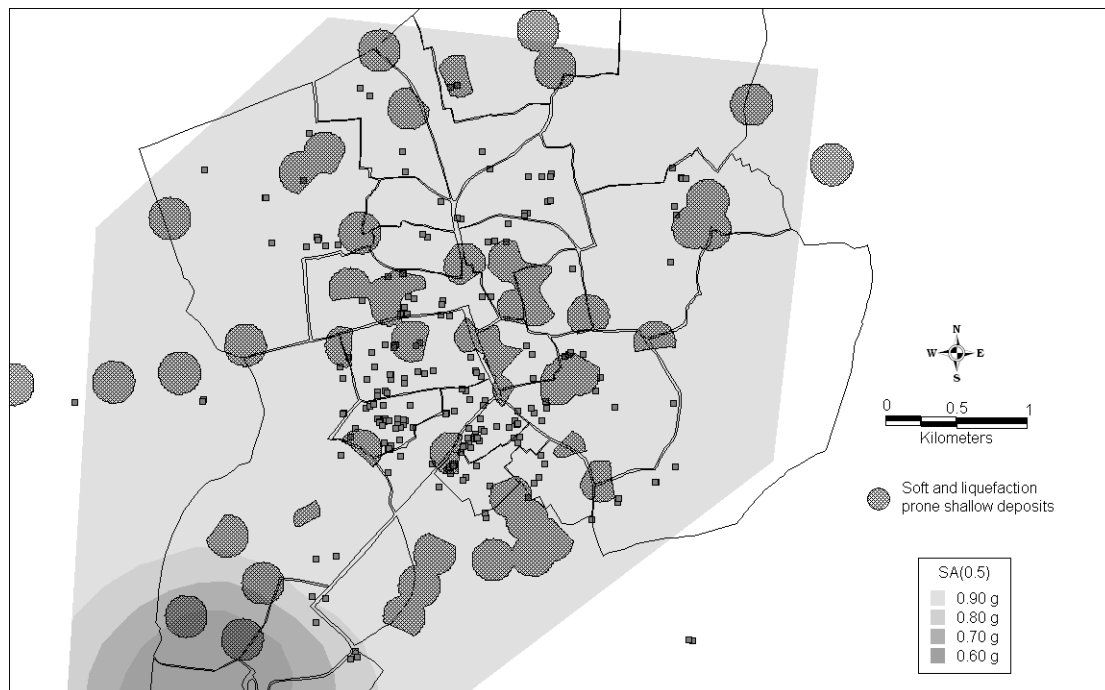
Figure 12. Variation of spectral acceleration corresponding to 0.5 s period (squares indicate locations of collapsed buildings and dark gray patches mark the soft sites)

Utilizing the idealized spectra (Figure 11) and variation of depth to bedrock (Figure 2), distribution of spectral accelerations is computed corresponding to the 0.5 s period, representative of the range of fundamental periods of 3 – 7 story RC buildings, and contour mapped in Figure 12. Distribution of the areas identified as soft sites are superimposed on the same figure, together with the positions of collapsed buildings for which the location coordinates were available. Spectral accelerations range over 0.6g – 0.9g and are observed to increase with increasing alluvium depth. Almost all of the collapsed buildings are located within the highest spectral acceleration zone, clearly indicating the influence of alluvium depth over seismically induced force levels imposed over building structures during the earthquake. The striking observation from Figure 12, however, is that the indicated locations of 4 – 7 story collapsed buildings, with few exceptions, lie outside the patches marking soft sites, over which substantial reductions in the seismic demand are anticipated to have occurred. This outcome is consistent with the post-earthquake observations relating to certain zones in the city where buildings with substantially reduced levels of structural damage were commonly accompanied by foundation displacements of various forms and levels, an apparent indication of strong nonlinear response of surface soils.
