DENSE ZONE IN SUBSOIL OF EMBANKMENT AS A COUNTER MEASURE AGAINST EARTHQUAKE

Chandradhara, G. P.¹, Prasad, S. K.² and Revanasiddappa. K.³

Ratiya dam

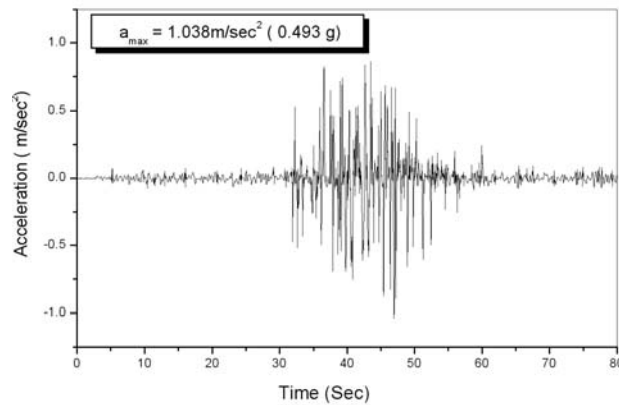
However, the recorded peak acceleration at 250 km from epicenter was 0.106g (A_{max}), which is about 4.66 times the calculated a_{max} . Thus, the peak acceleration near epicenter where many embankments have failed can be approximately obtained by increasing the calculated peak acceleration by the same proportion, which yields 0.493g. The corresponding ground motion is shown in Figure 1.

Figure 1. The North South acceleration component of Ahmedabad data modified using Campbell attenuation relationship and scaled to a peak acceleration of 0.493 g

The material properties used for the finite element analysis are shown in Table 1. The modified North South acceleration component of Ahmedabad data shown in Figure 1 was used as input in the analysis.

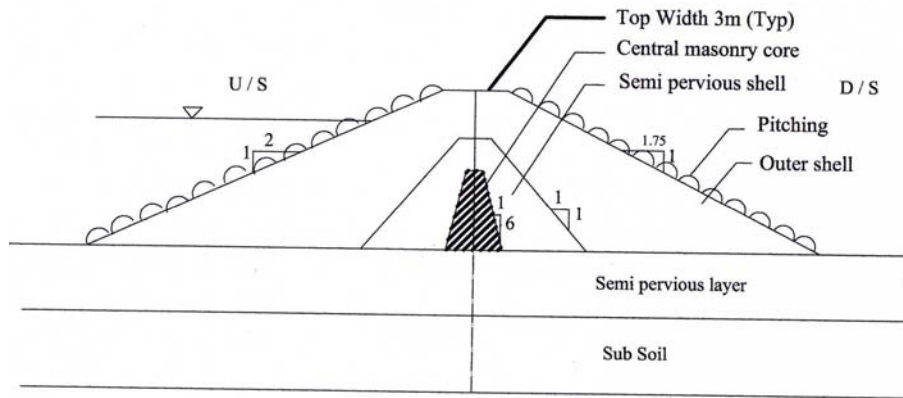
Ratiya dam is located near the village Ratiya about 10 km west of Bhuj. It is an earthdam, 10.6 m in height, 881 m long and constructed in 1948. The typical cross section of the dam is shown in Figure 2. Top width was maintained at 3 m and upstream and downstream slopes provided with pitching were sloped at 1 in 2 and 1 in 1.75 respectively. Inner core consisted of masonry zone, about 0.6 m top width with 6 in 1 slope. It is believed that inner core was surrounded by less pervious soil and the outer shell was made of strong and pervious mass. The catchment area was almost dry and the water in upstream was at dead storage level. Cattle and sheep were drinking water from here at the time the team visited the site. The schematic view of the dam is shown in Figure 3. At the two ends basaltic outcrop was visible and the upstream was very dry in these regions. The embankment was intact and slopes and pitching had maintained their position.

Figure 2. Typical cross section of Ratiya dam

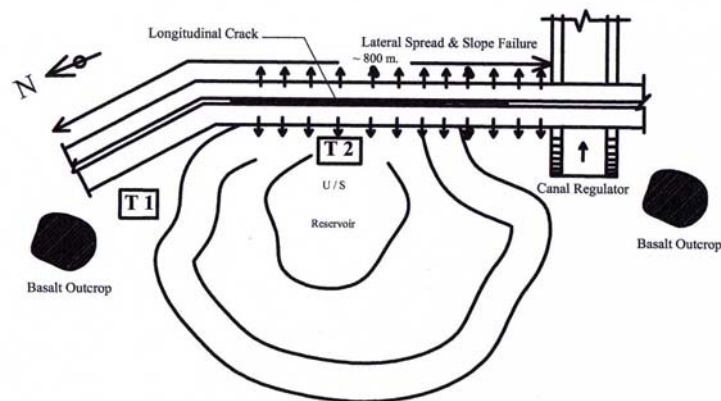
Figure 3. Schematic view of Ratiya dam site

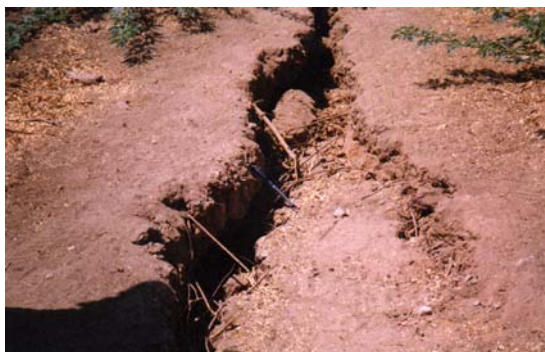
However, in the middle portion, for a distance of about 400 m, longitudinal cracks all along the length were visible. These cracks extended vertically for a depth of about 2 m, almost extending up to the masonry core. The slopes had suffered lateral movement and it appeared that the slip was more pronounced on the upstream. The stones on the pitching were totally disturbed. The embankment showed subsidence of the order of 1 to 2 m. The sluice and canal regulator made out of masonry had suffered serious damage.

Figure 4. Longitudinal Crack along the length of Ratiya dam

Figure 4 shows the longitudinal crack of width of around 150 mm observed at the crest of Ratiya dam. Figure 5 presents the damage suffered on the upstream at the canal regulator. The disturbed pitching stones indicate slope failure and lateral movement. Swedish weight soundings were performed at two locations T1 and T2 both near the upstream toe of the dam. T1 was in the undamaged portion free

It was therefore inferred that subsoil weakening was the major cause of failure of the earthdam. Similar situations were seen in most of the other dams in the region. All these dams were built immediately after the Indian independence in 1947. During that period, even geotechnical engineering was in infant stage in India and there was no design requirement from earthquake point of view. Hence, not much emphasis was given to strengthen the subsoil from earthquake shaking. Most of the dams being situated on weak subsoil need strengthening from earthquake effects. Since it is very difficult to strengthen the entire subsoil, focus can be given to strengthen only a small zone. This will also enable retrofitting the existing structure.

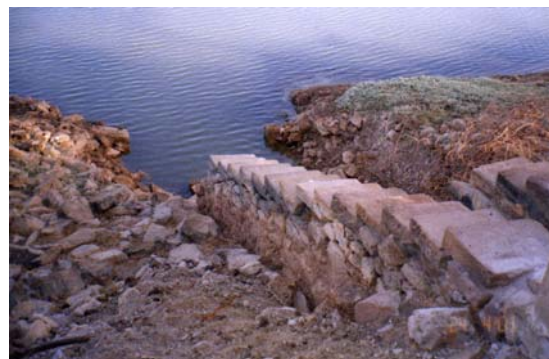
Figure 5. Upstream slope failure at canal regulator of Ratiya dam

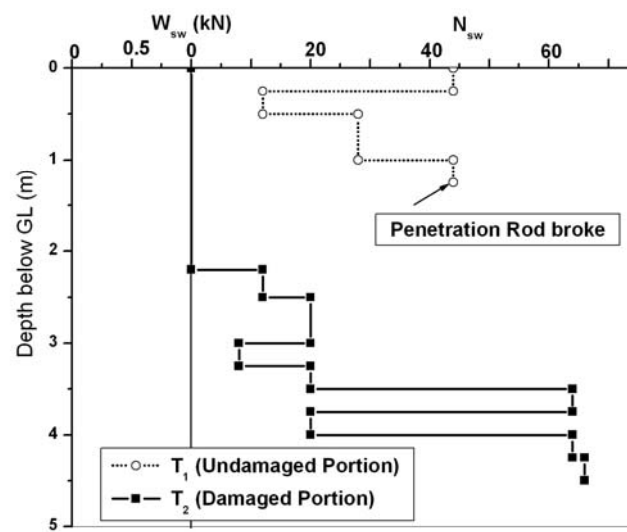
Figure 6 shows the Swedish weight soundings taken at the intact (T1) and damaged (T2) sites near the upstream toe of Ratiya dam. The graph consists of two parts. First part is the plot between relative weight (W_{sw}) along horizontal axis and depth of sounding along the vertical axis. Relative weight ranged from 0 to 1. When the soundings were taken with complete weight of 1 kN attached, relative weight was 1. The second part is the graph between number of half rotations for 1 m penetration of Swedish device (N_{sw}) and depth of penetration. It can be seen that T1 was performed only for a depth of around 1.2 m after which the penetration rod broke. It was difficult to further penetrate suggesting strong resistance. However, T2 penetrated immediately after full weights were placed for a depth of 2.2 m without any rotation being provided. After about 4.4 m of penetration the sounding was stopped as relatively strong frictional soil was encountered.

Figure 6. Swedish weight soundings at Ratiya dam site

The investigation revealed that the subsoil in the damaged regions had been weak during the earthquake. This subsoil was strong enough to support the static forces including the hydrostatic forces on the reservoir side. However, strong shaking during the earthquake was responsible in creating a very large strain level and degradation in both strength and stiffness of the material of the subsoil. As the subsoil below the Ratiya dam was inferred to be clayey in nature, cyclic loading must have created high amplification resulting in increased strain level. Inertial forces and perhaps the increase in the excess pore water pressure must have resulted in higher degradation.

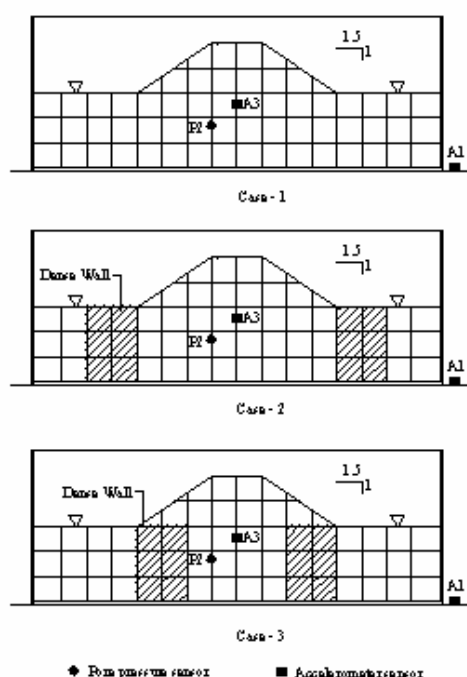
Figure 7. Schematic figures of Model Test setup

In the present work, model tests were carried out using manual shaking table and acrylic container of size 500 mm X 1650 mm in plan and 600 mm in depth. The model test was performed using sub-angular, fine, uniformly graded locally available sand (Chndradhara et al., 2002). The model consisted of 200 mm high embankment having 200 mm top width and 1 in 1.5 side slope and resting on 300 mm

thick subsoil. The subsoil was completely saturated to represent most vulnerable condition. The shaking table was subjected to horizontal unidirectional shaking of acceleration of around 0.5g with a frequency of about 2 Hz. The instrumentation included pore water pressure sensors and accelerometers that were placed in the model ground at salient locations. The colored sand was used to form grids which helped to understand the deformation experienced at different locations in the embankment and subsoil during shaking.

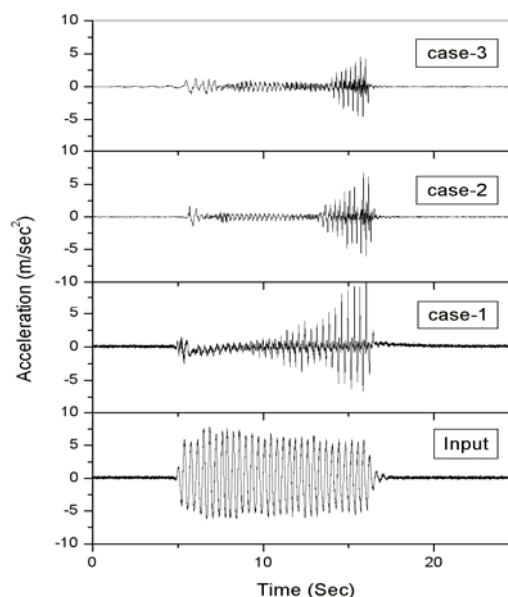
Figure 8. Acceleration time histories of Input (A1) and response (A3) in all the cases

Figure 8 presents the typical input (A1) and responses in three different cases through time histories of acceleration recorded from accelerometer placed 50 mm in to the subsoil (A3). It can be seen that subsoil showed softening behavior as sharp peaks are not visible in the time history. It may be observed that the magnitude of acceleration was extremely small in the initial period compared to the input acceleration in all the three cases. However, after some shaking, the acceleration level gradually increased suggesting the gain in stiffness. This behavior was more pronounced in case-1 compared to those of other two. It can be inferred that the subsoil immediately softened due to shaking and gain in stiffness was due to the settlement and densification. Excess pore water pressure variation with time in the subsoil (P2) is presented in Figure 9. The interesting point is that the level of excess pore water pressure was equal to that of initial effective stress in case-1, while it was only 90% and 80% respectively in case-2 and case-3. It can therefore be inferred that the subsoil experienced complete liquefaction in case-1 and lesser degree of liquefaction in cases 2 and 3. Subsoil had absolutely no bearing capacity in case-1 and relatively higher bearing capacity in the other two cases. This resulted in the embankment experiencing settlement and the material of embankment punching into the subsoil in case-1. In case-2 and case-3, embankment experienced reasonable resistance to this action.

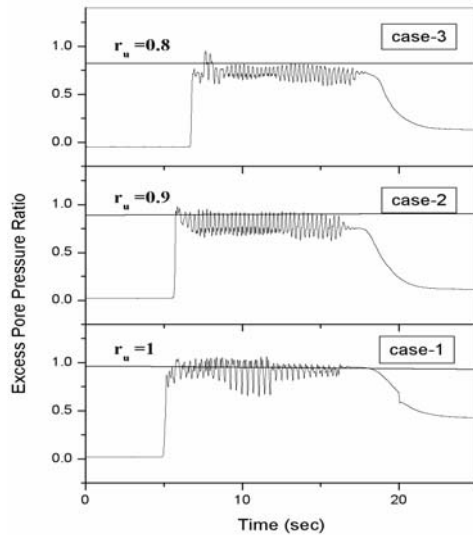
Figure 9. Time histories of Excess pore water pressure (P2) in all the cases

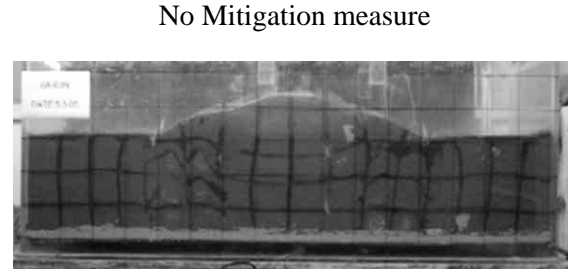
In order to avoid the lateral instability, the dense zone portion was confined by wrapping geo-textile around. The performance of the embankment in the enclosed dense zone was further improved. The deformation pattern of the model embankment with and without mitigation measure is illustrated in Figure 10 at three seconds after the shaking started. It is clear from the figure that the embankment slumped considerably when there was no mitigation measure. When the dense zone was provided, there was sufficient delay in the settlement of embankment.

Figure 10. Deformation pattern of Model Embankment with and without mitigation measures at three second after shaking started.

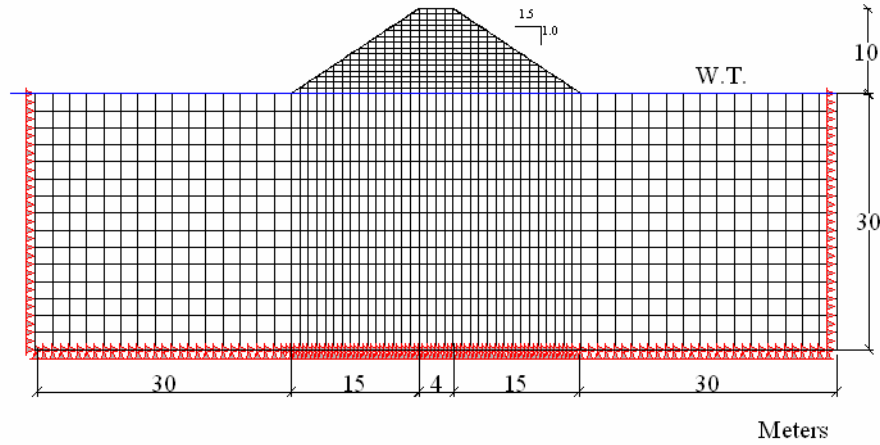
Figure 11. Finite Element Mesh and Dimensions of Embankment and Subsoil

The geometry of a typical embankment and subsoil considered for the finite element analysis and its discretization are shown in Figure 11. In order to represent the infinite boundary conditions, parametric study was made earlier to determine the finite depth and length of free field. The crest width of the embankment model was 4 m and height was 10 m with a side slope of 1 in 1.5. The subsoil was 30 m thick below which the presence of hard rock was idealized and free fields on both sides were maintained at 30 m each so as to depict the behavior of infinite boundary. The dense zone which extends for the full depth of subsoil was 4 m thick ($0.4 H$, where H is the height of embankment) on either side of the embankment. The aspect ratio of elements was maintained between 1 and 2 to achieve the best results. Quadrilateral and triangular elements with secondary nodes were chosen for the best performance. The optimum number of 1260 elements and 3909 nodes were chosen after convergence study.

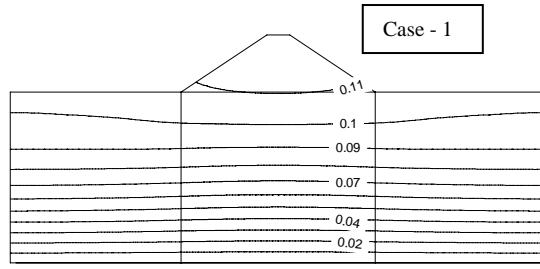
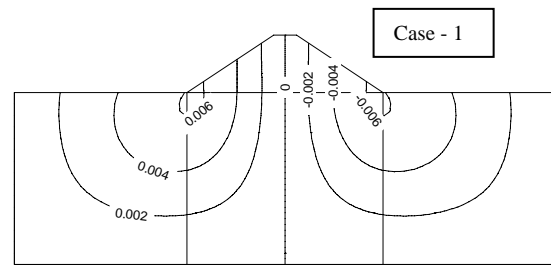
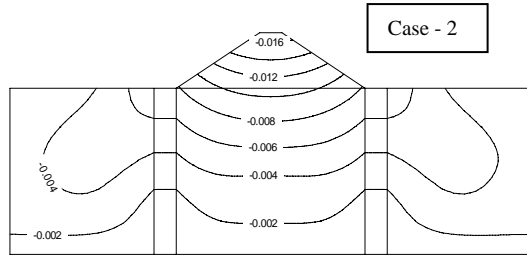
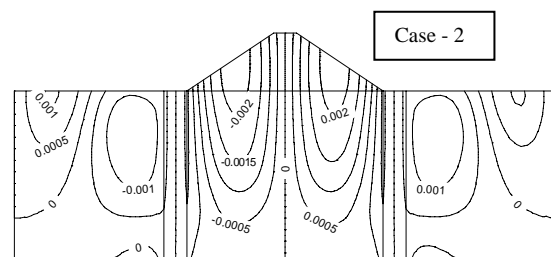
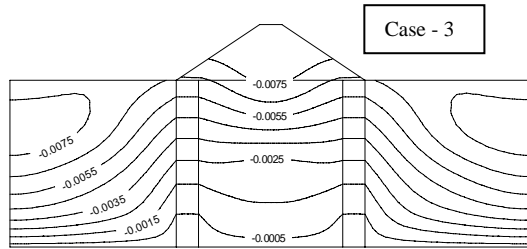
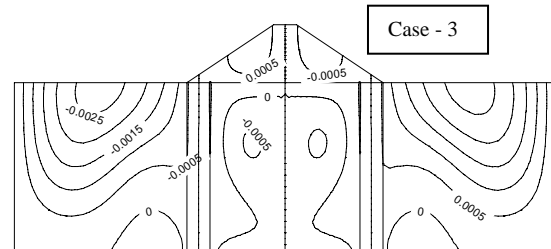
Figure 12. Contours of Horizontal Displacement at 46.96 sec. in all cases

Figure 13. Contours of Vertical Displacement at 46.96 sec. in all cases

Since the peak input acceleration occurred at 46.96 sec., the contours of displacements and stresses have been plotted at this time. Figure 12 and Figure 13 illustrate a set of typical results from finite element analysis to compare the earthquake induced deformations with and without mitigation measures. From the contours of horizontal displacement, it is seen that the displacement in Case-1 at the base of the embankment is 15 times more than that of displacement in Case-2 and 9 times more than that of displacement in Case-3. In the subsoil portion, the horizontal displacement reduced by 10 times, when mitigation measures were provided. Vertical displacement is maximum in Case-1 near the toe, indicating the necessity of the dense wall near the toe of the embankment. Further, in the other cases, the contour values show pockets of zero displacement at a number of regions. This substantiates the necessity of dense wall in the subsoil as a mitigation measure.

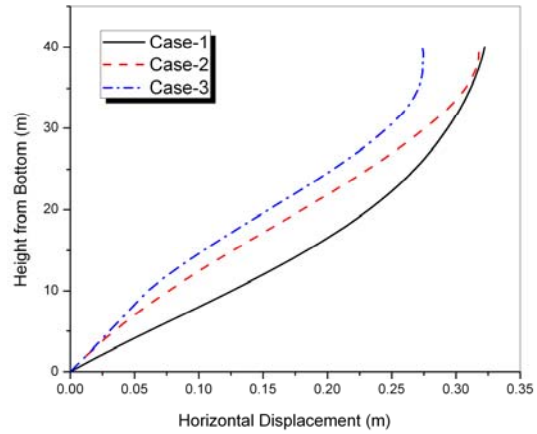
Figure 15. Peak Horizontal displacement along the center line of the Embankment

The variations of peak horizontal displacement along the vertical center line of the embankment and subsoil in all the cases are shown in Figure 15. The peak displacement increases with movement towards the top of the embankment in all the cases. However, when dense wall was placed inside the toe of the embankment (Case-3), the peak displacement was less throughout the height when compared to the peak displacement in other cases. The variation in horizontal displacement from Case-1 to Case-3 is considerable in the subsoil portion compared to that in embankment portion. This indicated that the provision of dense zone in subsoil enormously reduces the horizontal displacement in subsoil which in turn reduces the strain levels. Thus the possibility of settlement of embankment due to increase in horizontal displacement in the subsoil can be controlled by providing dense wall in the subsoil.
