AN INSIGHT INTO THE BAD REPUTATION OF BATTER PILES IN SEISMIC PERFORMANCE OF WHARVES

S. Ali Razavi ¹, Ali Fakher ², S. Rasoul Mirghaderi ³

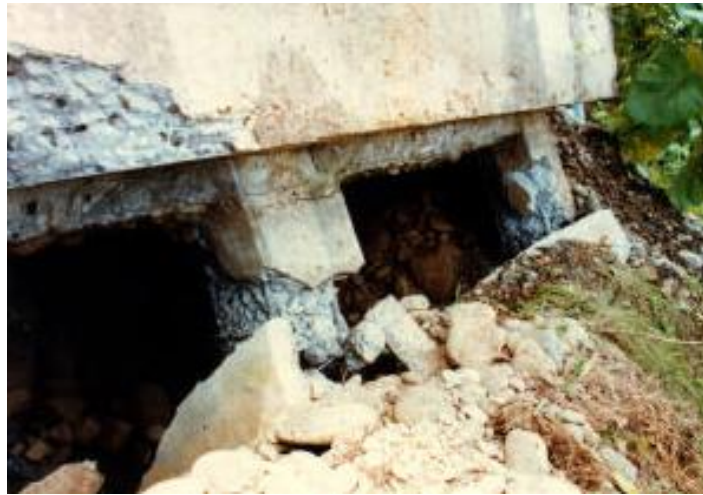
Figure 3. Preferential Damage to Front Batter Piles of Rio Banano Bridge during the 1991 Costa Rican Earthquake (after Priestly et al., 1991)

36 cm square precast concrete piles 66 cm toward the river (Figure 3). The front battered piles suffered flexural and shear damage, but the vertical piles at the rear showed less damage (Figure 4).

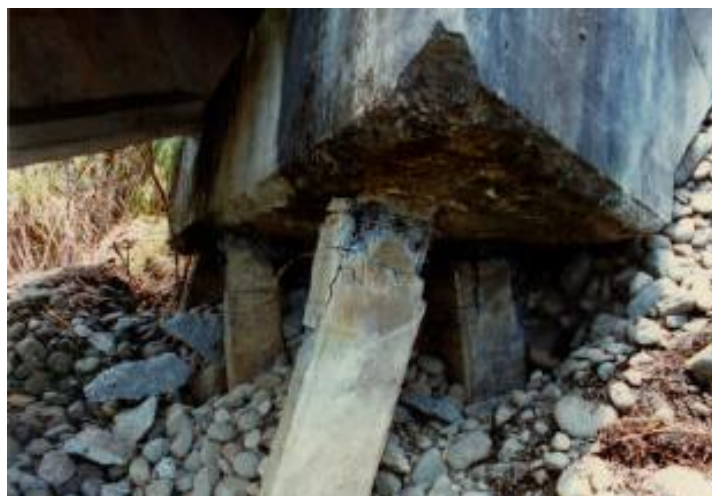
Figure 4. Failure of Rio Viscaya Bridge Piles during the Costa Rican Earthquake (after Priestly et al., 1991)
