## **MODEL TESTS TO DEMONSTRATE THE EFFECTIVENESS OF A NAILING METHOD ON THE STABILITY OF NATURAL SLOPES DURING EARTHQUAKES**

### **ABSTRACT**

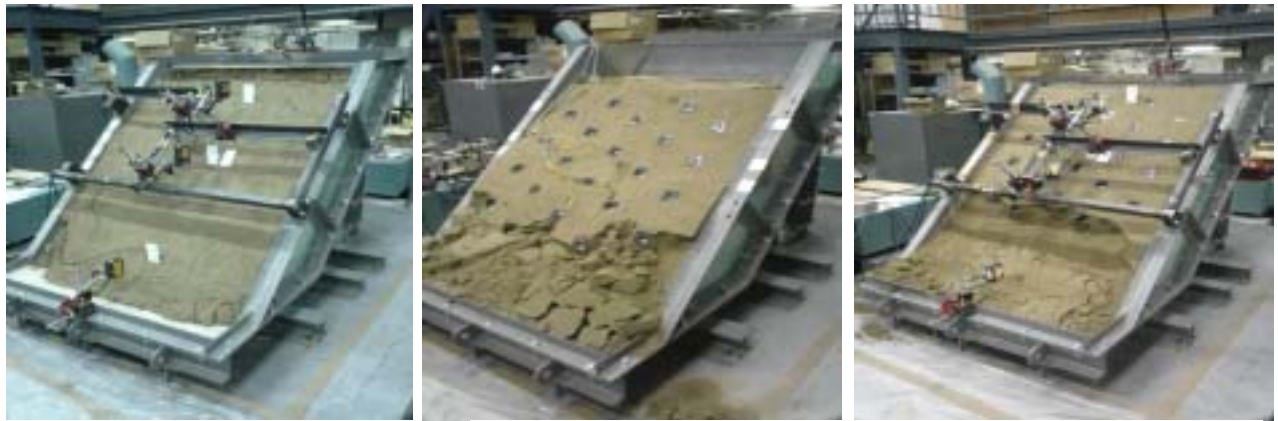
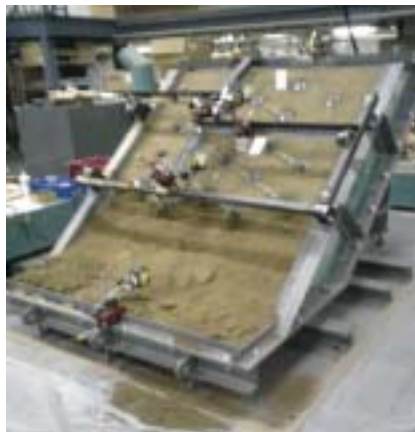
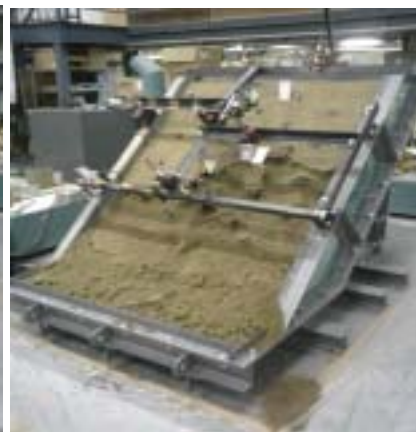
Photo2. Behavior stopes at critical acceleration

In Case No.1, not treated, settlement of top of the slope increased with input acceleration. Then entire slope failure occurred when input acceleration reached to 295 Gals, as show in Photo 2(a). After the test, the ground was excavated carefully. And a clear slip surface was observed at the depth of about 10cm.

In Case No. 0, treated with non-anchored nails, settlement of top of slope increased with input acceleration also. When the input acceleration reached to 650 Gals, non-treated zone failed as shown in Photo 2(b). As the critical acceleration was higher than that in Case 0, it can be said that the inserted iron rods resisted against sliding, even the iron rods were not anchored to bottom steel plate.

In Cases 2 and 3, treated with anchored iron rods, no obvious settlement or deformation occurred in treated zone even input acceleration exceeded 900 Gals. Partial sliding occurred in non-treated zone when input acceleration exceeded 900 Gals, as shown in Photos 2(c) and 2(d). Anchored iron rods were very effective to resist against sliding. By comparing Case 2 and Case 3, deformation of the slid soil in Case 3 was smaller than that in Case 2. Therefore, it seemed that wire ropes could decrease the deformation of slope.

In Case 4, slide occurred at 770 Gals as shown in Photo 2(e). The critical acceleration to cause failure was smaller than that in Case 2. Size of plates must be important.
