NON-SEISMIC SURFACE FAULTING: THE PERAIA FAULT CASE STUDY (THESSALONIKI, N. GREECE)

ABSTRACT

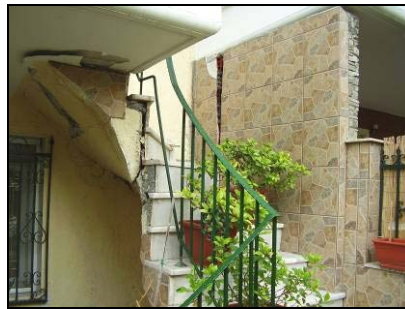
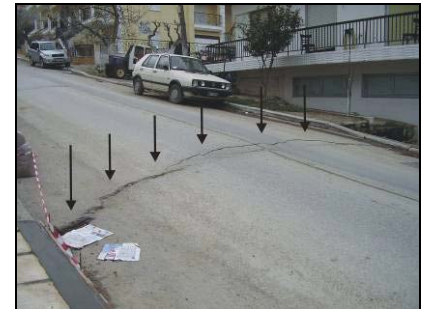
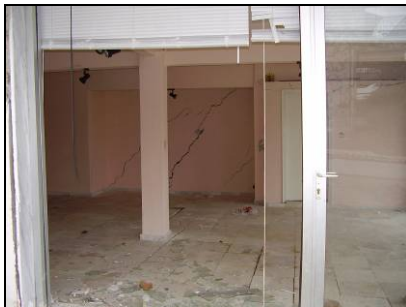
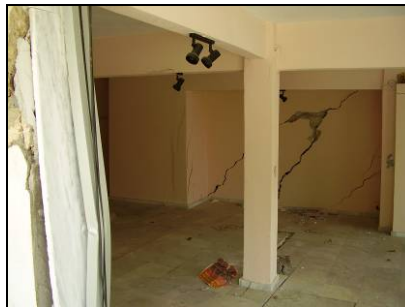
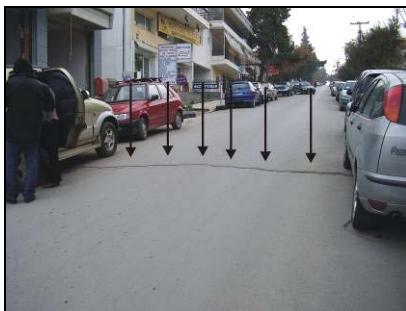
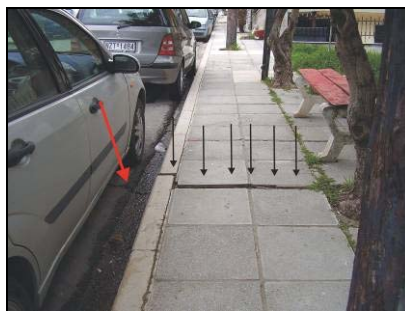
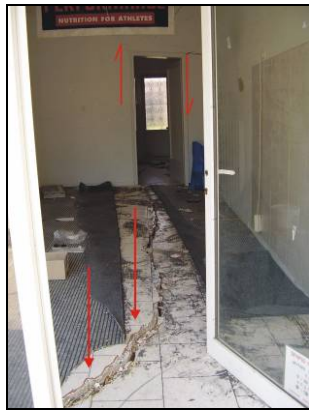
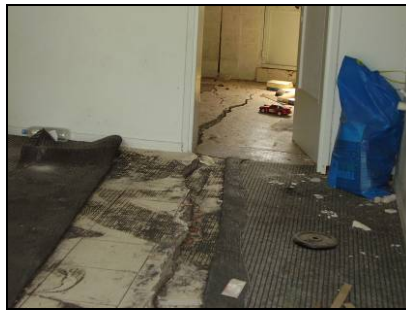
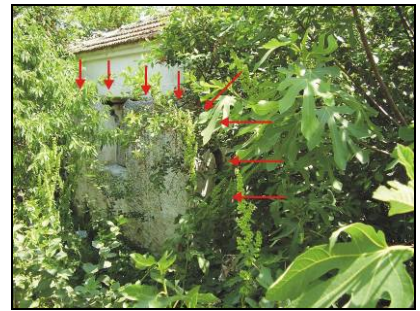
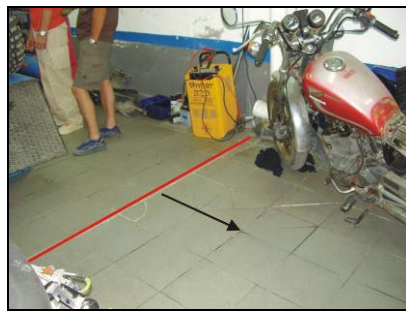
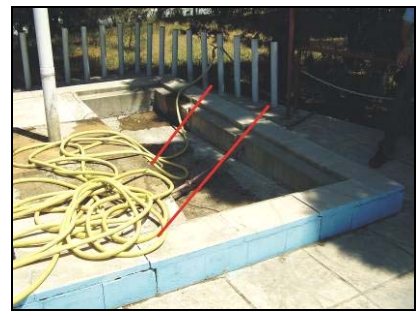
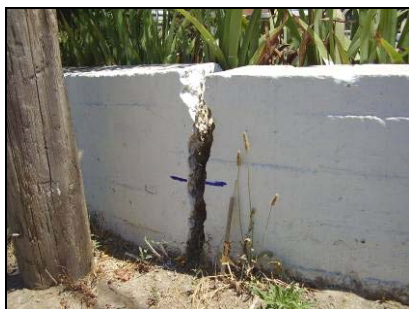
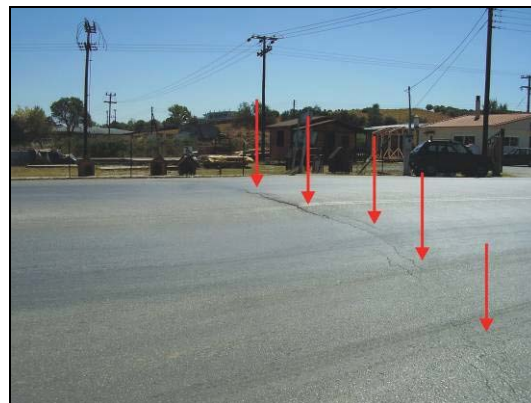
Figure 1. Photos showing various cases of surface rupturing in Peraia.

According to descriptions of the locals, the surface ruptures were initially observed as small fissures during June 2005 at Agnostou Stratioti Street (Upper Peraia). Rupturing continued by lateral extension of the fracture line and in November 2005 it affected a three-storey building at Agnostou Stratioti Street, which was damaged so severely that it was declared unsuitable for living. Until March 2006 two more two-storey buildings at Kyprou and Mideias streets were declared fit for demolition. Later on, serious damages have been observed in two more buildings in Upper Peraia and on street pavements (figure 1). The ruptures affecting the roads and the buildings are shown in photographs. The phenomenon is still evolving and new observations (January 2007) show that while the main rupture seems to have passed its peak phase, new fractures and building damages have been formed north of the main fault line.

The surface ruptures extend at a length of *ca.* one kilometre in Peraia urban area close to the Thessaloniki – N. Michaniona road. They are traceable from Pissalides Clinic to the east, up to Kyprou Street at a WSW-ENE direction, whereas from Kyprou up to Mideias street (Lower Peraia) its direction changes to WNW-ESE (Fig. 1). The maximum vertical displacement of the ruptures has been measured at the Agnostou Stratioti and Megalou Alexandrou streets. Surface ruptures have also been
