## **REINFORCEMENT AND PROTECTION OF A ROCK-CLIFF: METHODOLOGICAL APPROACH, ANALYSIS AND DESIGN**

This paper outlines the basic principles for the analysis and design of protection measures of a rock cliff against rock toppling and rock falls. The investigated case study is a rock cliff, characterized as natural monument, at the entrance of a village at Cyprus. Due to a considerable number of project restrictions, it was decided that the measures should be of passive character. The proposed measures include installation of a rock barrier of well-defined geometry, position and energy capacity, local strengthening of the existing fence, excavation of a shallow-depth, energy-absorbing ditch and localized installation of a protective rock retaining wire mesh. However, in cases where the demand or the financial surcharge of these measures is unjustifiable, active measures are proposed. All possibilities of rock instabilities are thoroughly checked (plane / wedge sliding and rock toppling) under static, extreme hydraulic and seismic conditions. Results from numerical analysis, carried out at a critical cross section, corroborate results from ultimate limit state analyses, under static a

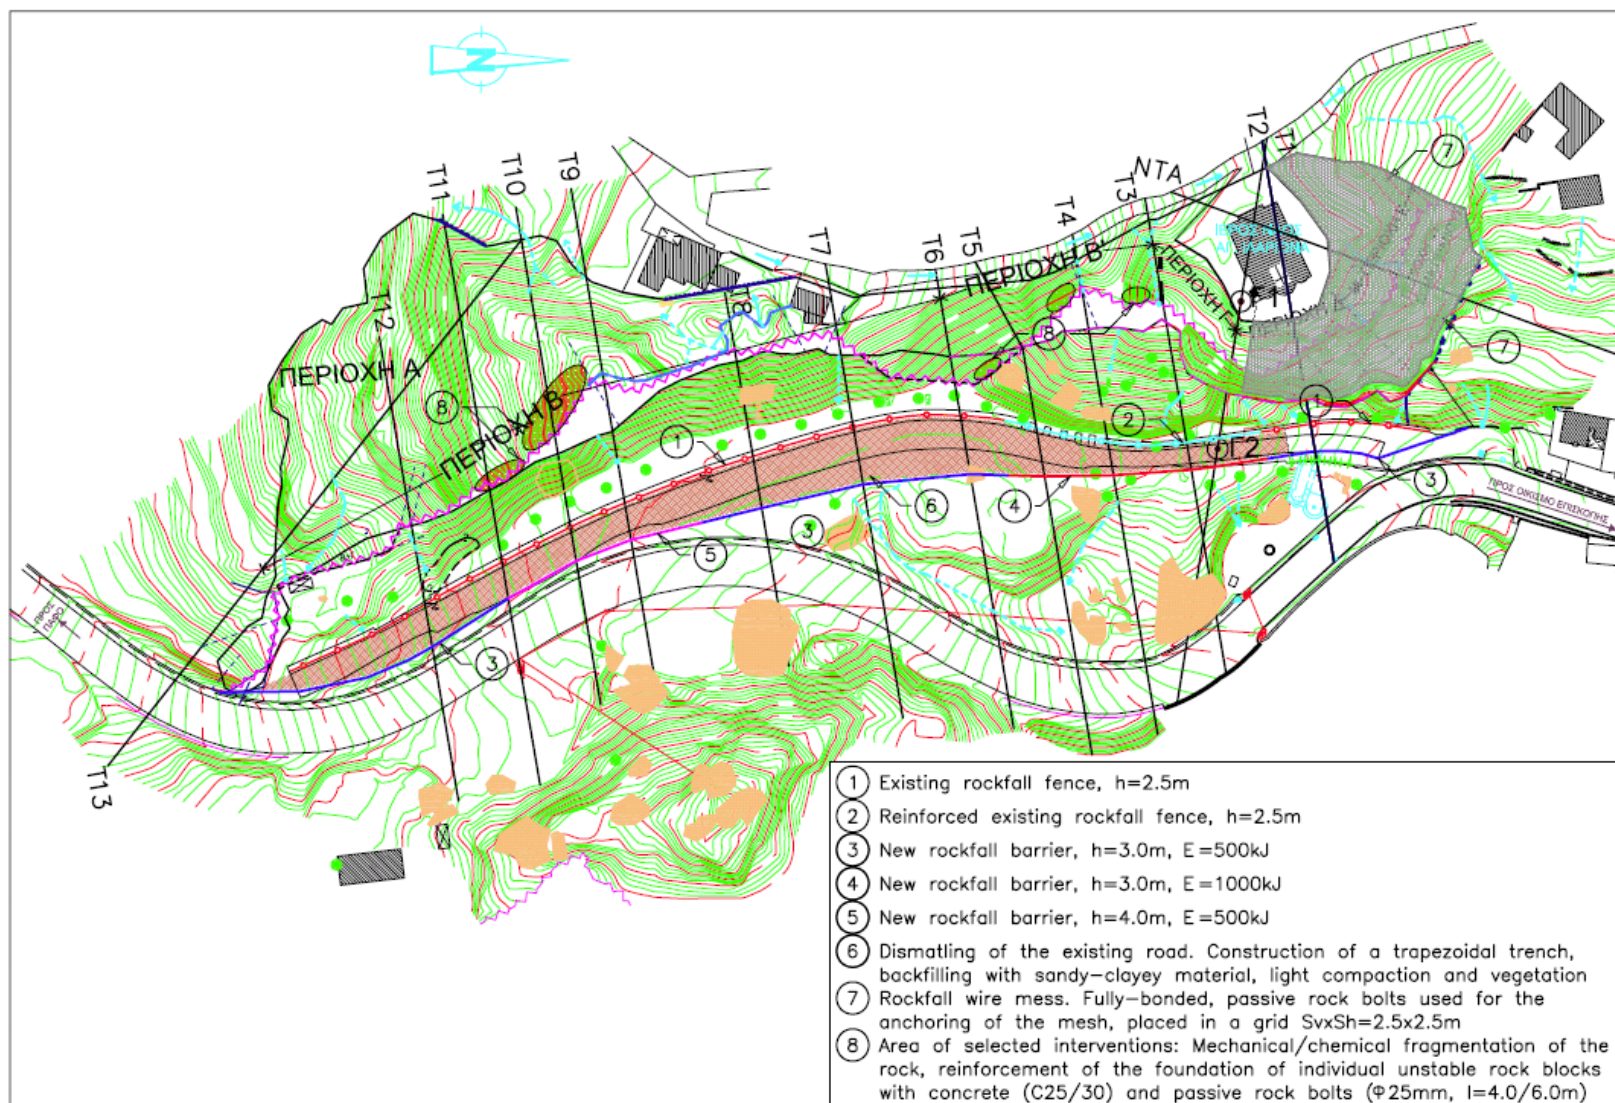
Location of the new rock barrier system is depicted in figure 1. The new rock barrier forms an angle of  $10^\circ$  with the vertical towards downstream. Details of the proposed rock barrier with technical specifications are presented in figure 3.

Based on a considerable number of rock toppling analyses, which were carried out, on the cross sections, three different categories of a new rock barrier have been considered satisfying energy and geometrical criteria. The following categories were positioned for different lengths downstream the existing fence (figure 1) on a south to north direction:

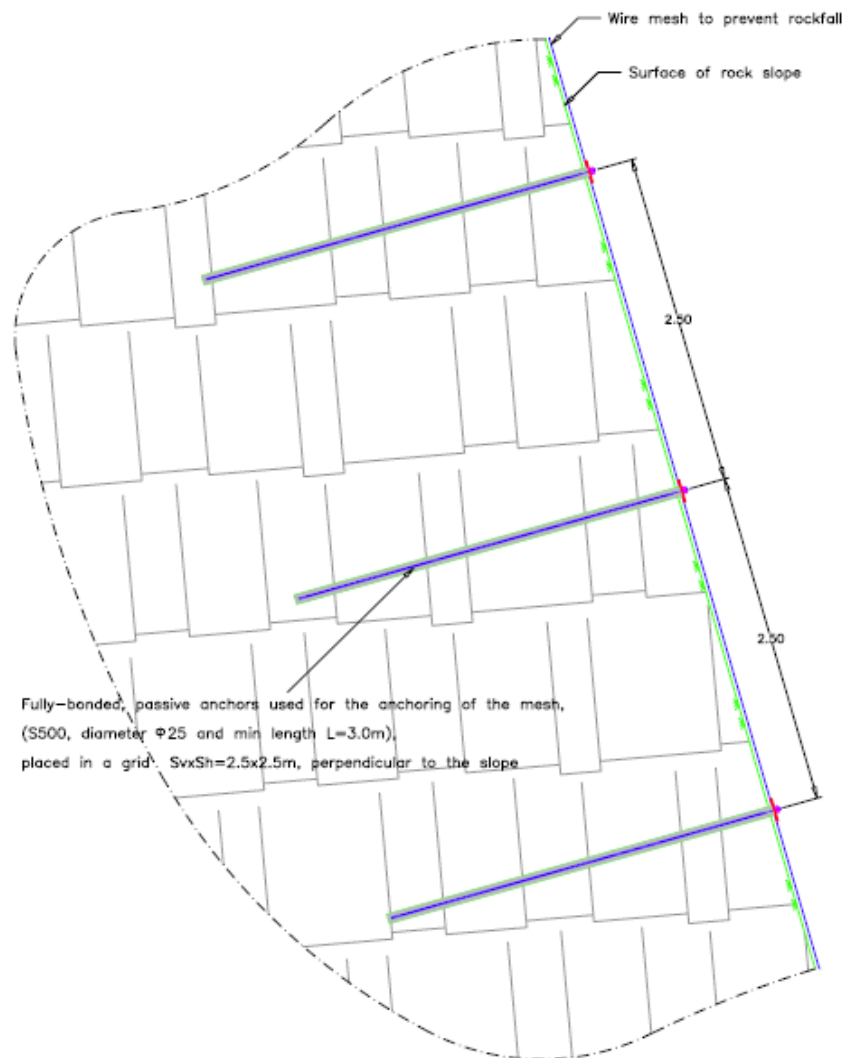
**Figure 5 Cross section of rockmass protected by wire mesh kept in place by a grid 2.5x2.5m of 3m length rock bolts, fully bonded into the rockmass**

Taking into consideration the above, as well as the imposed project restrictions, installation of a retaining wire mesh, was considered as best solution. Rock bolts spaced on a grid of 2.5x2.5m and a minimum length of 3m ensures retention of the mesh. Rock bolts are passive anchors, fully bonded in the rockmass, consisting of high strength, steel S<sub>500</sub> and a diameter of 25mm. All metallic elements of the retaining system are heavily galvanized and protected by a mixture of Zn and Al. A typical cross section of the retained area after installation of the wire mesh is depicted in figure 5.
