## REMOTE MONITORING SYSTEM OF THE BEHAVIOR OF THE NEW KORINTHOS ISTHMUS RAILWAY BRIDGE

### ABSTRACT

Keywords: New Railway Bridge of Korinthos Isthmus, Monitoring, ERGOSE S.A.

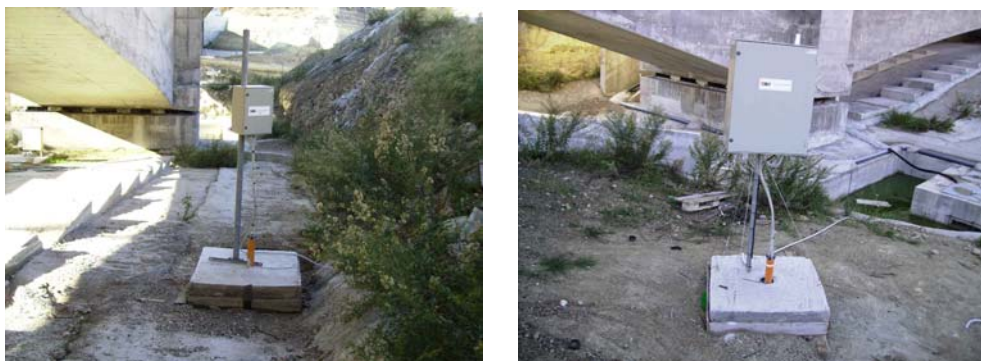
**Figure 6. Inclinometers with Data Loggers**

**Permanent Inclinometers (In-place inclinometers).** These are electronic devices permanently installed at pre-determined distance in vertical boreholes using properly oriented inclinometer casing. Three such permanent inclinometer strings were installed; one each near the edge of the Channel slope (one on the Sterea Hellada side and the other on the Peloponnesus side) so that a possible failure of the Channel slopes can be monitored over deep boreholes (35m); the third string was placed over the local geological fault P4 (a fault that crosses the structure transversely) so that a possible fault failure can be recorded as well as possible micro-movements possibly caused by secondary seismic excitation. These permanent inclinometer strings can record biaxial movements (X-Y) and store the measurements in the memory of an automating Data Logging unit installed on a mast above the borehole. The data is transmitted by a wireless modem at pre-determined intervals to the central Computer installed in the Terminal Monitoring Station that is located near the Sterea Hellada abutment .(Figures 6-7).

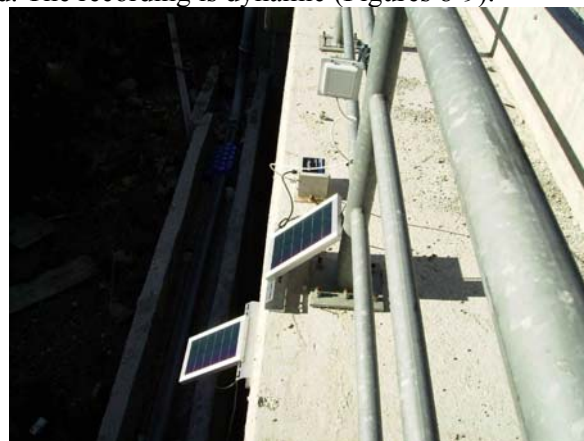
**Figure 8. Accelerometer on deck with sun cells**

**Triaxial Accelerometers.** Triaxial accelerometers have been installed monitoring seismic acceleration in three axes (X-Y-Z) so that the result of the seismic isolation of the bridge in relation to the bridge parts founded in the ground can be monitored. These sensors have a range of  $\pm 2g$  and have been programmed to trigger after a pre-set acceleration level (which will be modified by continuous evaluation of the system response) so that ambient noise-caused triggers can be avoided. Nine (9) such accelerometers have been installed for comparison purposes; one above the foundation of each pier/abutment and before the seismic isolation (4 pieces); one exactly above the previous, positioned on the bridge deck (4 pieces) and the last on the middle of bridge mid span, on the deck. Each accelerometer is combined with a local data logging unit and a wireless transceiver module. These units are powered by an internal battery recharged by a solar panel. The accelerometer possible movements are continuously transmitted to Central Base Station and through an array of aerials data is sent to the PC. The data is continuously evaluated by the software and, depending on the settings, an event is stored, if triggered. The recording is dynamic (Figures 8-9).

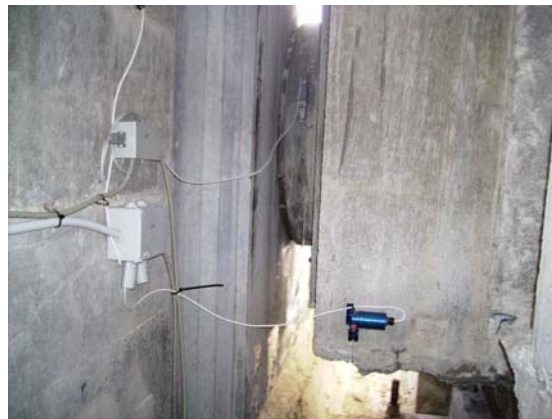
**Figure 10. Displacement (transverse) and side load cell**

**Displacement Transducers.** The relative movement of the isolated bridge structure against that of the piers/abutments is recorded in three axes (longitudinal, transverse and vertical). One instrument (wire transducer) has been used for each direction. Two triaxial devices have been installed, one on each abutment in Sterea Hellada and Peloponnesus and two uniaxial (transverse) units, one at each pier. These transducers are considered to be very reliable as they are also used for controlling the position of the flaps on airplanes and they can operate in accelerations exceeding 2g. (Figures 10-11)

**Side loading monitoring (Load Cells).** These were installed in the side perpendicular devices partially obstructing movements, at the location of A1 abutment, on Sterea Hellada, during the construction of the bridge in 2004 with a view to determine, through changes in exerted pressures, any side movement of the bridge girder caused by failure of the active fault P4 running almost laterally to the overall construction. Such failure could cause the bridge to move sideways and exert pressure on the sides. These load cells have been connected to the central Data Logging network of the bridge (Figure 11).

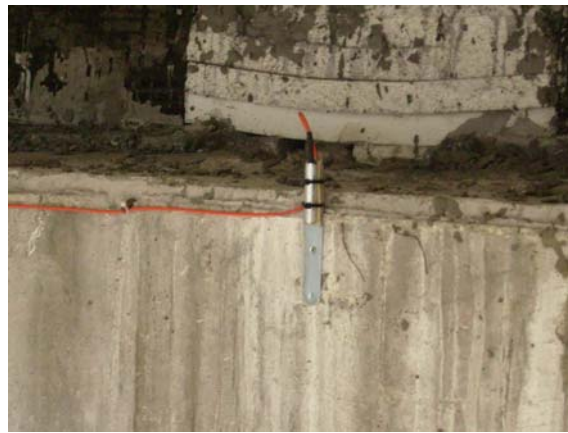
**Figure 12. Temperature sensor**

**Environmental thermometer.** A sensitive environmental thermometer is installed under the bridge on the Sterea Hellada side to monitor changes in the air temperature (Figure 12).

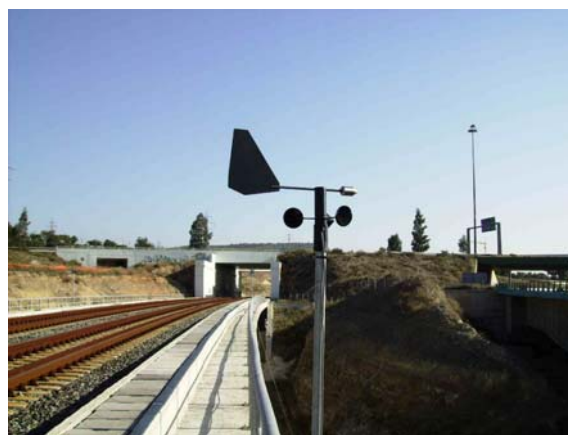
**Figure 13. Wind measurements, speed-direction**

**Wind Speed and Direction monitoring.** In the middle of the bridge span, a station for monitoring wind speed and wind direction has been installed on the bridge side rails. (Figure 13)

Both parameters are recorded in the PC running in the Terminal Monitoring Station at the same intervals as the other sensors.

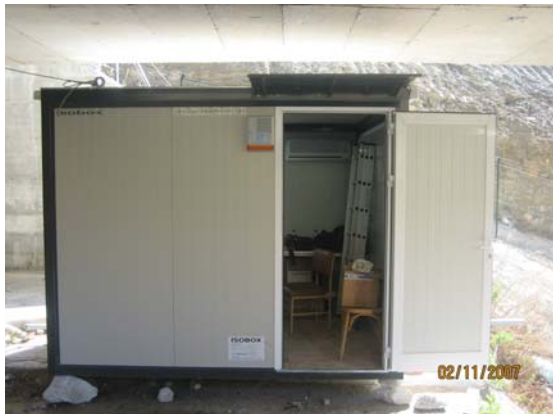
**Figure 14. Terminal monitoring station under bridge**

**Terminal Monitoring Station.** The station is installed in a pre-fabricated office box 3.5X3.0m placed under the bridge for better protection, near the Sterea Hellada abutment. It has been mains powered and has a telephone line available that allows remote communication via modem. A PC is continuously running in the Station and collects, through suitable antennas, the data from all the data

loggers as well as from all wireless accelerometers on the bridge. Data is evaluated, processed and stored, depending on the settings set by the operator, by three software packages running simultaneously (Figures 14-15).

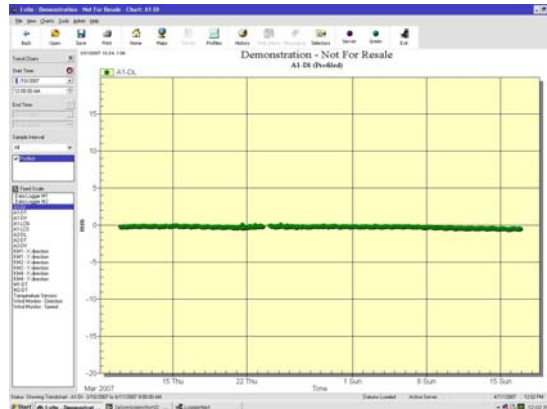
**Figure 19. Displacement of abutment A1(L)**

have some readings from the displacement transducers that indicate an “expanding” movement of the deck towards the Sterea Hellada abutment and to North East (n.b. the bridge is on a curved alignment) by 1-2mm and a lift of 2-3mm while, at the same time, the same movement is recorded as “moving away” from the Peloponnesus abutment. Another characteristic is, for example, that an event is recorded that exceeds the trigger level initially set for the accelerometers of Sterea Hellada and it is showing the moment the train is entering the bridge. In these cases, the triggering levels will be adjusted to a higher level.

These graphs provide some initial first evaluations of the “innocent” behavior of the bridge showing the changes induced by the climatic temperature changes during the first ten days of April as well as of the momentary triggers taking place during the passage of a Suburban train, or changes on the wind etc. It is characteristic, for example, that with the increase of ambient temperature after April 5 we
