# 2

## Cases of Machinery Failure

### 2.1 The Cases

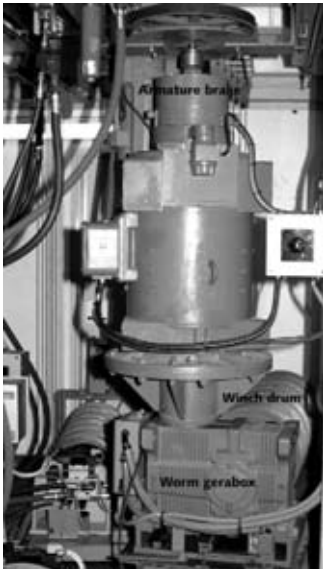
Figure 2.3 A winch motor and gearing system. The motor drive is attached to a worm gearbox

My personal involvement in this case commenced after the GMT evaluation as well as after the issue of the various writs against the thirteen defendants. Figure 2.3 shows a winch motor attached to a worm gearbox, from which the winch drums are driven. The smaller diameter component attached to the motor is a separate armature brake. This device is intended to stop the motor from over-revving or freewheeling in case of a power failure. Figure 2.4 is a view of the winch floor and Figure 2.5 is a typical winch motor shaft with the worm screw attached to it. At the time of my involvement in this matter, virtually no expense had been spared to investigate the mechanical issues identified by Goalie Ltd. My brief was to evaluate the whole system of winches and winching systems in addition to that found by Goalie Ltd. I suspected that my involvement was supposed to heavily reinforce the Art Centre insurer's case against the thirteen defendants and specifically against Ruckman, the American suppliers of the winching motors and gearboxes.

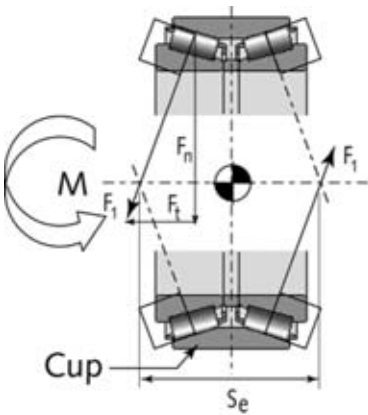
Figure 2.11 Schematic view of the main bearing indicating terminology

Figure 2.11 is a schematic view of the TBM main bearing, a double row taper roller bearing manufactured by the Torrington Corporation, estimated to cost \$20,000 in 1975, at the time of the accident.

In single row taper roller bearing terminology the outer race of the bearing is known as the *cup* and the inner race including the roller assembly as the *cone*. These terms are assigned to the bearing due to their overall physical shapes. In the *MRTA* failure it was the front section of the outer race (part of the cup) of the main bearing that broke away to permit the cutting head to fall out of its support. Figure 2.11 also indicates the types of loads acting on the bearing. Quite apart from the direct thrust load imposed on the bearing, resulting in the direct forces  $F_1$  being carried on the outer race (cup), the moment  $M$  on the machine head induces extra varying loads on these bearing cups. The weight of the machine head, outside the central plane of the bearing results in an added moment being carried by forces on the bearing cup.

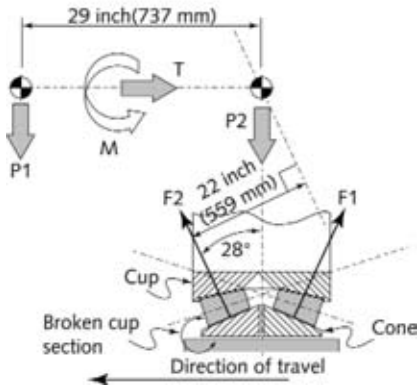
Figure 2.14 Detailed load model of TBM bearing used in analysis of retaining ring deflection

Figure 2.14 is a schematic representation of the various loads acting on the bearing and in turn on the retainer ring designed to maintain the bearing in its mounting within the deflection limits specified by the manufacturers. Torrington's specification for this bearing was a maximum tilt of the central plane of the bearing of 0.5 minutes of arc. Consequently it was necessary to investigate the mounting geometry and its flexibility.

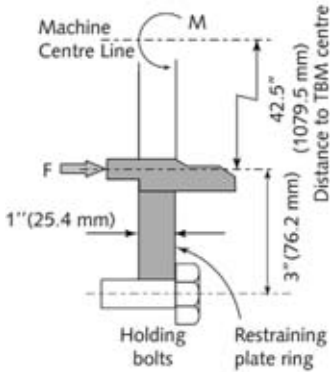
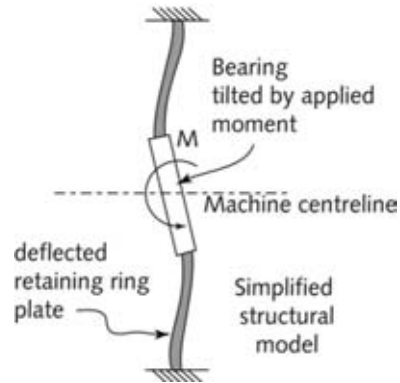
Figure 2.16 Bearing retainer ring dimensions used in analysis of deflection

Figure 2.17 Simplified model of the retainer ring deflection

Figure 2.16 shows a partially dimensioned section through the retainer ring and Figure 2.17 is a simplified structural model adopted for the evaluation of flexure of the retainer ring. It was modelled as a simple constant-thickness annular circular plate with a built-in outer edge (the holding bolt pitch circle), with a moment applied at the annulus.<sup>2.9</sup>

Figure 2.18 shows (approximately to the same scale as the original retainer shown in Figure 2.15) the sectional drawing with the modified bearing retainer. Clearly, the new retainer ring has been substantially increased in thickness, as a result of this investigation. Fortunately, there was sufficient space available in the original design to permit the replacement of the original retainer with this substantially thicker retainer ring.

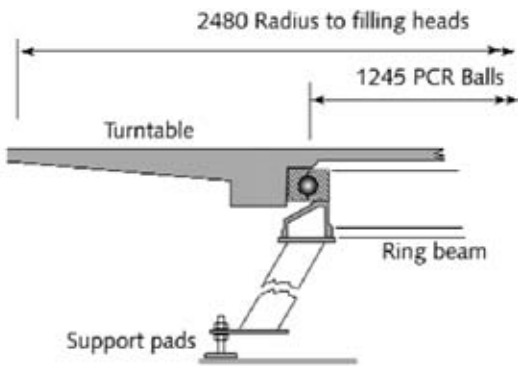
Figure 2.23 Schematic section of filler showing bearing mounting arrangement (not to scale)

GBF corporation. Figure 2.19 shows a typical stubby bottle, Figure 2.20 is a general view of the bottle filler at Tattaly, Figure 2.21 is a close-up view of filling stations and Figure 2.22 is a sample photo of the typical damage observed on the bearing races. Figure 2.23 is a schematic section through the filling machine showing the location of the failed bearing, nominally a KD600 *slewing -ring* bearing, with full details of its life and loading curves available from the *Rothe Erde Large-Diameter Antifriction Bearing Catalogue*. Figure 2.24 is a close-up photo of one of the legs and levelling pads on which the filling machine is supported. Figure 2.25 is a photo showing the underneath of the machine turntable and Figure 2.26 shows a photo of the balls and spacers of the bearing. These balls are made of hardened steel and in their travel inside the bearing they exert substantial local loading on the bearing surface. If the bearing race has any surface imperfections or some foreign particle imposed on it from lubricating grease contamination, the passage of these hardened balls over these imperfections or foreign matter will generate an exaggerated jarring loading on the bearing surface. On first inspection the surface damage to the bearing shown in Figure 2.22 was suggestive of this type of initiating process.

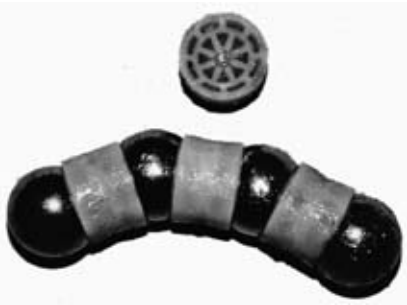
Figure 2.26 Ball and spacer arrangement

Figure 2.26 is a photograph of the 35 mm diameter balls and the plastic spacers used in the machine bearing. The bearing outer ring has a slot that permits the entry of balls into the bearing during assembly. Lubricant grease is pumped into the bearing at regular time intervals and there is a location on the bearing where the “new” lubricant extrudes “older” used lubricant from the bearing. Samples are taken from the extruded lubricant daily and analysed for metal content. When the content of metal shards in the grease exceeds some level specified by the manufacturer, the bearing is deemed to be near incipient failure. A few months after the failed original bearing was replaced by GBF engineers, the lubricating grease monitoring process showed up with unacceptably high metal particle content. It was this event that initiated the investigation described here.

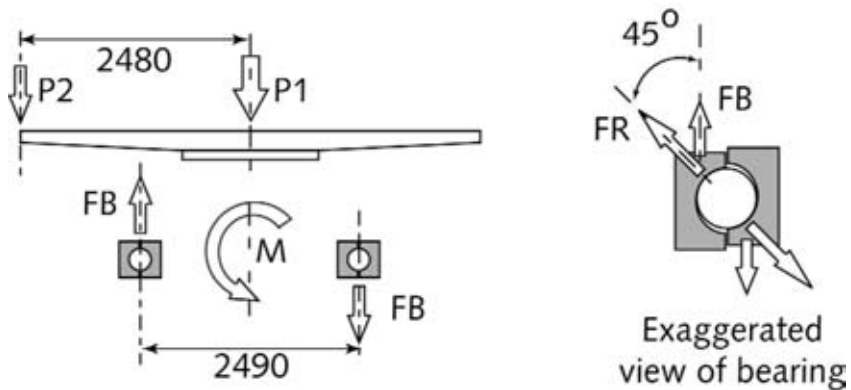
Figure 2.27 Loading on bearing

Although the bearing loads were not expected to be incorrectly assigned by the manufacturer, it was necessary to check both the load and the deflection on the companion structure to eliminate this mode of failure. As well as the static load on the bearing there was a small but significant out-of-balance load on the bearing due to the effect of the filling station loads over approximately 100° of arc on the machine circumference. This arc corresponded to 50 filling stations out of a total of 168, where the stubby bottles were pulled down from the filling heads by pull-down cams. Figure 2.27 shows the bearing loading schematically.

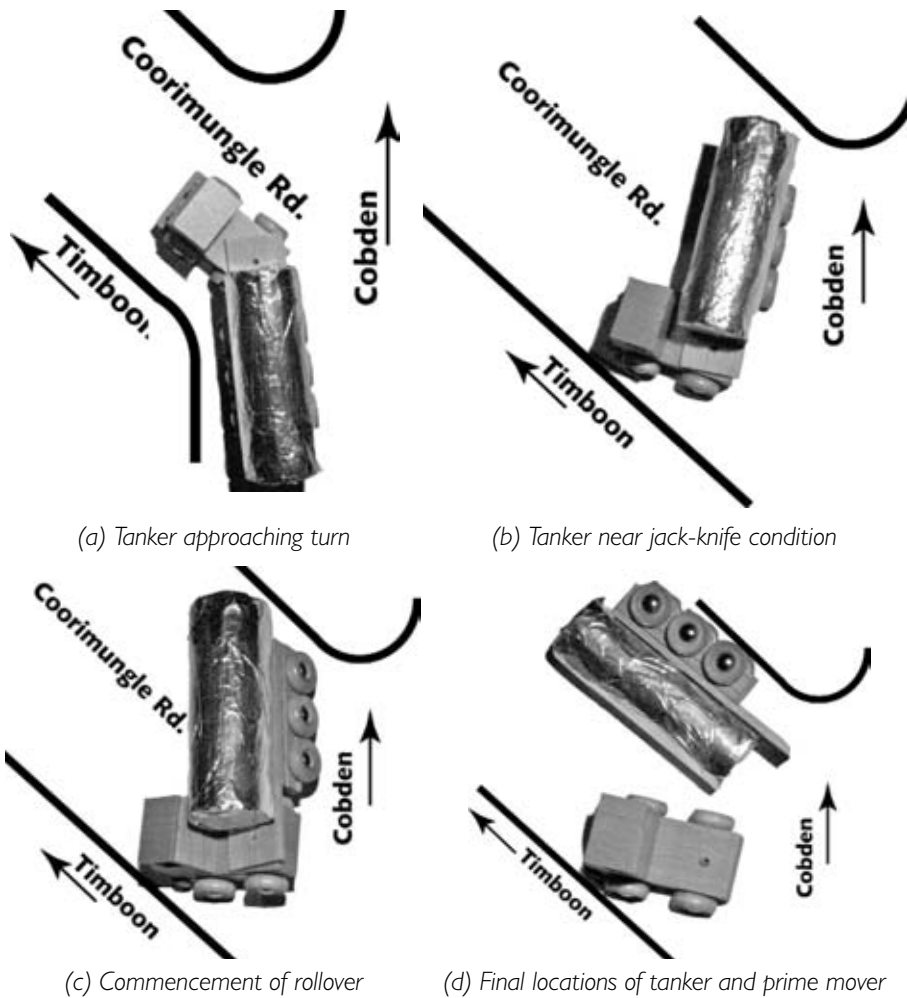
Figure 2.35 Model demonstration of the tanker rollover process (not to scale)

- (b) Tanker trailer begins to slide on wet road;
- (c) Inexperienced driver applies brakes;
- (d) Tanker trailer rolls and tears out kingpin bolt from the bottom plate of the hitch. Trailer and prime mover settle in locations indicated in the photo of Figure 2.35 (d). This was confirmed by the police report of the accident scene.

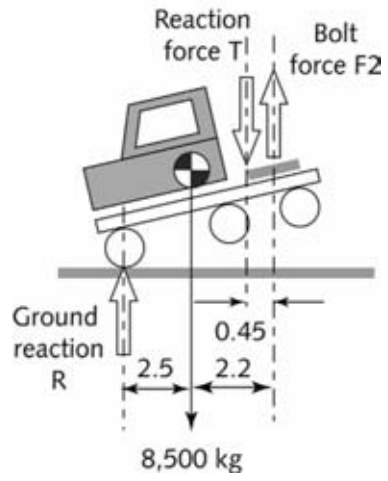
Figure 2.37 Phase 2 of the roll

In Phase 2 of the rollover the moment acting on the top plate due to the rolling over of the trailer is  $F2 \times 0.45 \text{ Nm}$ .  $F2$  could have been estimated from the conjectured centrifugal forces acting on the rolling trailer at various road speeds and turn diameters. However, a simpler approach was to recognise that the bolt had indeed been torn out from its location and the twisting moment responsible for this was as indicated in Figure 2.37.

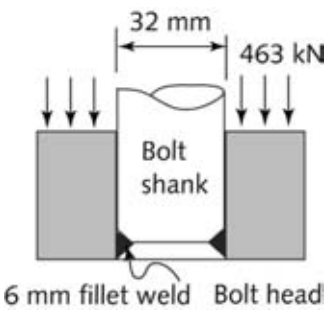
Figure 2.38 Schematic view of bolt head under load

Figure 2.38 is a schematic view of the bolt head under load during Phase 2 of the roll. The stress developed in the weld is given by<sup>2.17</sup>

$$\sigma_{\text{Max}} = F_{\text{Max}} / (\pi \times D^2 / 4) = 463 \times 10^3 / (\pi \times 0.036^2 / 4) = 455 \text{ MPa}$$

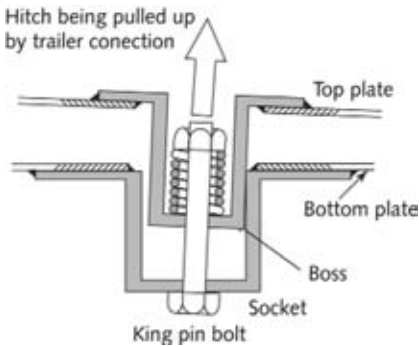
Figure 2.39 Greasy-plate hitch at its extreme displacement

This calculation does not take into account the failure of the bolt at its thread, where the root diameter is smaller than the shank diameter, and stress concentrations are introduced by the thread elements. The significance of the calculated stress on the bolt is that it would have failed in any circumstances whether it had been a standard bolt or a modified manufactured bolt. This bolt is not expected to carry substantial loading at any time other than when the hitch spring (refer to Figure 2.39) is fully compressed. In this condition the load is taken by the kingpin bolt

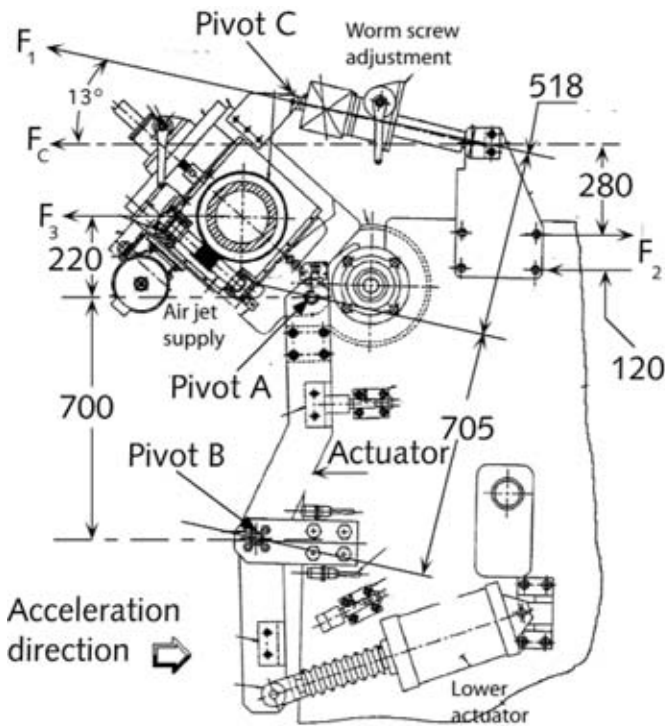
Figure 2.46 Side view of the airknife coater indicating some of the major features of adjustment to the machine

**(a) The Accident Scenario** – Figure 2.46 shows a side elevation of the airknife machine taken from a copy of drawings supplied by the Holker Corporation. The measurements were scaled from the drawing, using comparative dimensions measured on the actual Holker machine on site. Figure 2.47 is a simplified mechanism view of the moving parts of the airknife machine. The lower actuator is a pneumatic cylinder and in principle the air in this cylinder will act as a pneumatic spring until the lever arm pivoted at B hits a machine stop (see Figure 2.47). The following nomenclature is assigned to the analysis:

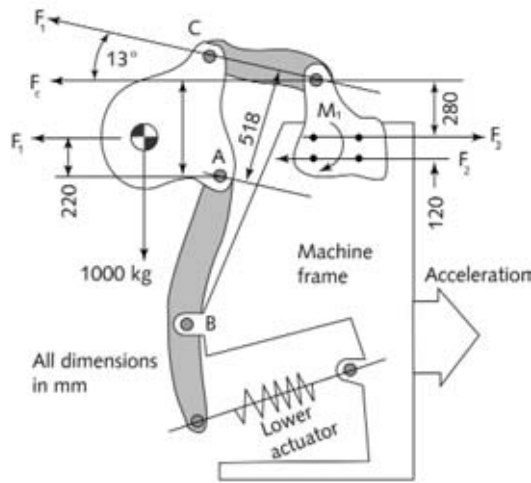
Figure 2.47 Simplified mechanism schematic of the major moving parts of the airknife machine indicating acceleration of the crated machine

$F_1$  = force acting on Flange 1 eventually causing it to shear the 15 mm diameter mounting cap screws;

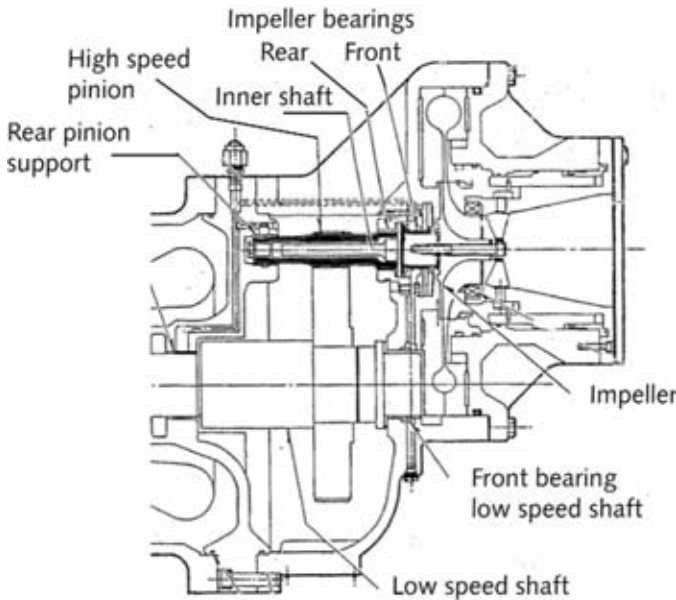
Figure 2.48 Sectional drawing of airconditioning compressor

Figure 2.48 is a sectional drawing of the compressor. The shaded component is the high-speed pinion running at approximately 20,000 rpm. This pinion is hollow and carries a smaller diameter shaft inside it. The impeller of the compressor is attached to this inner shaft. The apparently strange design of this impeller drive system was dictated by manufacturing economy and weight saving considerations. The pinion gear cut on the outer shaft is expected to last considerably longer than the simple sliding bearings on the unit. Simple sliding bearings were used in the design to save on space and inertial loads that might be imposed by rolling element bearings. The most critical part of this construction is seen to be the thrust bearing

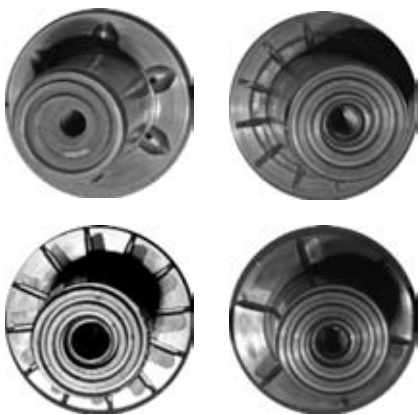
Figure 2.54 Original thrust face compared to various alternatives tried by Electra

the several failed attempts at replacing the bearing it is also clear that Electra's design approach was one of trial and error rather than informed analysis. A reference to Neale's handbook on thrust pad design would have enlightened Electra to the real nature of angled pad thrust bearing design (refer to Figure 2.55). Moreover, tables in that publication would have advised them of the proper geometry for the loads and speeds encountered in the compressor. In the event the rather crude attempt at concocting such a bearing resulted in the ultimate seizure and failure of the compressor.

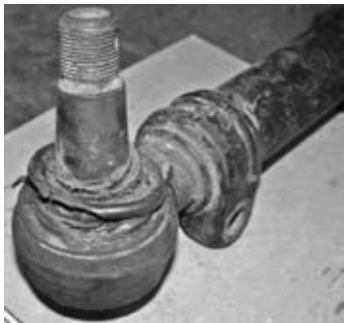
Figure 2.58 Original design of track rod (worn sample from Fillyary)

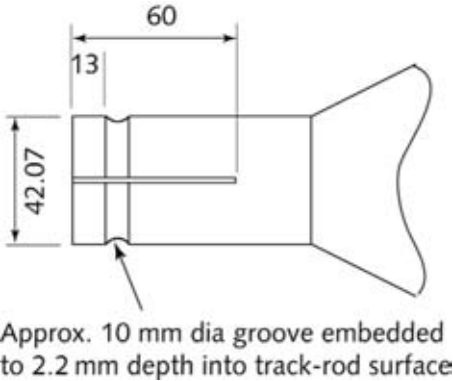
Figure 2.62 Sketch of track rod end as found on flipped tractor

Tractors, as well as other farm implements are regularly redesigned to meet customer requirements. No doubt, the Bigbrother design team responded to a need for greater transmission power, probably for driving the tractor in heavy mud, when they substantially increased the size of the front differential on the RS232 tractor. This design change called for a redesign of the originally straight track rod, to permit it to pass around the now much larger differential. The new design also made use of substantially heavier tubing with increased wall thickness. To accommodate the original steering knuckles the tubing was swaged<sup>2.22</sup> down to the original smaller diameter tube at the end. However, the wall thickness of the heavier tubing was retained. Figure 2.58 is a photo of the original design for track rod and steering knuckle. This photo is of a worn sample track rod, found in the Fillary scrap box. It was intended for comparison with the new track rod design. Figure 2.59 shows the track rod end taken from the flipped tractor. On inspection, this track rod end had one transverse slot cut in it for clamping the steering knuckle thread and it had a circumferential groove for the clamping bolt. Figure 2.62 is a schematic sketch of this new track rod end.

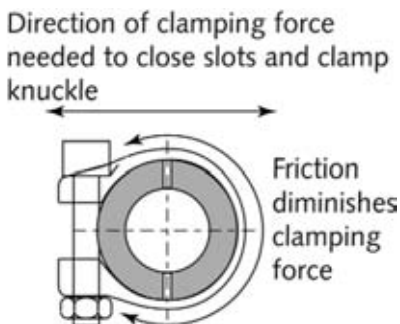
Figure 2.64 Schematic view of tube clamp with the clamping bolt oriented in the least desirable direction

From Figure 2.59 it is evident that the locking bolt of the tube clamp used on the new track rod end is constrained to be oriented at right angles to the tube axis by the bolt groove. However, the bolt is not constrained to be located at any specific orientation relative to the slot in the tube end (refer to Figure 2.62). It is this slot that should permit the clamping together of the tube end onto the steering knuckle thread. If the clamp bolt is not at right angles to these slots, the clamping force will be partly dissipated in clamp friction, the worst case being when the bolt is parallel to the plane of the slots (refer to Figure 2.64).

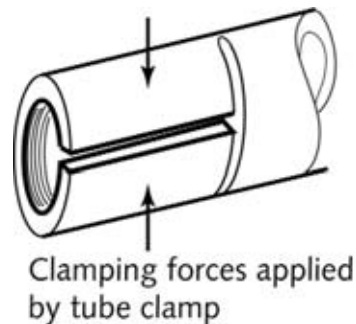
Figure 2.65 Schematic sketch of a pipe clamp designed to permit better grip on the steering knuckle thread

A more appropriate design for clamping the track rod end to the steering knuckle thread is seen in the sketch of Figure 2.65. This design permits clamping of the thread along substantial part of its length and would have avoided the problem experienced with the RS232 tractor. Interestingly, the

design shown in Figure 2.65 is well known and used in many engineering applications, though perhaps not in the farm machinery industry.

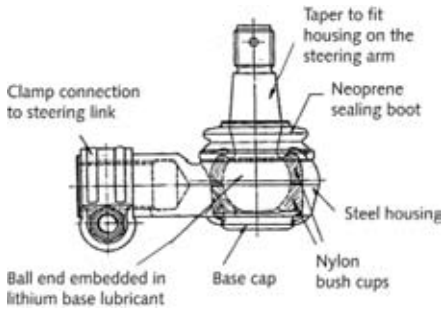
Figure 2.71 shows the two major parts of the failed ball joint. The socket was found to be completely filled with local clay and had to be cleaned out for full metallurgical examination. Figure 2.72 shows the ball joint at the other end of the failed steering link. Figure 2.73 shows a schematic sketch through a typical ball joint used on Safedrive vehicles. In the investigation of the accident the nylon bushes were not recovered. Figure 2.74 shows some parts of the sealing boot recovered from the failed joint. Sealed ball joints are generally expected to last for many years. If the sealing boot remained intact then it would be reasonable to expect such joints to last the full lifetime of the vehicle. The dispute in this case resolved into the following two issues:

Figure 2.73 Typical ball joint (not to scale) The nylon bushes were missing from the failed joint
