# Chapter 2

## Tsunami Damage: What Is Unexpected?

Koji Ichii

Geotechnical Predictions and Practice in Dealing with  
Geohazards

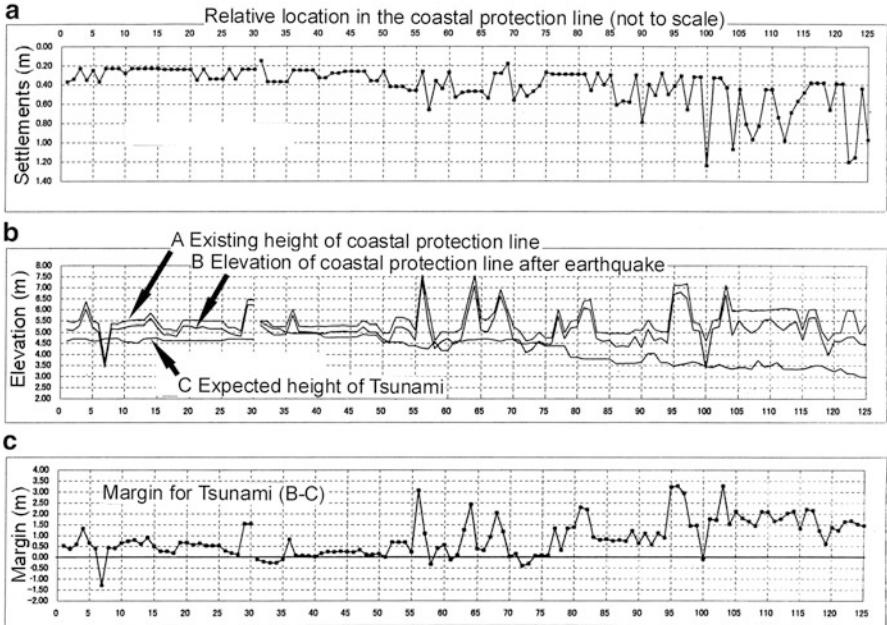
**Fig. 2.2** An example of seismic performance evaluation along a coastline (Osaka Prefecture). (a) Settlements of coastal structures. (b) Elevations of coastal protection lines before and after earthquakes and the expected height of a tsunami. (c) Margin of a tsunami

structures along a coastline of the Osaka Prefecture. In this area, 125 total types of structures are located on the 70-km coastline. For each structure, settlement induced by the anticipated ground motion was evaluated (Fig. 2.2a). Then subtracting the evaluated settlement from the height of the structure (A in Fig. 2.2b), the residual height of the coastal structure could be evaluated (B in Fig. 2.2b). The margin for tsunamis (Fig. 2.2c) could be evaluated by comparing the residual height (B in Fig. 2.2b) and the anticipated tsunami height announced by the Japanese government (C in Fig. 2.2b). In the case shown in Fig. 2.2, there was no margin at approximately seven parts, and further detailed investigations or countermeasures were necessary.

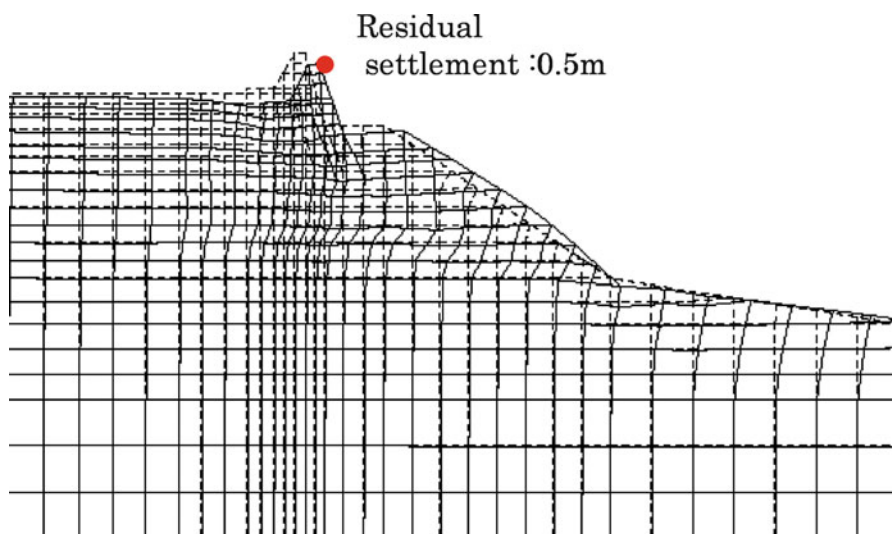
The evaluation of the settlement shown in Fig. 2.2 was performed by referring the summary of finite element method (FEM) parametric studies. An example of FEM analysis is shown in Fig. 2.3. Not only the deformation pattern, but also the settlement at the crest can be evaluated. The applicability of FEM analysis for coastal structures has been widely published (i.e., Iai et al. 1998). However, it was not cost effective to build a FEM model for each site. Therefore, a simple but cost-effective system to evaluate the settlement of coastal structures by referring the summary of FEM parametric studies was proposed, and it was applied to obtain the result shown in Fig. 2.2. The author was a member of the project that proposed the system.

**Fig. 2.3** An example of finite element method analysis of a seawall

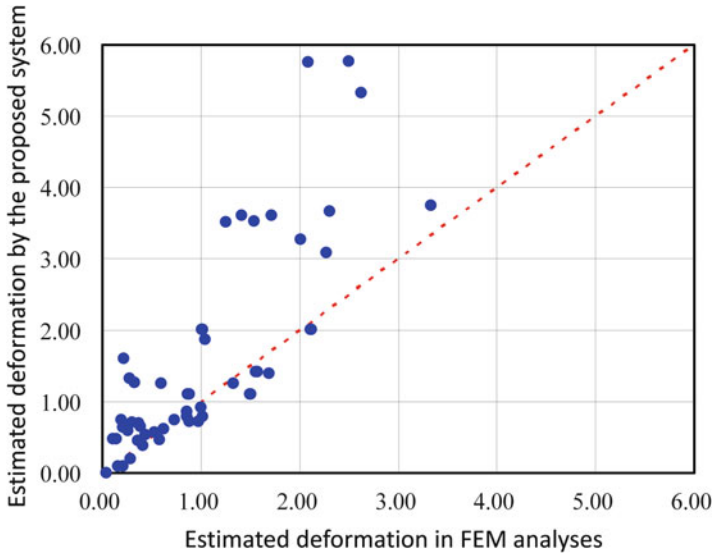
**Fig. 2.4** Comparison of the results of detailed analyses (FEM) and of a simple (but safer side) system

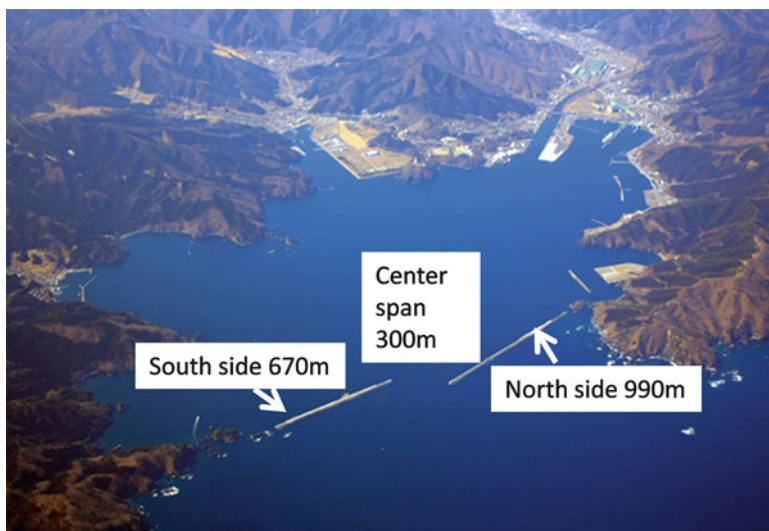
An example of countermeasures should be noted here. For the Kuji, Kamaishi, and Ofunato ports, breakwaters were constructed both at the gate of the port and the harbors. Figure 2.5 shows the Kamaishi Port Gate Breakwaters, which were constructed to mitigate the impact of tsunamis.

Fig. 2.5 Kamaishi Port Gate breakwaters (Kamaishi Port Office)

Figure 2.7 shows snapshots from the video recorded by a government official. He evacuated to the roof terrace of a building and recorded the entire event from the terrace. The tsunami height shown on the left side of Fig. 2.7a was almost as high as a two-story house, and the houses shown in the figure were swept away. The entire city was covered by the tsunami, as shown in the right side of Fig. 2.7b. These scenes were recorded at the Kamaishi Port, where breakwaters were installed as shown in Fig. 2.5.

The observed tsunami height was larger than expected in the design of breakwaters. The real performance and effect of breakwaters for the mitigation of tsunami impact were still under investigation and discussion. The situation at the first tsunami wave at the breakwater site was recorded by the official mentioned in the preceding. Figure 2.8 shows the tsunami at the breakwaters. In the beginning, white bubbles were observed behind the caissons of breakwaters (Fig. 2.8a). The reason of this phenomenon might be the difference of the water level between the front (tsunami) and back (port) sides. But there is a discussion that this was caused by the water flow between caissons or upward flow from rubble foundations owing to the high permeability in the foundations. Nevertheless, a few moments later, the tsunami overflowed as shown in the right side of Fig. 2.8b.
