DEFORMATION OF A RIVER DIKE DUE TO THE MIYAGI-KEN HOKUBU EARTHQUAKE

Osamu NAKAYAMA¹, Yasushi SASAKI², Motoharu SEKIZAWA³, Tomoyuki HIRATSUKA⁴,
and Yoshitomo SUZUKI⁵

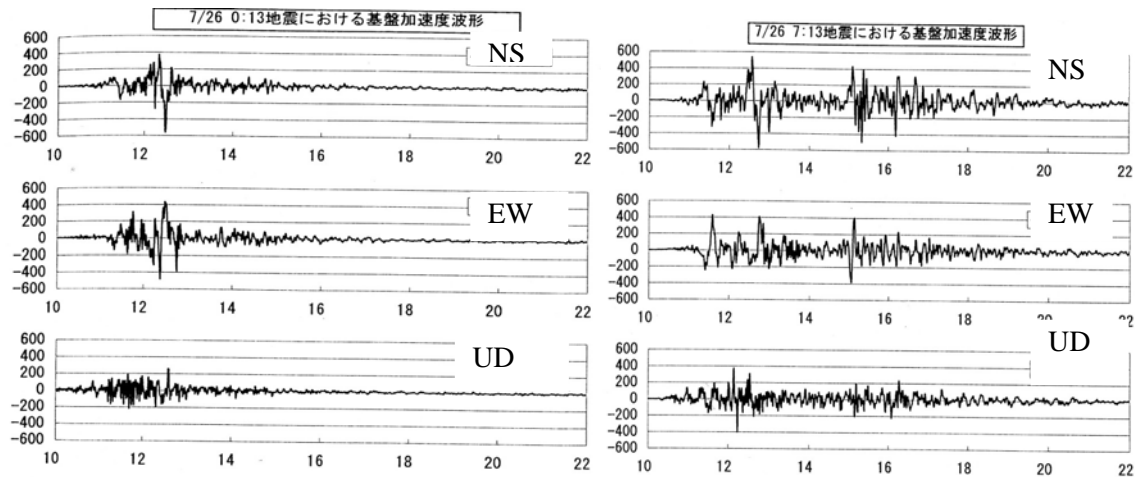
Figure 2. Seismic vibration records (Nakashimo Vibration Observation Station)

Distinct characteristics of this earthquake include a short time interval (7 hr) between the foreshock and main shock, and a nearly equal maximum acceleration, but the duration at 100 gal or more was as long as 8 sec in the main shock, which is three times longer than the duration of the aftershock. Figure 1 shows strong motion records of the foreshock and main shock observed by the Nakashimo Observation Station at the lower reach of the Naruse River.

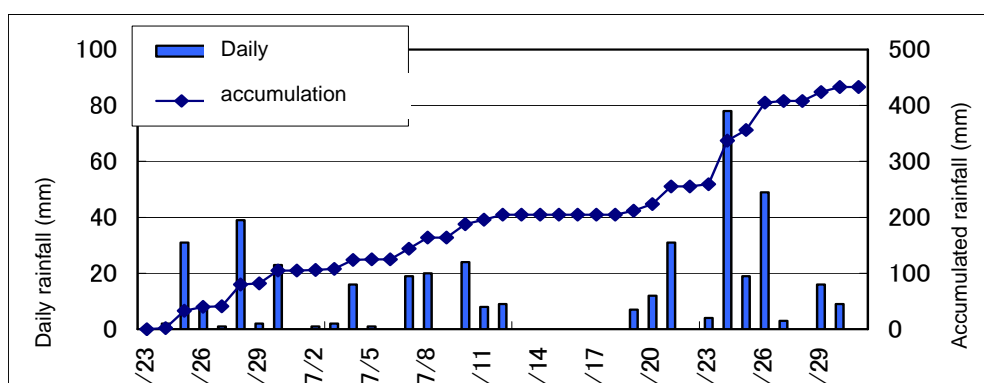
Fig. 7 Rainfall before and after earthquake (Accumulated rainfall from June 23, recorded at the Kashimadai Rainfall Station of the Sendai District Meteorological Observatory of the Meteorological Agency)

Figure 7 shows the state of rainfall for the month preceding the earthquake. It rained intermittently during the month and rainfall was 78 mm on July 24, immediately before the occurrence of the earthquake. The accumulated rainfall up to the time of the earthquake was 356 mm, so quite a lot of water is considered to have permeated the dike body.

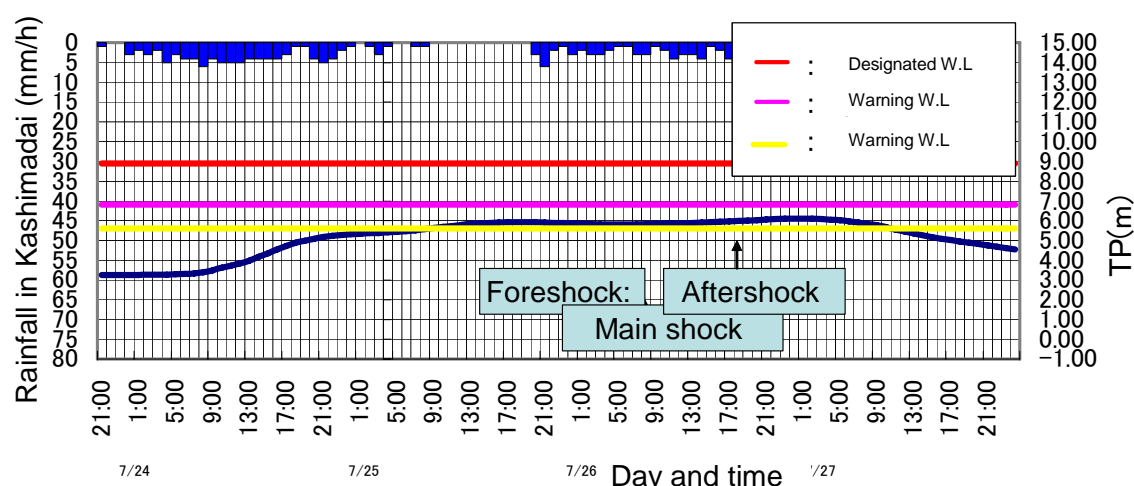
Figure 8. Water level at the 13.0 km position of the Naruse River

A flood warning was issued for the Ishinomaki District at 5:20 a.m. on July 26 due to prolonged rainfall that started in the Naruse River basin on the evening of July 23. At the Kashimadai Rainfall Station, the Naruse River rose above the preparatory water level for flood-fighting activities at 1:00 p.m. on July 25. Three earthquakes registering 6- or more occurred during this state. Meanwhile, the ground height behind dike was now only a little lower than the water level.

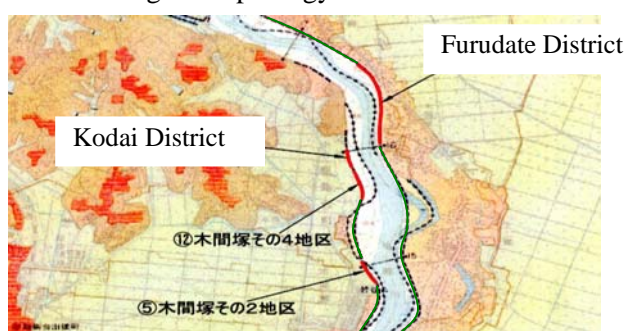
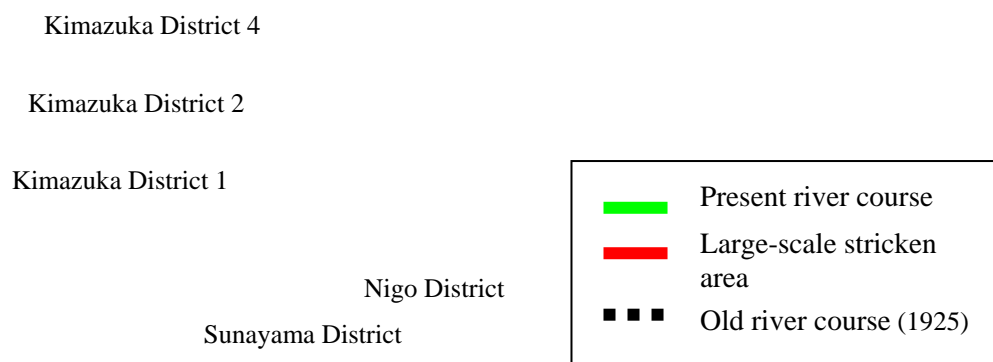
Figure 9. Geomorphology near the severely damaged sections

Locations of the severely damaged sections of dike are shown on the geomorphology classification map/for flood control of the Naruse River. Earthquake damage to dikes is generally represented by liquefaction of foundation ground, and damage tends to occur in old river courses(Sasaki et al.,1997), but in the case of the Northern Miyagi Prefecture Earthquake, no clear relationship is found between the old river courses and damaged sections/damage degree, and severely damaged sections belong to the hinterland marshes of geomorphology classification.

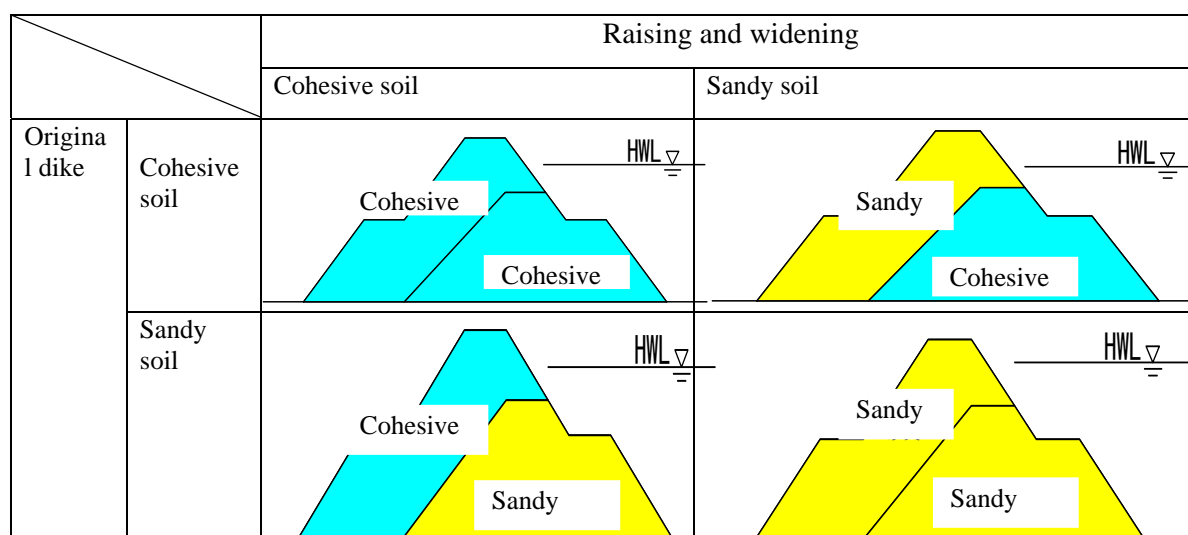
Figure 10. Classification of dike by material soil and structure

From the embankment history, past soil examinations and results obtained from boring after the damage due to the event, it was found that the dike at the middle and lower reaches of the Naruse River was mainly composed of cohesive soil or sandy soil as shown in Figure 10 and that the soil of the dike body was of a one- to two-layer structure. The dike in which intense deformation occurred is old and either originally composed of cohesive soil and widened by sandy soil, or originally composed of sandy soil and widened by cohesive soil.

Furthermore, there is considerable foundation ground where a loose sand layer having an N-value of 10 or less, susceptible to liquefy, is distributed at surface underlain by weak cohesive soil having an N-value of 3 or less depositing about 40 m.

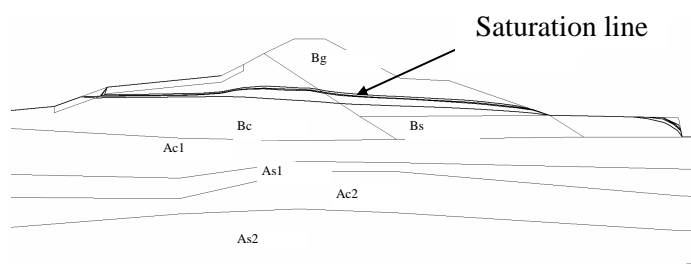
Figure 14. Analysis results of infiltration flow

The dike in the Kimazuka Section where significant failure occurred was modeled based on the results of the soil investigation and excavation examination (Figure 13). Two-dimensional saturation and non-saturation seepage flow analysis (Akai et al., 1977) was performed using the records of rainfall (Figure 7) and water level at river side as boundary condition (Figure 8) to calculate a seepage line in the dike. Meanwhile, since sheet piling and revetment were provided on the river side of the dike, and as there was no damage caused by the earthquake, the sheet piling and revetment were also modeled in performing seepage flow analysis. The analysis results indicate that the groundwater level, which is believed to be about 50 cm below the ground surface before the rainfall, rose by about 2 m due to rainwater infiltration, and saturated zone had been formed in the dike body before the earthquake as shown in Figure 14.

This height almost matches the water level observed through the boring implemented immediately after the earthquake and the level of the water surface found in Figure 5. Presumably, the water level in the dike rose when the earthquake occurred, and the degree of saturation in the dike also increased.

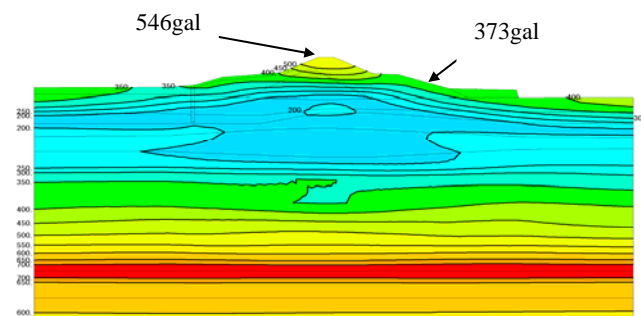
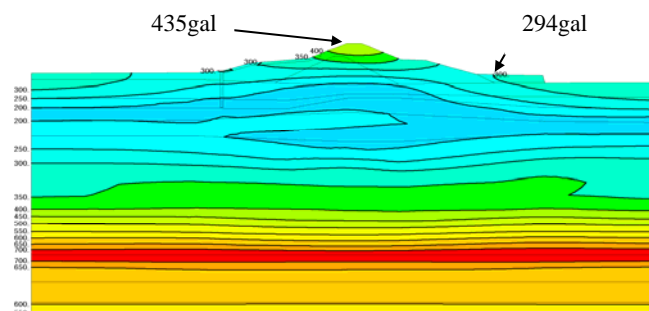
Two-dimensional response analysis (Lysmer et al.,1974) of the Kimazuka dike was performed using the observed records at the Nakashimo Observation Station in the lower reaches of the Naruse River shown in Figure 2 as input motion. Figure 15 shows the presumed results of maximum acceleration distribution. A similar acceleration distribution is shown during both the foreshock and main shock, but the maximum acceleration value is larger during the foreshock as is the case with the actual earthquake. Meanwhile, soil constants of the dike and foundation ground at the points of analysis are shown in Table 2. The constants are determined based on geophysical logging and laboratory soil test data.

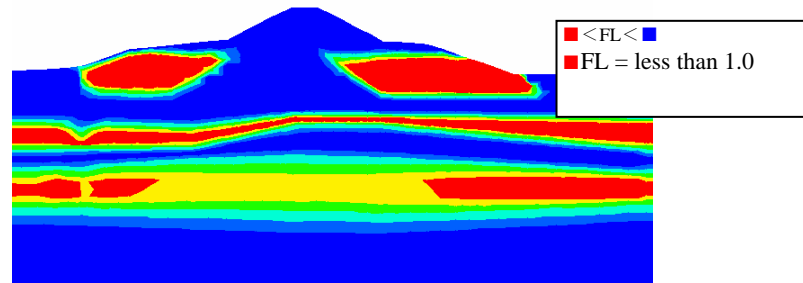
Figure 16. Distribution of F_L value (during main shock)

The state of liquefaction when the main shock occurred was presumed based on the Highway Bridge Specification method(Japan Road Association,2002) with the use of the maximum acceleration distribution obtained by the above two-dimensional response analysis. Figure 16 shows an F_L distribution when the main shock occurred, and it is known that liquefied zone of $F_L < 1.0$ spreads widely in the dike.

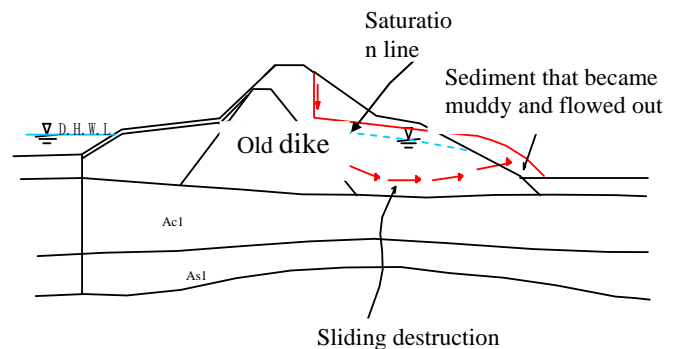
Figure 21. State of dike when damage occurred

- a) As a result, the stability of the dike was lost, and sliding failure, which pushed out the failed mass of soil to the land side along the border of the original dike (cohesive soil), presumably occurred.
- b) On the other hand, no deformation was found on the water side. Since impervious sheet piling and revetment had been provided on the water side, they are considered to have effectively suppressed deformation.
- c) Settlement presumably occurred as well in accordance with the liquefaction of the A_{s1} layer. However, since traces of sand boiling could not be found in or around the dike, it is considered that the A_{c1} layer above the A_{s1} layer was not destroyed.

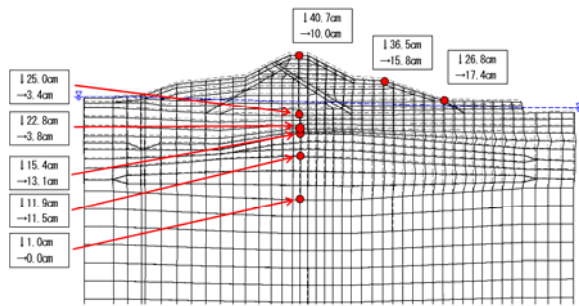
**Figure 22. Deformation of the dike)
(No rainwater permeation)**

The rise of the saturation line in the dike due to rainfall prior to the earthquake event is considered to have greatly affected the degree of damage. To investigate the difference in deformation amount, earthquake inducing deformation analysis was conducted based on the supposition that the saturation line of the dike did not rise, namely, the state in which there was little preceding rainfall. Shown in Figure 22 are the results of ALID deformation analysis for the state in which there was no pre-rainfall. Table 3 shows the difference in deformation amount for both the dike crown and the toe of the land side slope depending upon the presence or absence of pre-rainfall.

When there was no preceding rainfall, the deformation amount at the dike crest was 40.7 cm maximum, which is half or less compared with the case in which there was preceding rainfall. On the land side, the amount of horizontal displacement toward inland was 17.4 cm, which is only 1/7 compared to the case in which there was pre-rainfall.

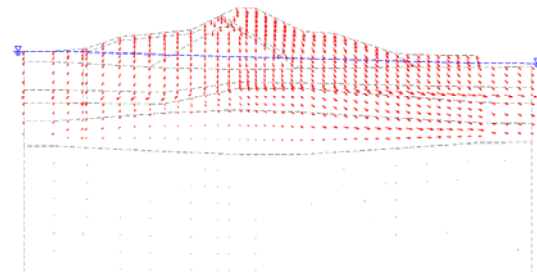
**Figure 23. Displacement vectors
(No rainwater permeation)**

A comparison of displacement vectors reveals that when rainwater permeated into dike, movement followed such as failed mass of soil pushing out the dike toward the land side, but when rainwater did not permeate the dike, such movement did not occur, and the displacement was small.
