EARTHQUAKE DAMAGES TO EMBANKMENTS IN ANDAMAN ISLANDS IN INDIA

Prasad, S. K.¹ and Chandradhara, G. P.²

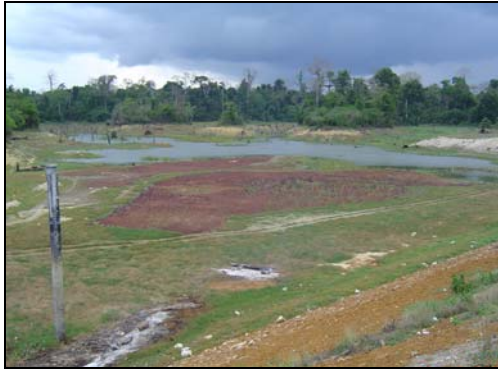
R. K. Pura dam is situated about 15 km from Hutbay on the interiors. It is reasonably away from the sea beach, at least by around 6 km. The reservoir is always filled and over flows during the rainy season. After the earthquake, the reservoir became empty and the dam embankment was subjected to sufficient shaking. It should be noted that the region being at a higher elevation and sufficiently far from the coast, there was no effect of Tsunami and all the damages observed were due to earthquake shaking. Figure 7 presents the upstream reservoir portion of the dam after the quake. It can be seen that the reservoir is completely dry. The vertical scale in the reservoir with changes in color indicates the previous minimum level of water. The earthen embankment dam had experienced dislocation of alignment in addition to settlement, longitudinal cracks and side slope failure.

Figure 7 : Upstream of the reservoir of R. K. Pura Dam
