DAMAGE IN NIAS ISLAND CAUSED BY THE M8.7 OFF-SHORE SUMATRA EARTHQUAKE, MARCH 28, 2005 AND THE SUPPORT ACTIVITIES FOR THE RECOVERY AND RECONSTRUCTION

ABSTRACT

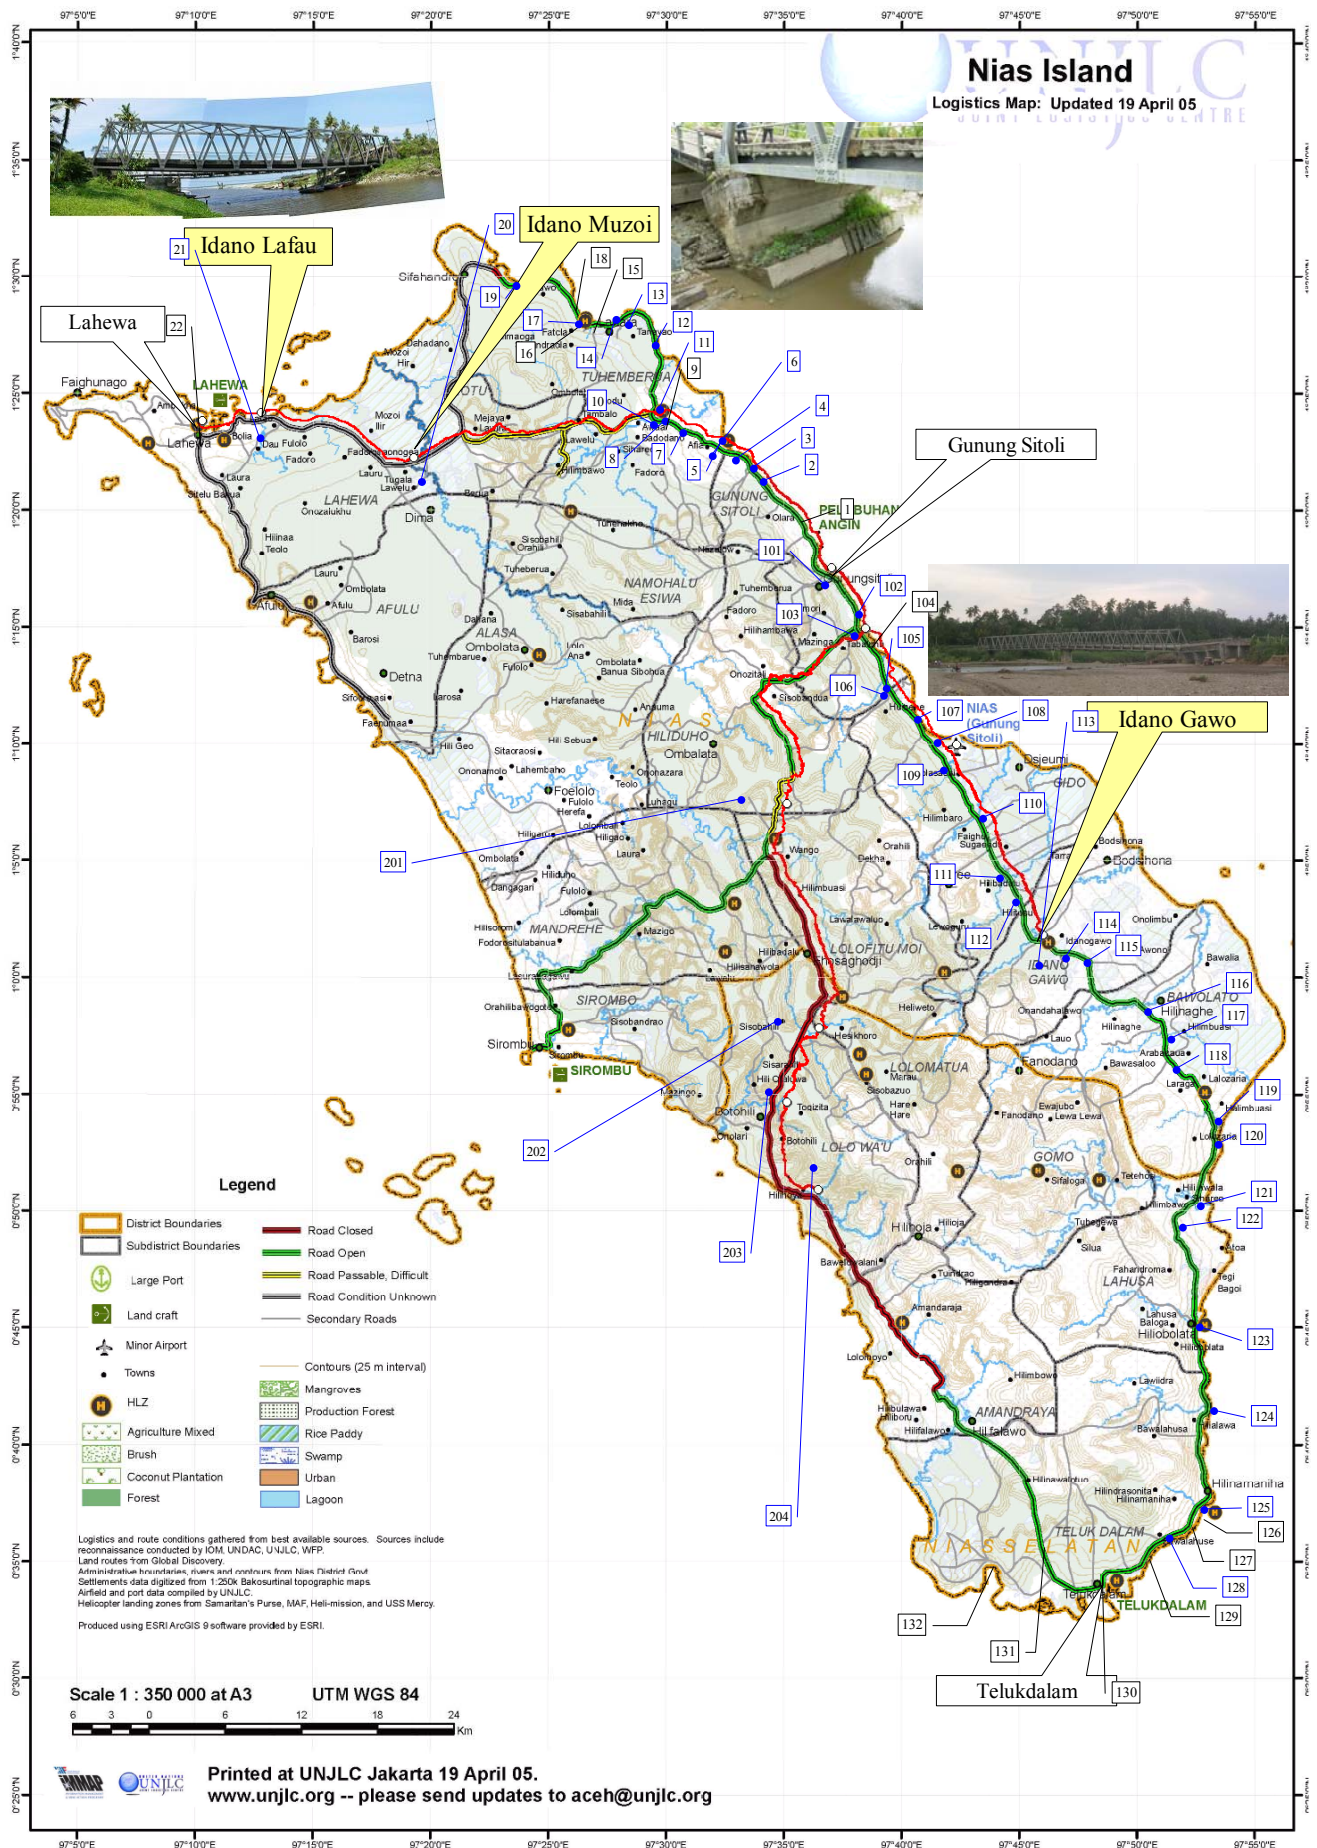
Figure 3. Investigated bridges and Major cites and towns

The roads connecting Lahewa in the northern part of island to Gunung Sitoli, Gunung Sitoli to Telukdalam in the southern part along eastern coast, and Gunung Sitoli to Telukdalam through the center of island are main roads. Bridges in Nias Island may be broadly classified as Truss bridges, RC bridges, RC Box Culvert bridges, Wooden paved steel framed bridges, and Wooden bridges. Long span bridges are either truss bridges or RC bridges with or without box culverts. Truss bridges were especially used for long span bridges along main roads. The list of bridges and dominant forms of their damage are listed in Table 3 and locations of these bridges are shown in Figure 3.

Many truss bridges along Gunung-Sitoli and Telukdalam route and along Gunung-Sitoli and Lahewa route were damaged by permanent movement of abutments as a result of lateral spreading of liquefied ground. The ground consists of mudstone-like layer, sand layer and clayey-silty soil and top organic soil from bottom to top. Sandy layer is generally found at the water level of river and it is expected to be fully saturated. During earthquake shaking, it seems that this sandy layer was liquefied and caused the lateral spreading of the ground. The lateral spreading of ground was particularly amplified on the convex side of the riverbank as the ground can freely move towards the river. These movements caused high lateral forces on the abutments, which caused the sliding and tilting of piers or fractured the piles of the abutments of truss bridges. Similar situations are also observed on RC bridges.

The approach embankments of bridges are generally damaged and settled due to lateral spreading of ground and failure of wing-embankment walls. The settlements were generally greater than 30cm in many locations. The backfill materials of approach embankments consist of gravelly soil and it is expected that the potential of settlement or liquefaction is low. The bearing supports of many bridges do not have shear-keys or stoppers against both horizontal and vertical movements. The truss section shifted horizontally towards the upstream side or downstream side at some bridges.

The damaged bridges generally need to be re-constructed and It should be moved next to existing piers where geotechnical investigation of ground and its characteristics are necessary. The present truss decks can be used in the new-constructions with some replacement of damaged elements and bolts and bearings together with appropriate stopper against horizontal and vertical relative movements.

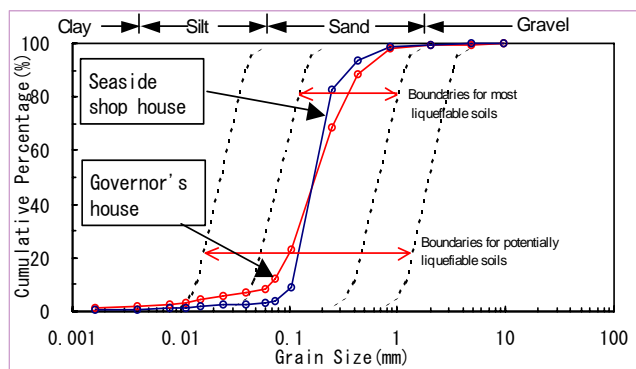
As expected from the magnitude of this earthquake, the liquefaction of sandy ground is very likely. The sandy ground is observed along seashore and riverbanks in Nias Island. Permanent ground movements such as settlement and lateral spreading, and associated structural damage due to liquefaction were widely observed in various locations along the coastal area and reclaimed ground. The lateral spreading of ground nearby bridge abutments were almost entirely associated with liquefaction of sandy soil layer. The damage induced in Gunung Sitoli due to ground liquefaction is widespread along the coastal area, reclaimed ground and riverbanks. All the possible forms of ground movements and the effects of ground liquefaction were observed such as sand boils, lateral ground movements and settlement. As a result, many buildings in such areas were heavily damaged with partial settlement, inclination and uplift of ground floor. The buildings without raft foundations and continuous tie-beams could not resist to ground failures due to liquefaction unless they are built on piles extending into the non-liquefiable layer. Figure 7 shows the damages of buildings due to liquefaction. In Figure 8 grain size distribution curves for soil samples in Gunung Sitoli can be seen. It can be seen that these soils have almost the same grain size and they are very liquefiable. Swedish weight sounding tests were conducted at 2 points in Gunung Sitoli. Soil profile, converted SPT N-value from Swedish weight sounding test and Liquefaction Potential based on the result of geotechnical investigation are shown in Figure 9.

Figure 8. Grain size distribution curves for soils at 2 sites in Gunung Sitoli
