DUZCE (M7.2, 1999) EARTHQUAKE: DAMAGE CORRELATION WITH THE MICROZONATION STUDY AND VULNERABILITY ASSESSMENT OF THE WATER SYSTEM IN DUZCE, TURKEY

Dimitra MANOY¹, Maria ALEXOUDI², Dimitrios RAPTAKIS³, Kyriazis PITILAKIS⁴

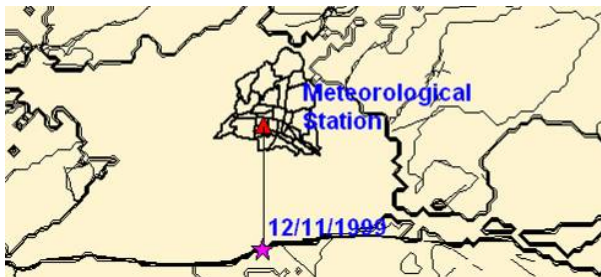
November 12th, 1999 Duzce M7.2 earthquake was associated with the North Anatolian fault, and in particular with the Duzce fault, which forms a morphological boundary at the south of the Duzce Plain. The Duzce fault, (Figure 2a), extends eastwards about 70km from the main branch of the North Anatolian Fault, having its terminus near the village of Kaynasli, located to the southeast of Duzce. It is a right lateral strike-slip fault.

Figure 2a. The Duzce fault which caused the 12-11-1999, Duzce strong seismic event.

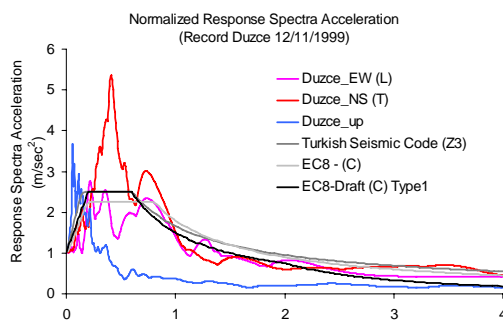
Figure 2b. 12-11-1999 Duzce earthquake response spectra at the Meteorological Station.

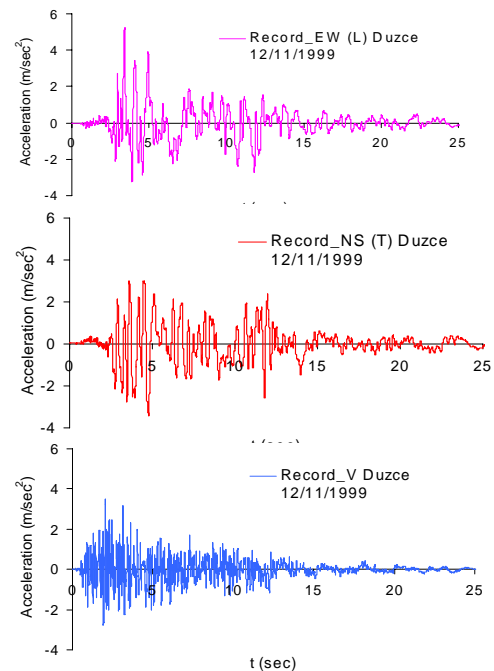
The peak ground acceleration recorded at the Meteorological Station of Duzce was invariably large, ($PGA_{[EW]}=0.51g$), something that is not unexpected due to closer proximity of fault rupture. The long duration and the long period energy content in the time history of the Duzce record, (Figure 2c), is a strong indication of basin response and effect of soft soil behaviour (Sucuoglu, 2002). Moreover, from the shape of the corresponding acceleration response spectra, (Figure 2b), it is evident that the acceleration demands for periods between 0.1 to 1.0 seconds, which is the expected range for periods of most structures at the area, were considerably large. Due to these considerably high demands, the structures that survived the first 17/8/1999 Kocaeli quake were severely damaged and many of them collapsed in the Duzce 12/11/1999 earthquake.

Figure 2c. 12-11-1999, strong motion recordings at the Meteor. Station.

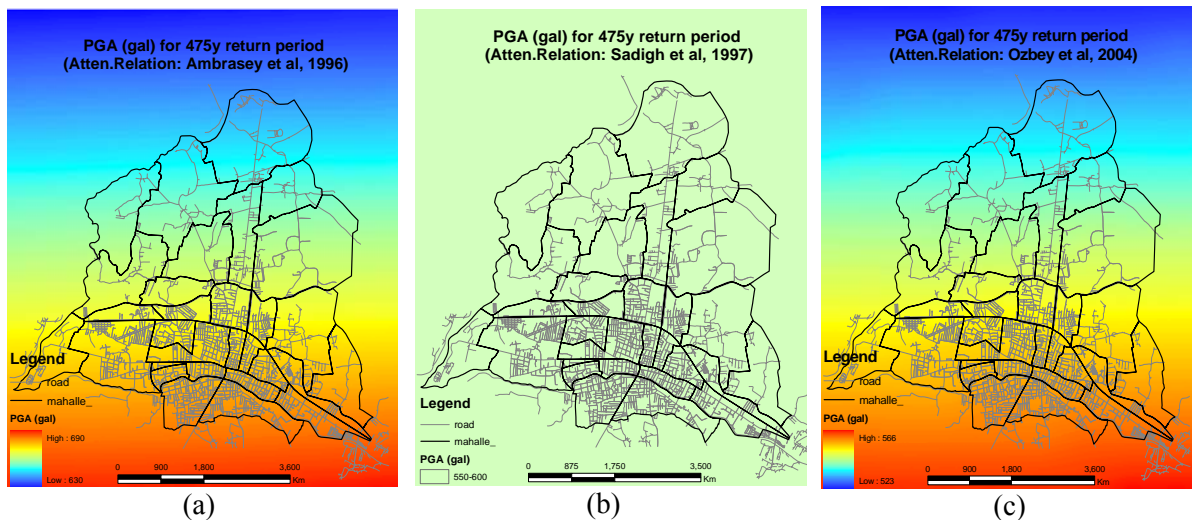
Seismic hazard analysis of Duzce has been estimated applying a probabilistic approach, using code CRISIS 99 and considering the seismic zones affecting Duzce (Kayabali, 2002). The probabilistic seismic hazard analysis has been performed using three different attenuation relations proposed by Ambraseys, (1996), Sadigh et al., (1997) and Ozbey, (2004), estimating the distribution of PGA values in case of rock conditions for a mean return period of 475 years. The resulting PGA maps (Figure 6) have been validated with existing results from previous studies already performed in the area. PGA values for outcrop conditions according to Ambraseys, (1996) relation give higher values compared to Ozbey, (2004) and Sadigh et al., (1997) relations, as they are presented in Table 1. However, they could be used as the peak input motion values for the site response analysis. It is also estimated that the 475 year mean return period earthquake is similar to the November 1999 earthquake.

Figure 6. PGA (gals) values for Duzce - Probabilistic scenario for mean return period of 475 years. Attenuation relations (a) Ambraseys (1996), (b) Sadigh et al., (1997), (c) Ozbey (2004). Soil conditions: Rock.

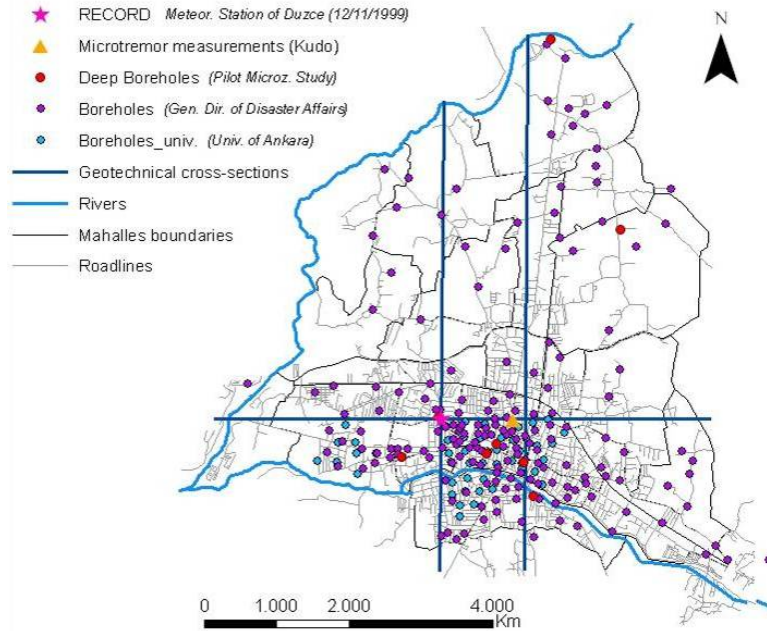
Figure 7. Available geophysical and geotechnical data in Duzce.

Following the 12/11/1999 earthquake, a number of geophysical surveys were conducted in Duzce. Kudo et al., (2000) carried out array measurements of microtremors aiming to determine the S-wave velocity structures at the DZC (Duzce) strong motion site (Figure 7); based on his results, the site is a sedimentary basin of thick and soft sediments at the surface ($V_s \sim 260$ m/sec) and intermediate depths ($V_s \sim 460$ -510 m/sec), while the depth of the bedrock reaches -750m. Rosenblad et al., (2001) applied the spectral-analysis-of surface-waves (SASW) to characterize small-strain shear wave velocity profiles, using in situ seismic measurements. The SASW profile indicates that the velocity of the near-surface materials is less than 200 m/sec, but the velocity quickly increases to 400 m/sec at 15m depth. Kudo et al., (2000) profile shows a constant shear wave velocity of 260 m/sec extending from the surface to a depth of 35m. At depths below about 40m, both profiles show a shear wave velocity between 400 and 450 m/sec. Yamanaka et al., (2002) conducted single-point measurements and array measurements of microtremors at 25 sites in Duzce along a line from the south to the north. He proposed a 7-layer model according to which the shear-wave velocity is $V_s = 769$ m/sec at a depth of approximately 100m. Finally, a site specific microtremor survey has been conducted by Tromans, (2004) applying the horizontal-to-vertical spectral ratio technique. According to this study the predominant HVSr frequency f_p varies between 0.5–1.5 Hz in a rather wide area which covers the southern part of the city of Duzce, while the value of f_p at the record site (Meteorological Station) was defined at $f_p = 0.73$ Hz.

In addition to the geophysical surveys, borehole investigations (10-15m and rarely 20m depth) have been performed at 185 proposed locations by the Ministry of Settlement and Public Works, General Directorate of Disaster Affairs, (2000) in the provincial centre of Duzce (Figure 7). Moreover, the Department of Geology and Geophysical Engineering of Ankara University (Kayabali et al., 2001) performed in the research area, approximately 60 drillings with a maximum depth of 15m each. Within the framework of the Pilot Microzonation Study of Duzce (Pitilakis et al., 2006) eight deep boreholes were drilled which are presented in Figure 7; in specific, six boreholes of 40m depth and two of 90m. Six boreholes (four of 40m and the two of 90m) were drilled at the southern part of the city, where as already mentioned before, the major damages were observed after November 12th, 1999 earthquake.

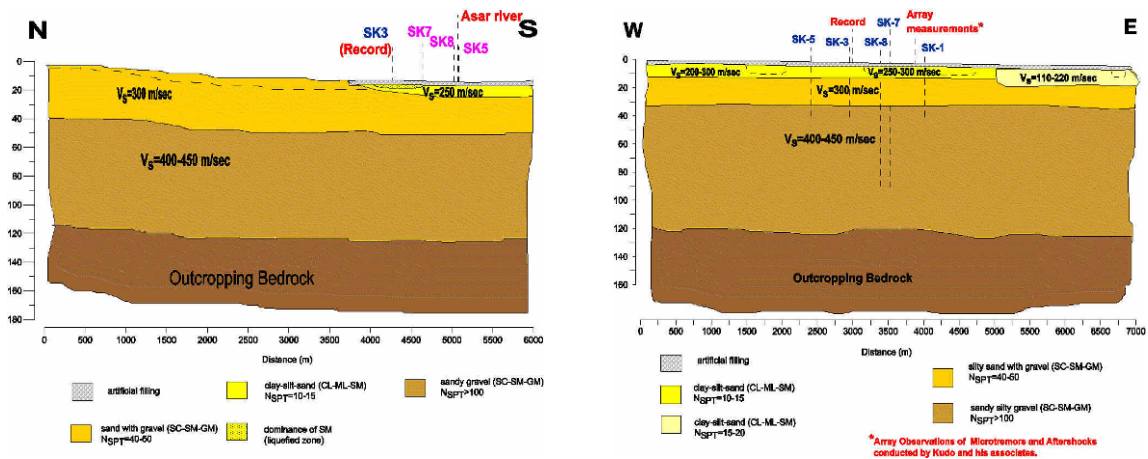
From the 2D geotechnical cross-sections (Figure 8) it is evident that at the southern part of Duzce the shear wave velocity at the surface (10m) varies between 250-300 m/sec and the soil configurations

Figure 8. NS-left and WE 2D geotechnical cross-sections along Duzce.

consist from soft alluvial clay, loose sand and gravel river sediments. At depths between 10-30m, the shear wave velocity values increase up to 300 m/sec, and the soils are composed of alterations of silt and clay with generally soft-medium consistency and loose-moderately compact fine-grained sand. Finally, at the depth between 30-120m, the shear wave velocity values (V_s) have been estimated around 400-450 m/sec, and the soil gradually change into relatively moderately stiff-stiff clay or silt and moderately compact to very compact sand, clay and gravel. Based on all the above data and information we estimated 1D soil profiles, (Figure 9a), to perform a set of 1D equivalent linear analyses.

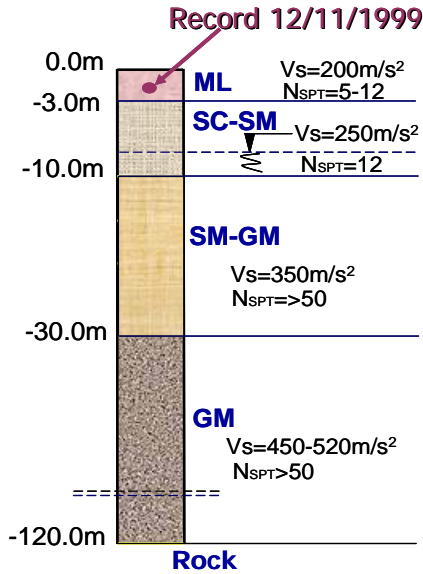
In the frame of the Pilot Microzonation Study, the compilation of a number of aftershocks at the record site (Meteorological Station of Duzce) and the estimation of the HV spectral ratio has been conducted in order to define the outcropping bedrock's depth, the results of which are analytically presented in Figure 9b. As a result of the HV spectral ratio computation, the predominant HVSr frequency was estimated at the value of $f_0 = 0.75$ Hz, and it was possible to estimate the depth of the "seismic bedrock" which should be approximately at -120m. Taking under consideration that the estimated value of the predominant frequency f_0 is in full agreement with the f_p value estimated by Tromans, (2004) who performed array measurements of microtremors in the field and also validating this results with data from topographic maps of the area as well as with published reports [Kudo et al., (2000), Rosenblad et al., (2001) and Yamanaka et al., (2002)], we have finally accepted that the "seismic bedrock" for the site effects analyses, ($V_s \geq 750$ m/sec), lies in this depth of around 120m (Figure 9a).

Figure 9a. 1D soil profile at the Meteorological Station of Duzce.

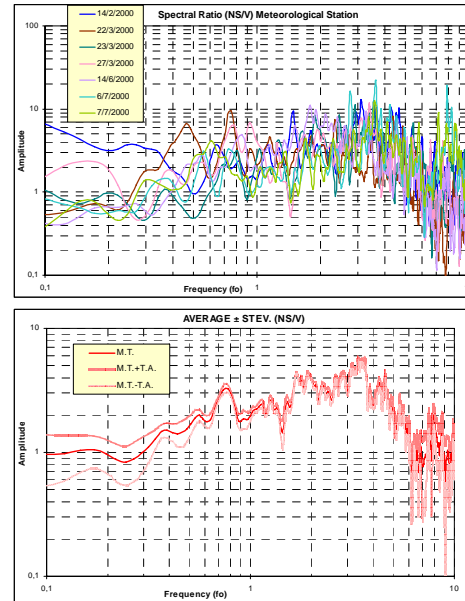
Figure 9b. H/V spectral ratio of the aftershocks recorded at the Meteorological Station of Duzce.

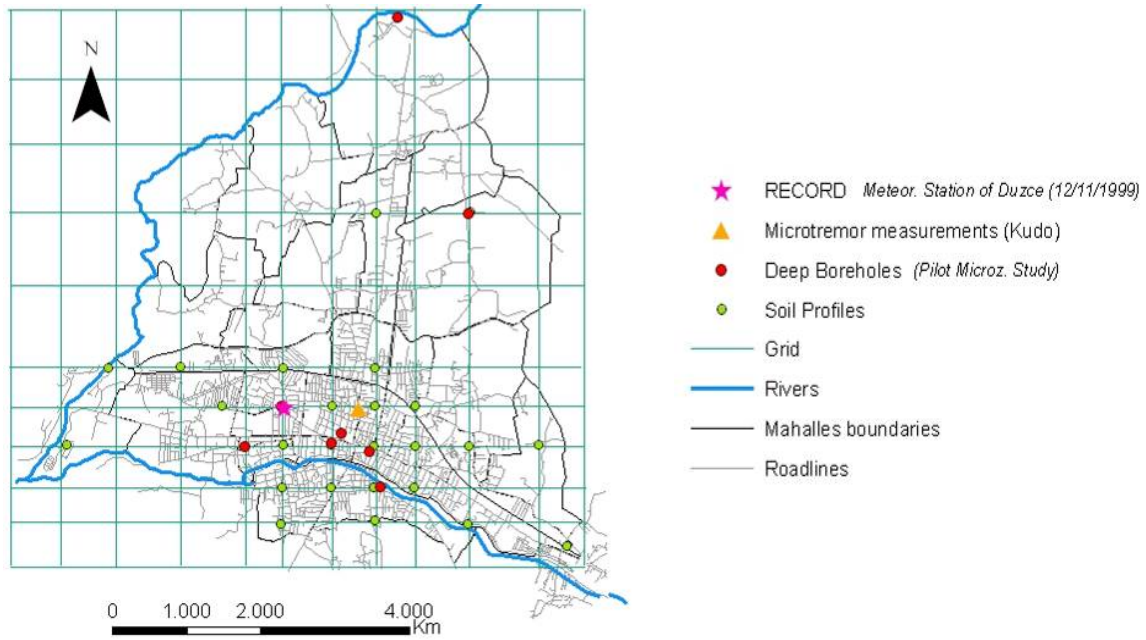
A series of 1D EQL analysis has been performed in Duzce on thirty (30) typical soil profiles (Figure 10). 1D analysis must be quite suitable for the case of Duzce as the plain is very large and there are not apparently strong lateral discontinuities except at the southern part at the fault area. The dynamic soil properties and the soil profiles were derived from the synthesis of previously mentioned surveys and studies (Pitilakis et al., 2006). Considering the fact that there was no record available of the 12-11-1999 Duzce earthquake in “outcropping” conditions in or near Duzce, in order to be used as the input motion, the selection of the appropriate input motion was a major problem. This problem was encountered by proceeding at first in the deconvolution of the available record at the Meteorological Station of Duzce in order to estimate the 12-11-1999 record at the “seismic bedrock”. Except the deconvoluted time history of the Duzce earthquake record, four (4) other seismic motions recorded in “outcropping” conditions were also selected, among them the Gebze record of the 17-8-1999 Kocaeli earthquake, two records from the 1994 Northridge earthquake (Pacoima Dam and Wonderland records) and the Sturmo record of the 1980 Campano Lucano earthquake in Italy. The specific selection of these five input motions was based on the processing and analysis of all aftershocks recorded at the Meteorological Station, and in other sites around Duzce (Pitilakis et al., 2006).

Figure 10. Location of 1D soil profiles sites in Duzce.

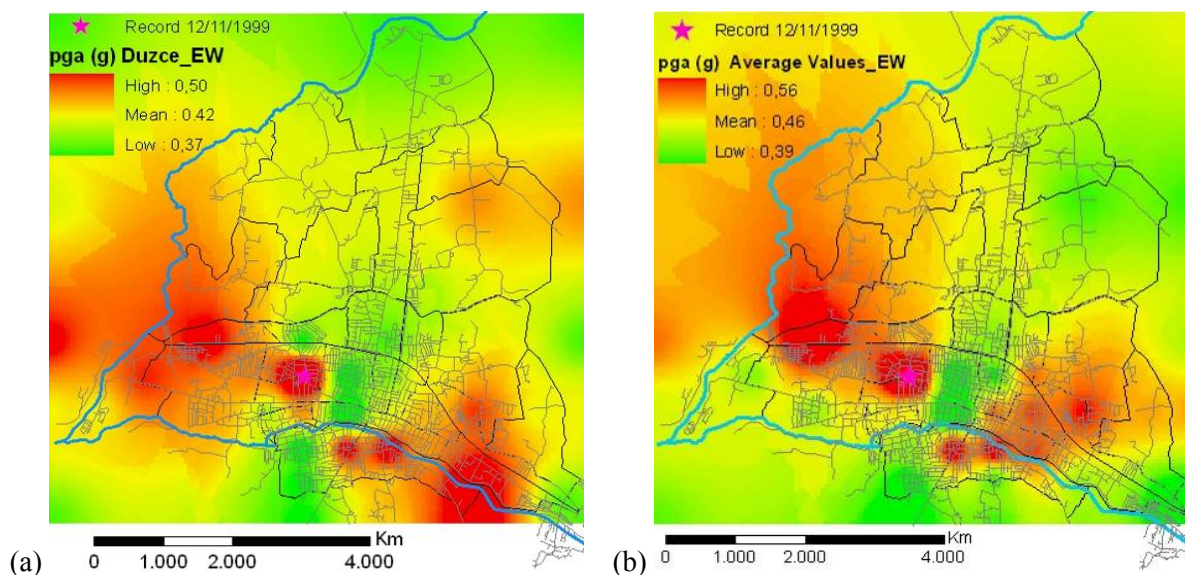
As it is observed in Figure 11a, the computed PGA values vary between 0.37–0.50g when 12-11-1999 Duzce deconvoluted time history is used as input motion, and between 0.39-0.56g, when the average values of the five input motions used are depicted (Figure 11b). The maximum PGA values are observed at the south-west and south-east part of the city, mainly around and close the Metereological Station (DZC station) and around the river. Comparing these results with the effective ground acceleration coefficient ($A_0=0.40g$) that applies for Duzce according to the Turkish Seismic Code, we conclude that they are generally in good agreement, although both recorded and computed PGA values reach 0.50g at the southern parts of the city where the soft river sediments are dominant. The average value for the whole city of Duzce is effectively of the order of 0.40g. Some spots of higher values are observed at the rivers zone where actually more damages were observed. Considering now the computed PSA values they vary between 0.75g and 1.5g for $T_0=0,3$ sec (Figure 12a) and between 0.85g and 1.3g for $T_0=0,6$ sec (Figure 12b). The highest spectral values at these two characteristic periods are concentrated at the area of major damages and certainly this is a persuasive observation of the role of local soil conditions on the magnitude and the spatial distribution of damages.

Figure 11. Spatial distribution of the computed PGA (g) values, EW component
(a) Deconvoluted 12/11/1999 Duzce record (b) Average values of the 5 input motions used.
