Chapter 2

Technology of Rammed-Earth Constructions (“Tapial”) in Andalusia (Spain): Their Restoration and Conservation

Eduardo Sebastián and Giuseppe Cultrone

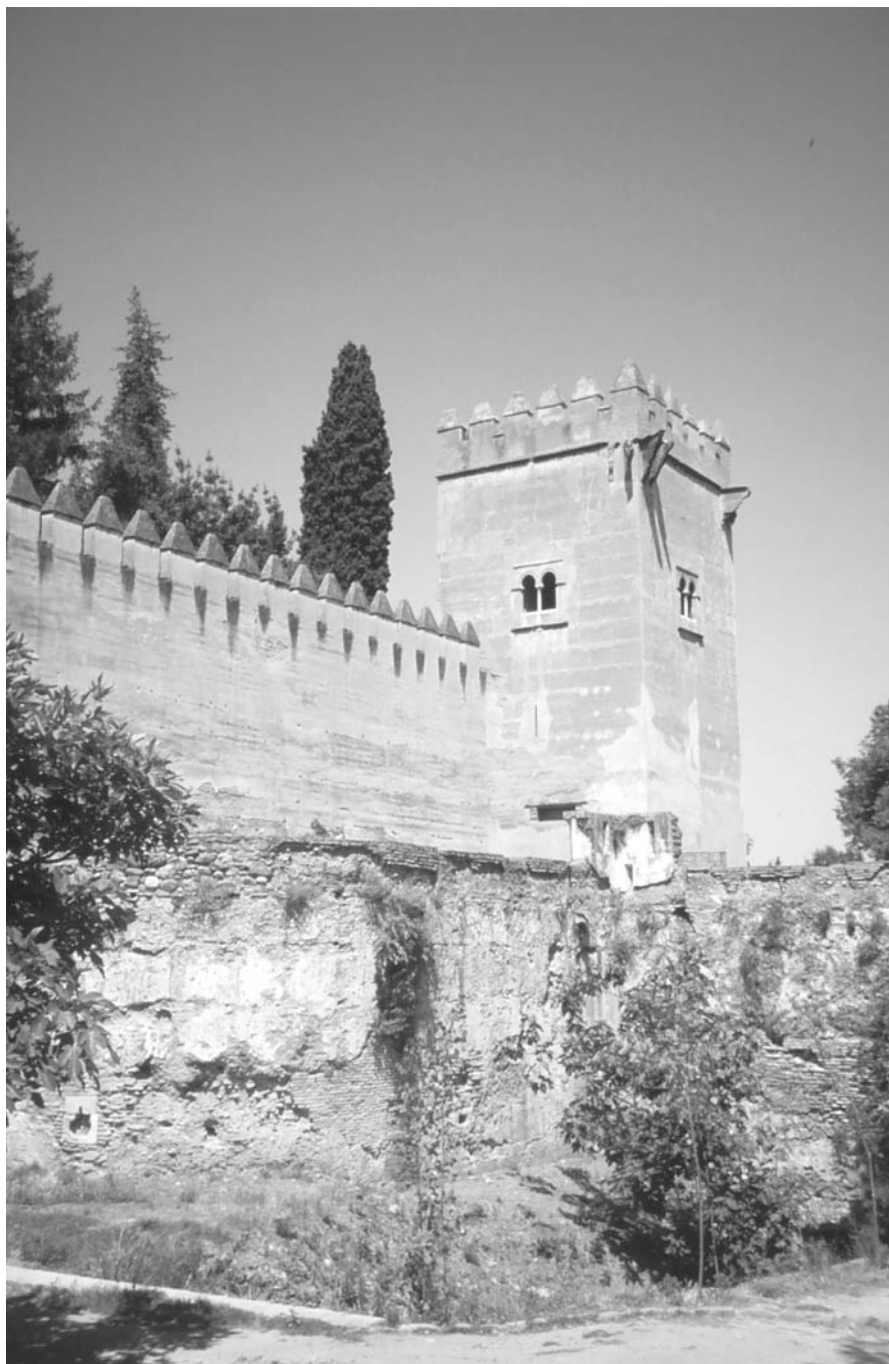
Fig. 2.1 General view of rammed-earth construction in the Alhambra (Spain)

The Alhambra of Granada (Andalusia, Spain) is perhaps the best-known and most striking example of rammed-earth construction (Fig. 2.1), but it is obviously not the only one. There are magnificent rammed-earth constructions in different parts of America, Africa, and Asia (The Great Wall of China is an excellent example). There are also more recent, smaller-scale buildings in different parts of Spain (in Aragon and Castile for example), with perhaps the best examples being found in Andalusia (and especially in Granada which has an important architectural tradition in rammed-earth construction) where a large number of historical buildings made out of earth survive today. From the 11th century onwards earth was used very frequently in the construction of forts, city walls, and towers. This technique was also used in churches built after the conquest of the city by the Christians in 1492. The Church of San Juan de los Reyes in the Albaicín quarter of Granada, thought to be the first Christian church built in the city, is an excellent example. This year the European Community awarded a prize for the restoration work done on this building.
