Analysis of the Effect of Vibration from Footfalls on Office Building

Proceedings of the International Civil and Infrastructure
Engineering Conference 2014

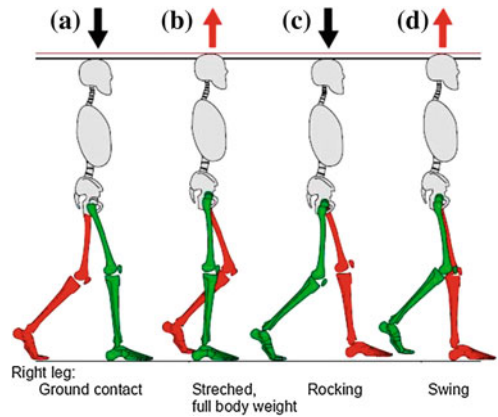
Fig. 1 Phases of legs and feet during walking [4]

Vibration from footfall is induced from the movement phases of legs and feet during walking. Hence, the body weight is transferred to the floor. Figure 1 shows the movement phases of legs and feet during walking.

When the right foot touches the ground with the heel, this is the starting point of the contact forces and when the right leg is stretched, the full body weight is transmitted to the floor. Next, the right foot will rock while the left leg swings forward. This is called “Rocking”. And finally, the left foot touches the ground while the right leg swings forward.

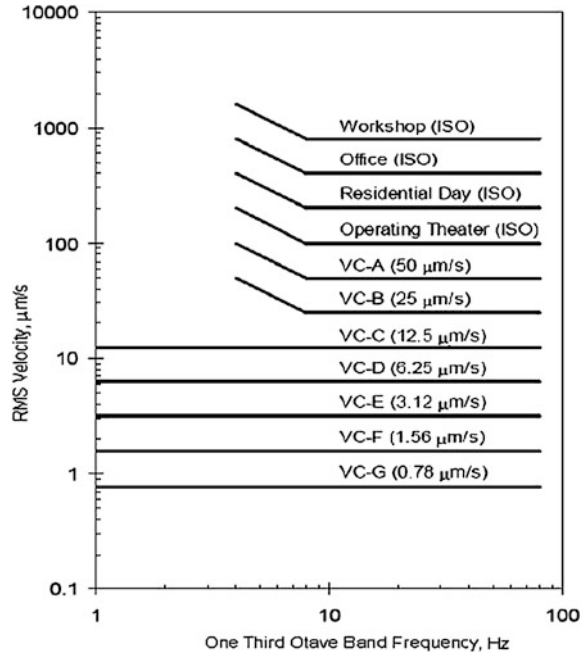
Fig. 2 Generic vibration criteria (VC) curves for vibration sensitive equipment [7]

Vibration criteria curves is important as a guideline in designing facilities such as buildings and instruments that are sensitive to vibrations [4]. Each curve of the criteria are associated with line width or size detail which is a representation of the device capabilities [7] as shown in Fig. 2. The form of the criteria is taken through a

set of one-third octave band velocity where the generic vibration criteria ranges from ISO for the effects of vibration on human occupants in building to VC-G for evaluation only [4].

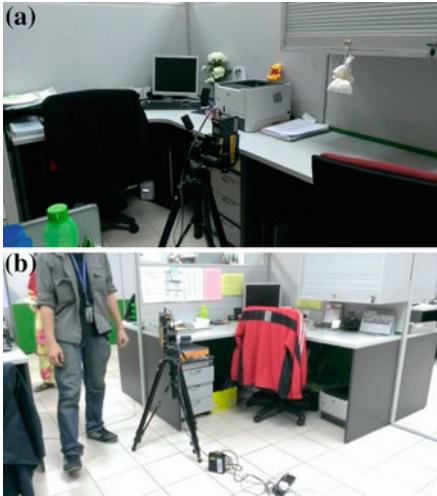
Fig. 3 a Laser Doppler vibrometer (LDV 100). b Measurement at site

Field measurement was conducted to obtain the signal data for this study by using the Vibrometer equipment. The amplitude of the vibration produced by footfalls is measured during office hour on working days. Figure 3a shows the Vibrometer equipment used in this study, Laser Doppler Vibrometer (LDV 100) and Fig. 3b shows the location of the measurement in the office building, while Fig. 4 shows the side view of the Registrar office building.

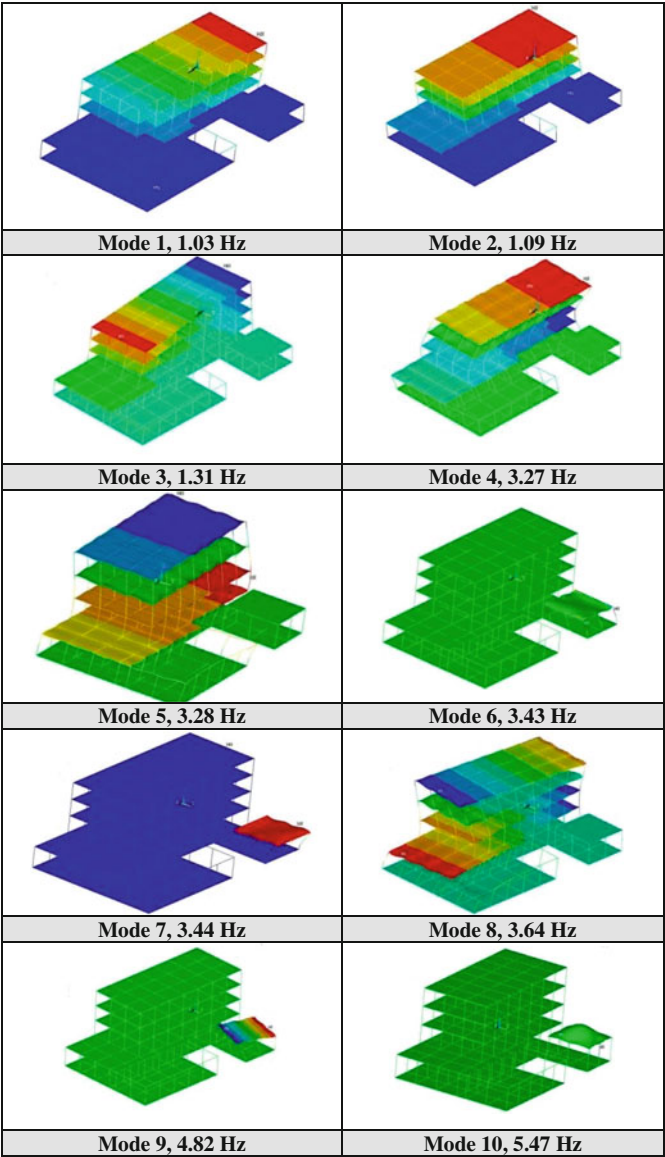
Fig. 7 First ten mode shapes of the Registrar office building

Mode shape analysis was performed to determine the condition of the floor structure of the Registrar office building when subjected to different frequency modes. The first tenth modes are shown in Fig. 7. The fundamental mode of the building has a natural frequency of 1.02 Hz and shows no obvious deformation for the rest of the modes. Changes in the horizontal direction are not taken into account as the displacement at the column is not considered in this study. Only the vertical direction which shows changes on floor behaviour is taken into consideration.

The highest peak displacement for both directions is represented by the red area while the minimum displacement is represented by the blue area. For areas with the highest deflection, it is not recommended for sensitive equipment. The occupants in that area may also be affected.

A detailed description for each mode as shown in Fig. 7 is described in Table 3 for both horizontal and vertical directions. The model was analyzed under 100 modes to obtain the peak response of natural frequency and vertical behavior of the building floor structure.

represented by the red area while the minimum displacement is represented by the blue area. Green areas shows a little displacement and not so obvious. For areas with the maximum deflection, that area is not suitable for sensitive equipment and people in this area may also be affected.

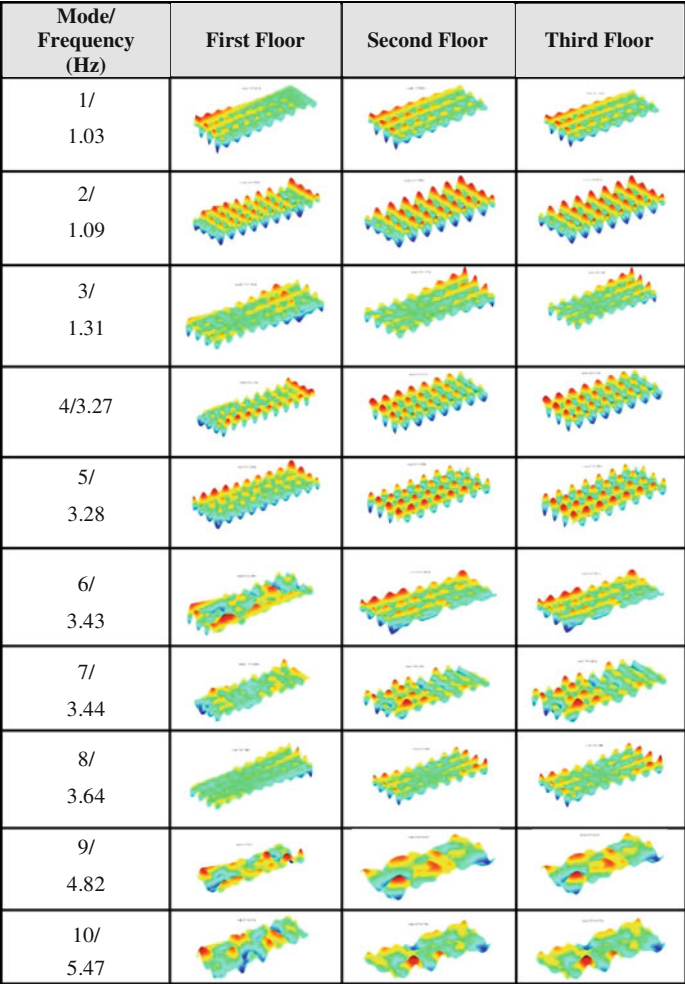
Fig. 8 Deform shape in VSATs, **a** first floor, **b** second floor, and **c** third floor

Figure 8 shows the mode shapes of the first tenth modes obtained using VSATs analysis. Results obtained from VSATs in Fig. 8 shows the mode shape of each floor be identical or almost identical with the mode shape obtained in Fig. 7.

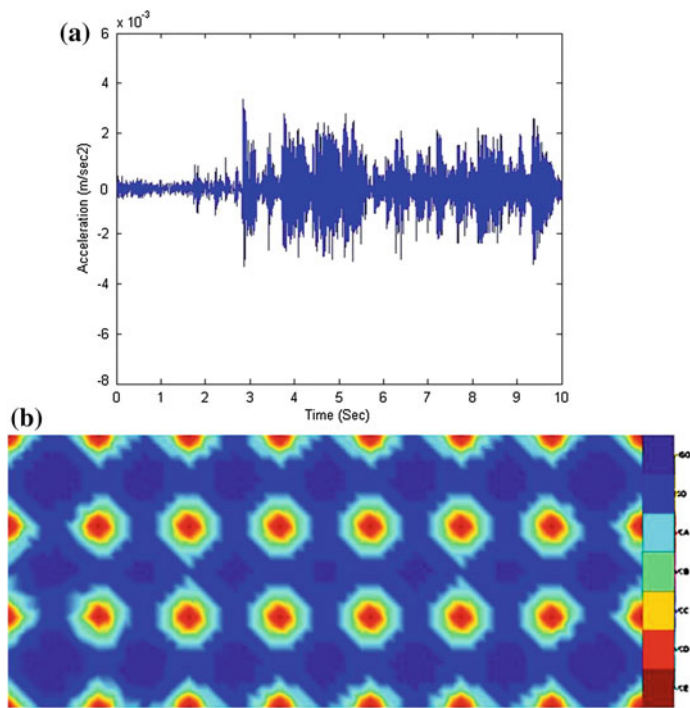
Fig. 9 a Vibration input and b response on the third floor of the Registrar office building

Vibration serviceability analysis was carried out on each floor using VSATs. Figure 9a shows the vibration input and Fig. 9b shows the response after applying the input from field measurement on the third floor of the Registrar Office building.

The dark blue areas represent the highest VC level which is above ISO standard, unsuitable for area with sensitive equipment while the light blue areas represent the ISO standard VC level, appropriate for office and no sensitive areas. The brown area represents VC-E, the lowest VC level.

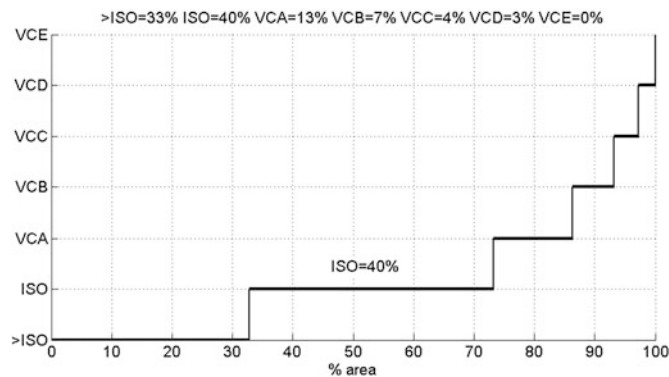
Fig. 10 The vibration criteria value on the third floor of Registrar office building

generic criteria guideline [4], 38 % ISO for first floor, 39 % ISO for second floor and 40 % ISO for the third floor. The vibration response for third floor is shown in Fig. 10.
