CYCLIC SOFTENING OF LOW-PLASTICITY CLAY AND ITS EFFECT ON SEISMIC FOUNDATION PERFORMANCE

ABSTRACT

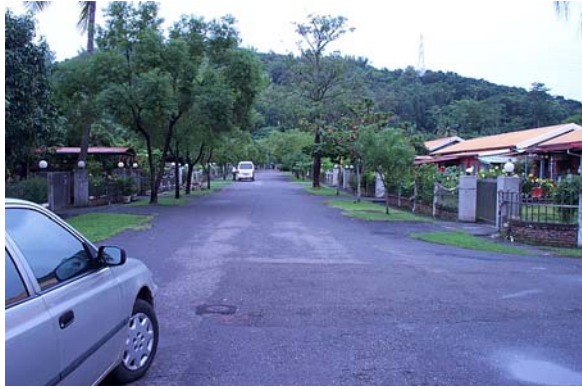
Figure 2. Single-story buildings on the east side of Wufeng Site A (P-1 by D. Chu, 2001)

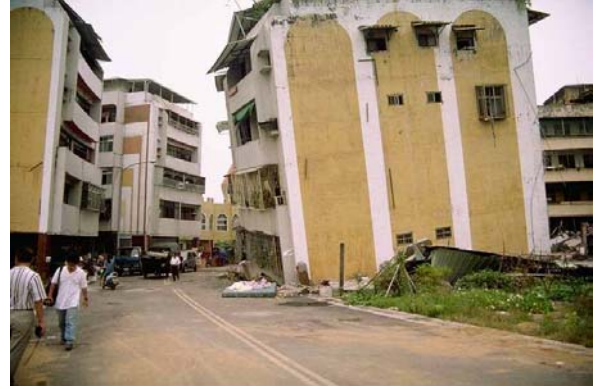
Figure 3. Collapsed 6-story reinforced concrete building on west side of Wufeng Site A (P-2 by R. Seed, 1999)
